EAGLE CREEK RESORT ASSESSMENT

ILLINOIS DEPARTMENT OF NATURAL RESOURCES

DNR PROJECT 3-15-006

May 9, 2016

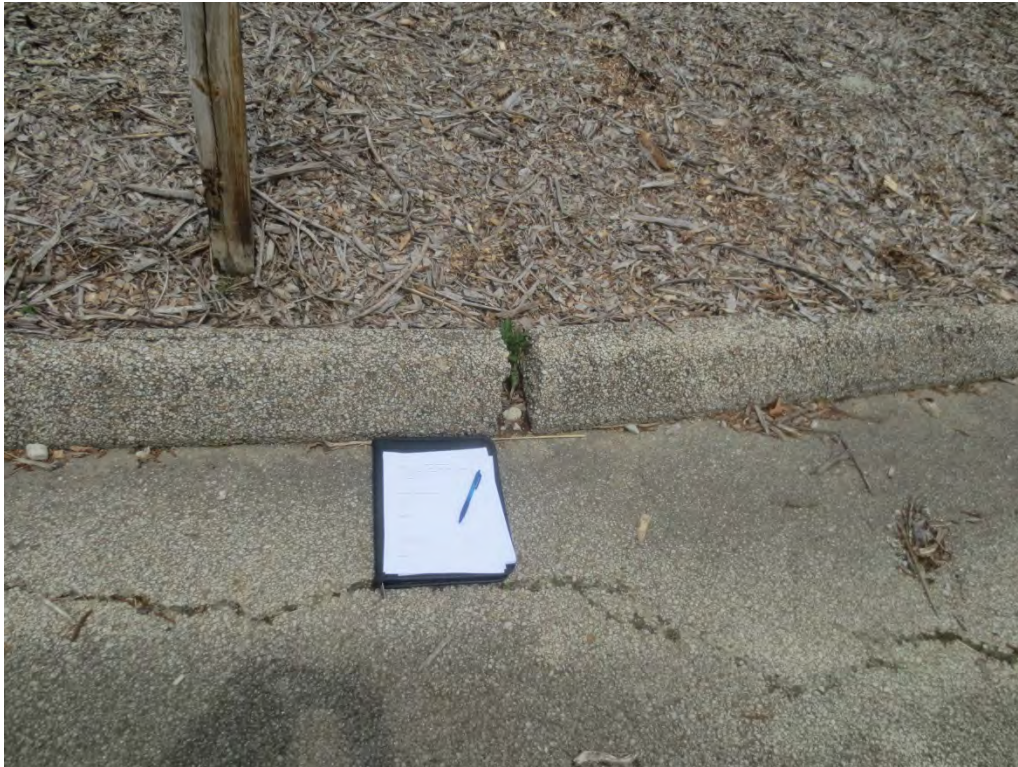
Asphalt curb cracks - typical

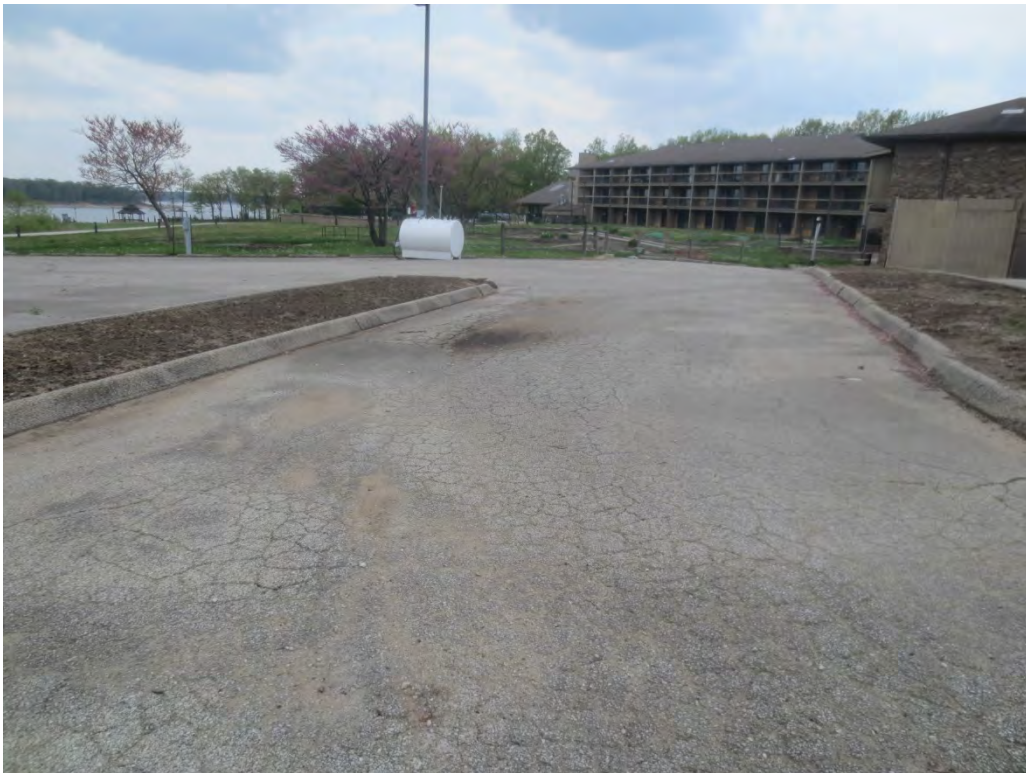
Alligator cracking northwest end of parking lot

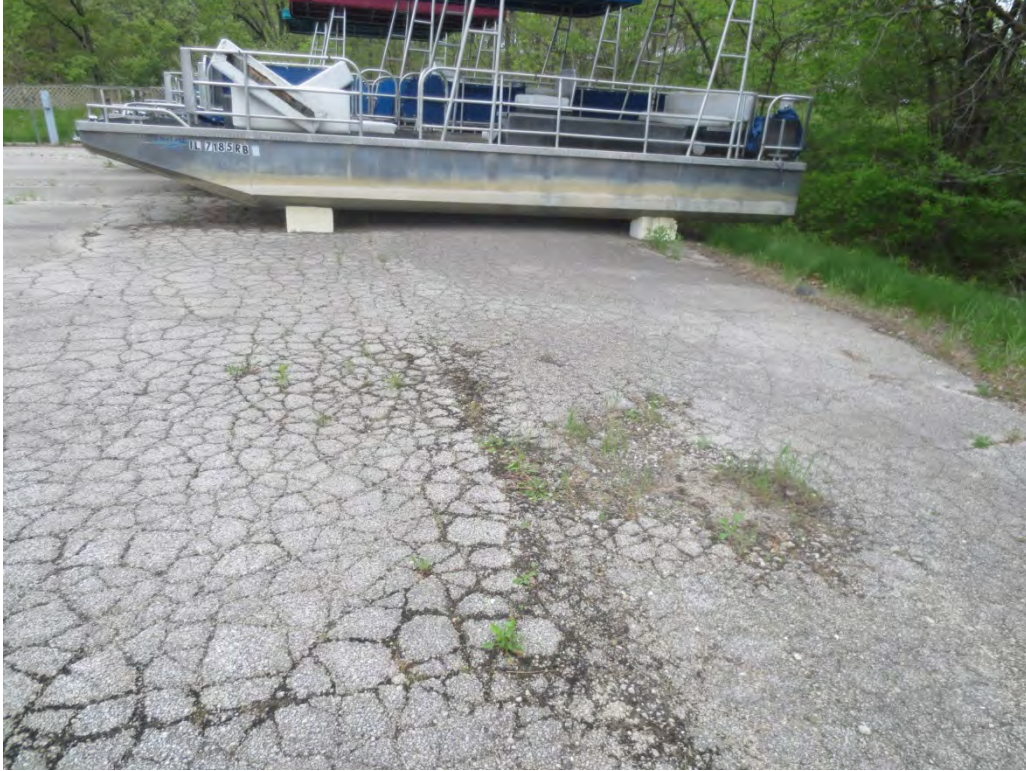
Significant pavement deterioration south end of parking lot

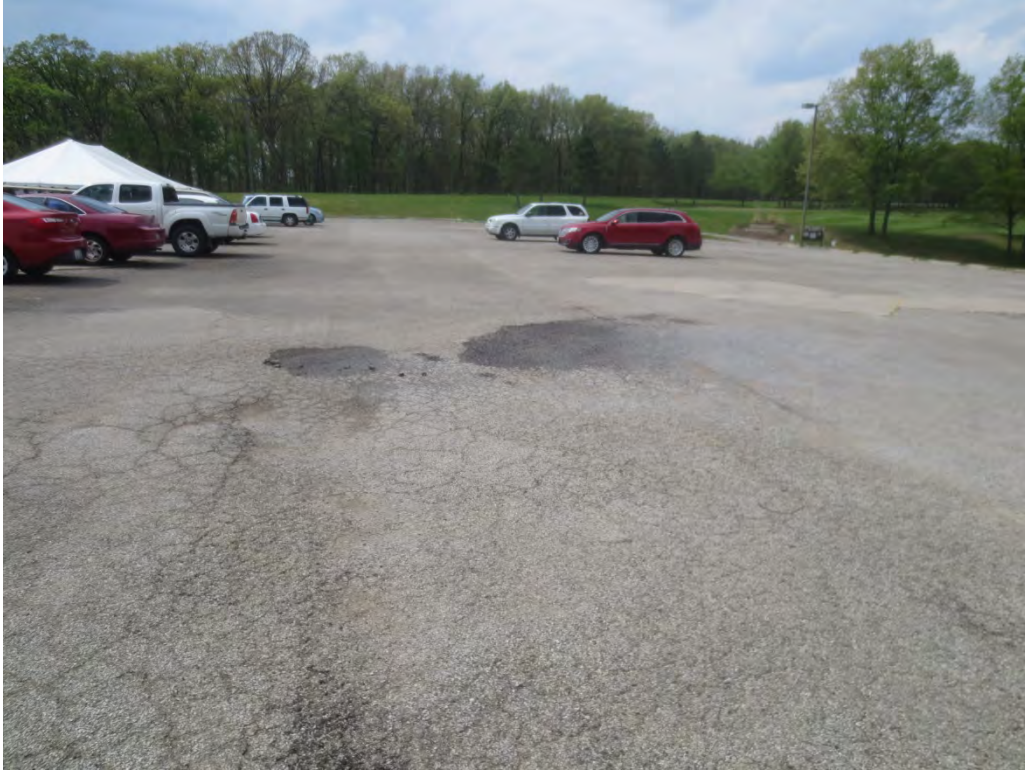
Evidence of localized ponding and pavement deterioration

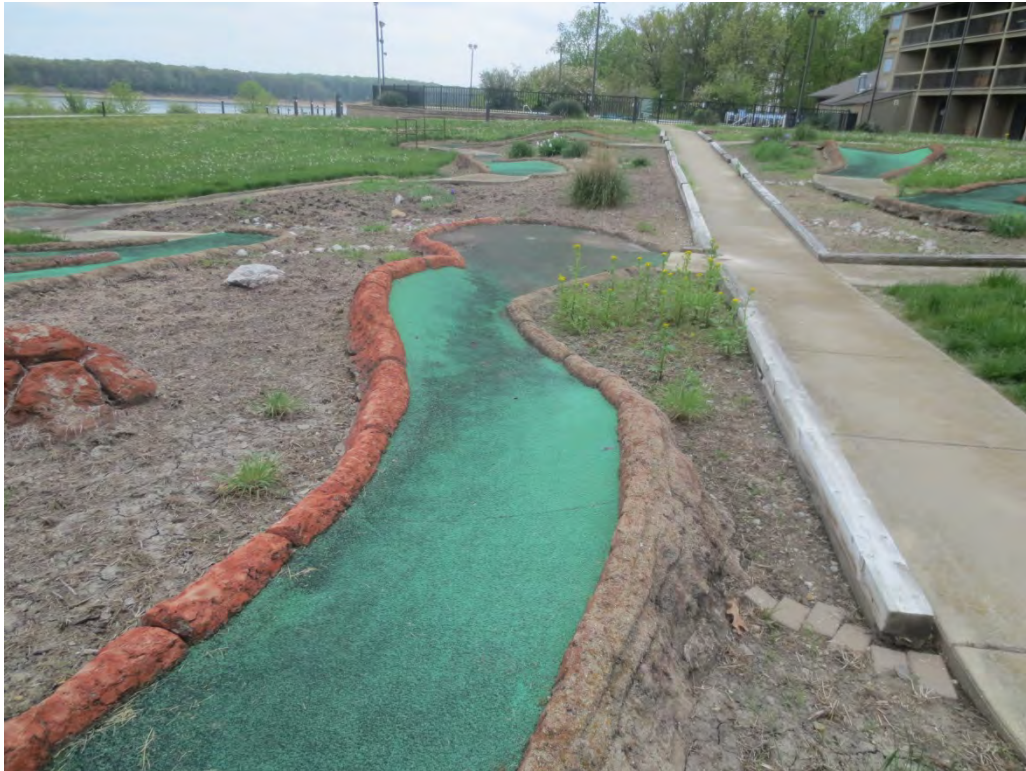
- The mini golf area is in fair to poor condition. The holes are carpeted over concrete. The putting surface carpeting is in very poor condition and requires replacement.
- There is minimal landscaping or trees in the area.
- Generally, slopes do not appear to meet current ADA requirements.
- This area would require a complete rework during reconstruction phase.

Mini golf area – typical condition*

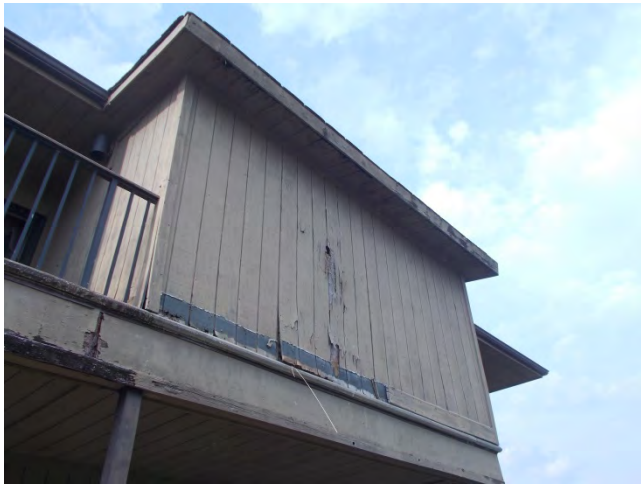
Wood siding and trim is typically in poor condition throughout. Holes, cracks, and missing trim pieces appear in numerous areas (Figure 7). These deteriorated conditions have been typically left uncovered and therefore have made the wall cavities susceptible to water infiltration. There is some evidence of water damage from inside the walls (Figure 8). Additionally, the removal of thru-wall air conditioner units without properly covering the wall opening has often left the inside of wall cavities exposed and susceptible to water and moisture damage (Figure 9). There is water damage on the wood trim in numerous areas. The original paint finish on the siding and trim has faded and begun to peel over time leaving the bare wood susceptible to further deterioration (Figure 10). Wood trim is also separating from the façade at various locations.

Figure 7 – Typical Wall Deterioration

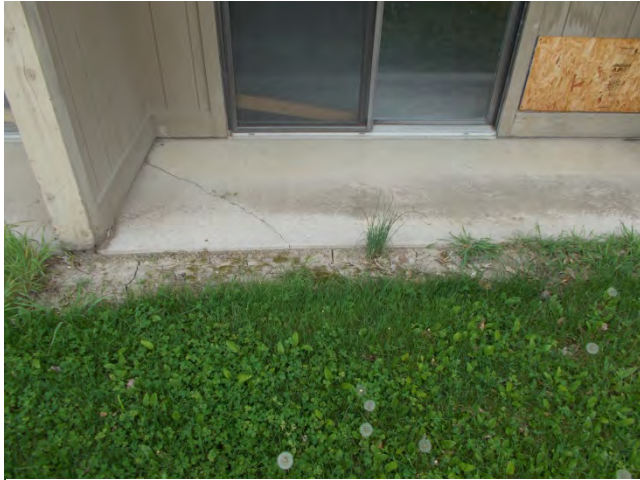
Concrete patios at hotel rooms often have significant cracks appearing (Figure 11). This could be partly due to poor drainage around the foundation as there is some evidence of eroding of the subbase beneath the concrete patios (Figure 12).

Figure 11 – Concrete Patio

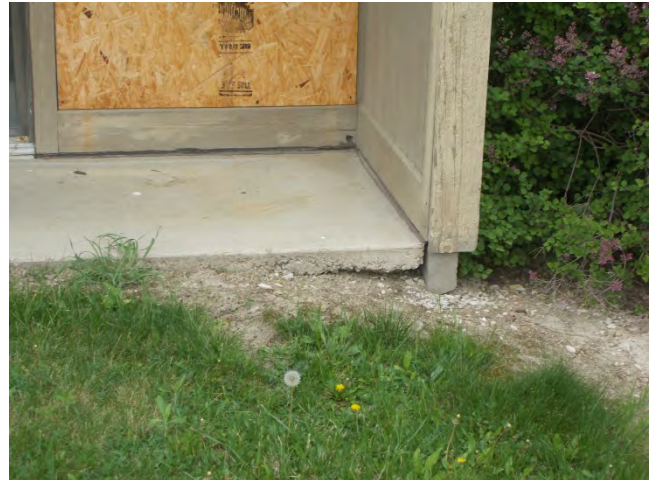
Figure 12 – Soil Erosion at Patio

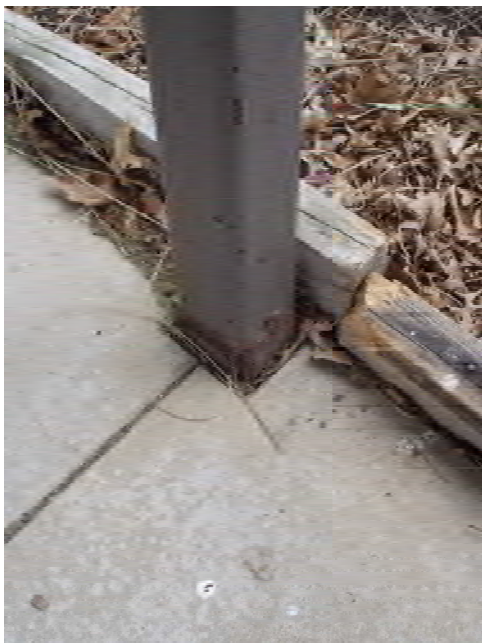
Exposed painted steel posts at both the main entry walkway and south patio have significant rusting at their bases typically (Figures 13 and 14). Significant section loss due to corrosion would require full replacement.

Figure 13 – Steel Supports

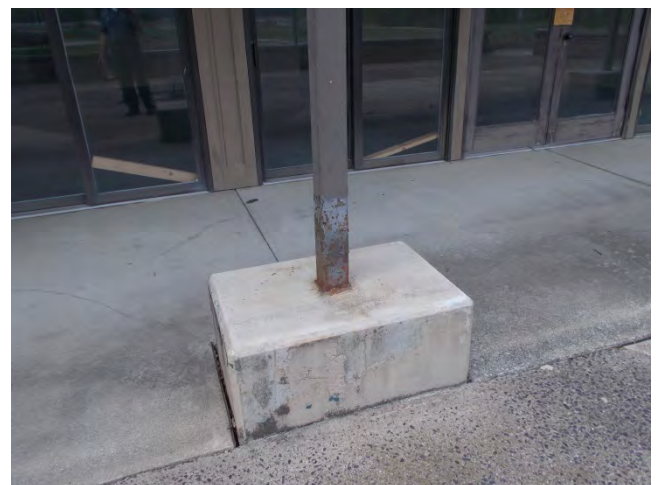
Figure 14 – Raised Pier and Steel Support

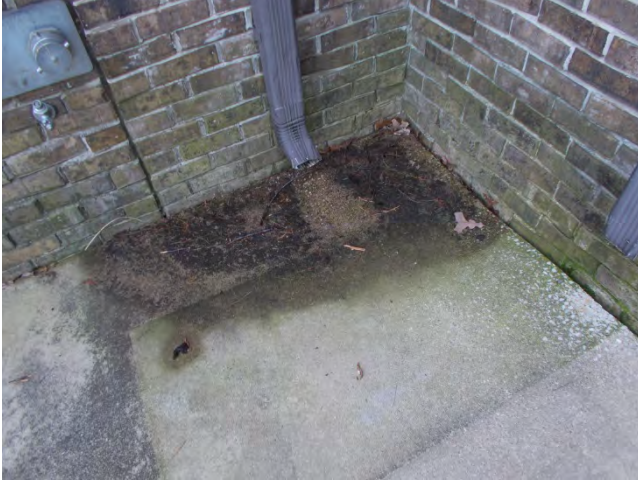
Missing or damaged downspouts and splash blocks have created conditions where water has not been shedding properly away from the building and has likely caused roof/foundation damage due to erosion (Figures 15 and 16).

Figure 15 – Downspout

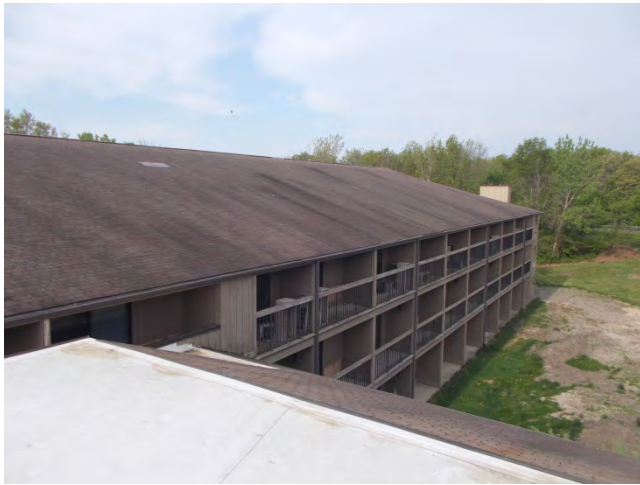
Asphalt shingles are in poor shape and have presumably outlived their useful life, and are likely original to the hotel. Visual imperfections such as discoloration and sagging at ridges suggest the age and wear of the shingles and substrate (Figures 23 and 24). In numerous areas throughout the shingled portions of the roof substantial holes have appeared, most likely created by animals. These holes have been temporarily covered with stainless steel sheets anchored to the roof through the shingles (Figures 25 and 26). However, it is likely that water has infiltrated the inside of the building and may have caused damage to the roof structure. The plywood sheathing is likely to be damaged and require replacement in some areas. There are numerous areas inside where ceiling tile has sustained water damage.

Figure 23 – Roof

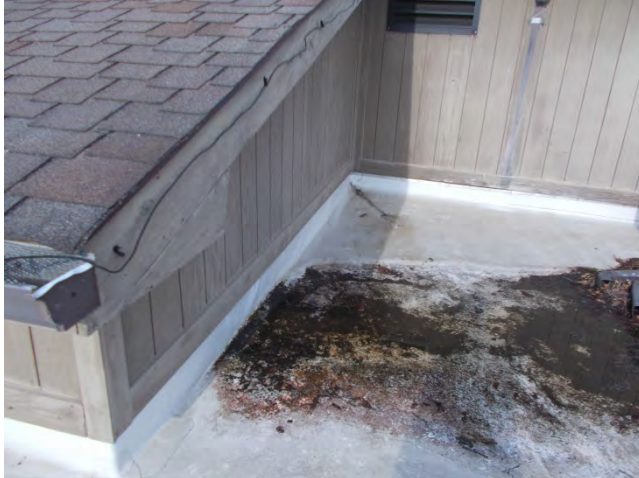
Gutter and downspout system is substantially damaged and is missing pieces throughout. Missing downspouts have caused water to pool and collect in some parts of the flat roof and has caused staining and deterioration to the wood siding, trim, and asphalt shingles (Figures 27 and 28). Some flat roof areas are exhibiting mold.

Figure 27 – Mold at Flat Roof

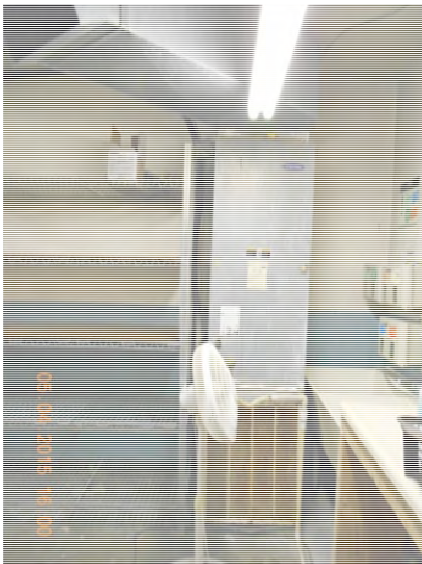
The laundry room supplementary split system cooling unit and gas fired hot water heater appear to be original and in poor condition. These units have exceeded their useful service life. These units are Class 1 items (Figure 4).

Figure 4 – Laundry room cooling unit

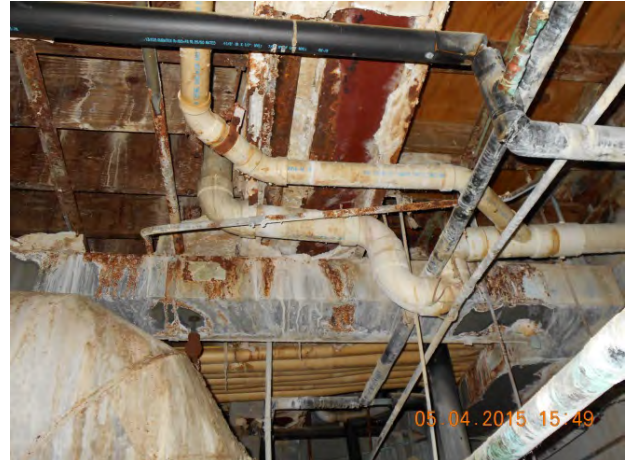
Ductwork appears to be original and in poor to good condition. Interior condition of ductwork was not observed. These are Class 2 and Class 3 items (Figure 10).

Figure 10 – Mechanical room ductwork corrosion

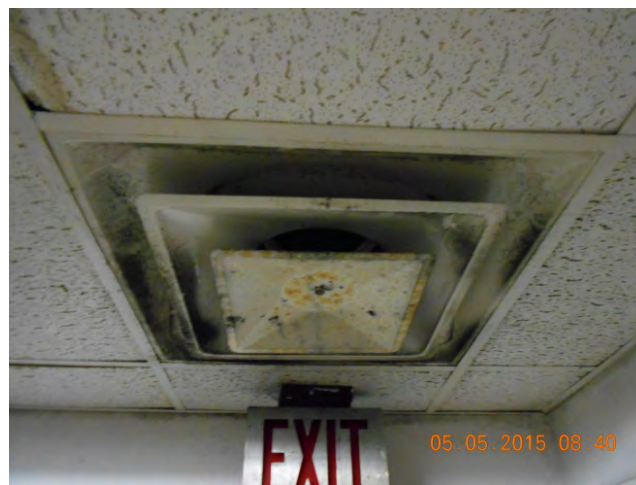
Observed diffusers, grilles and registers appear to be original and in poor to good condition. These are Class 1 and Class 3 items (Figure 11).

Figure 11 – Supply diffuser mold

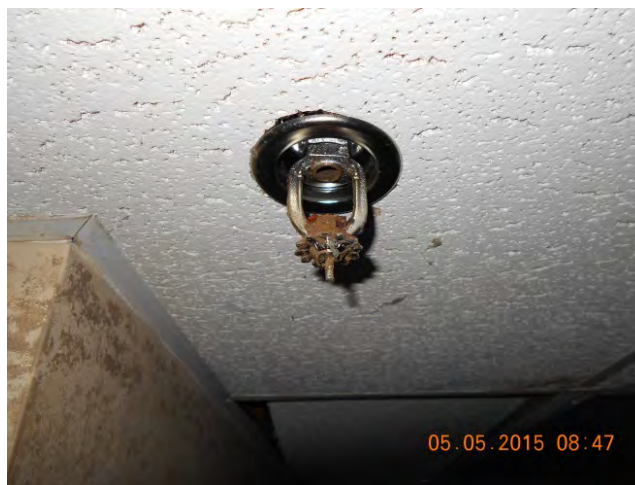
Building sprinkler heads are a combination of exposed pendent type, recessed, exposed, sidewall and upright depending on room architecture. All sprinkler head fuses have been removed (Figure 5).

Figure 5 – Sprinkler head with fuse removed located in main hotel

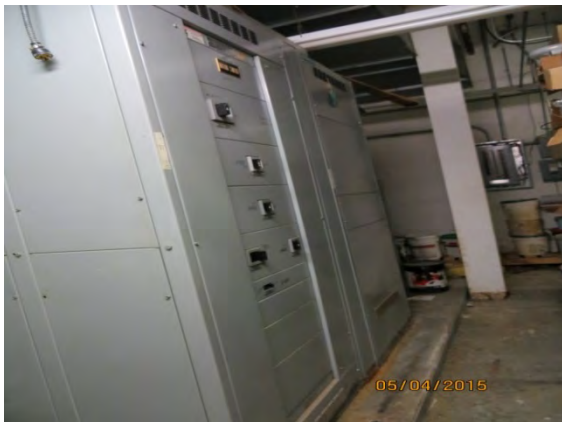
The load side of ATS is connected to the 2500 Amps 277/480 volts, 3 phases, 4 wires Service Switchboard, which is located in basement in the Electrical Room (Figure 5). The feeder cables are in concrete encased conduits from the ATS to the switchboard. These conduits are also filled with water and water can be seen in the conduit space below the switchboard (Figure 6). In addition, there is 4 inches of corrosion along the perimeter of the switchboard providing evidence that water has infiltrated the switchboard via the conduit system.

Figure 5 – 2500 amp, 277/480VAC main switchboard with corroded base

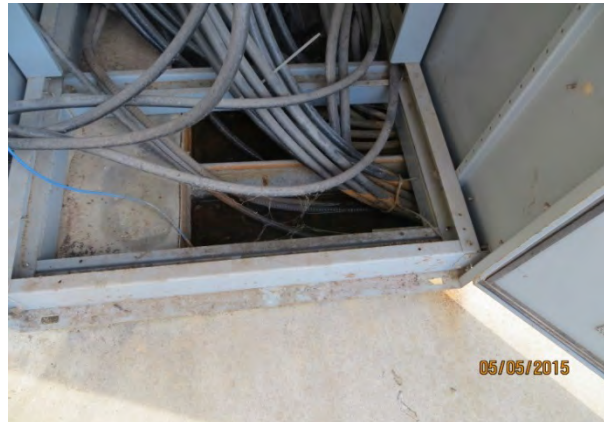
Figure 6 – 2500 amp, 277/480VAC main switchboard with submerged service feeders

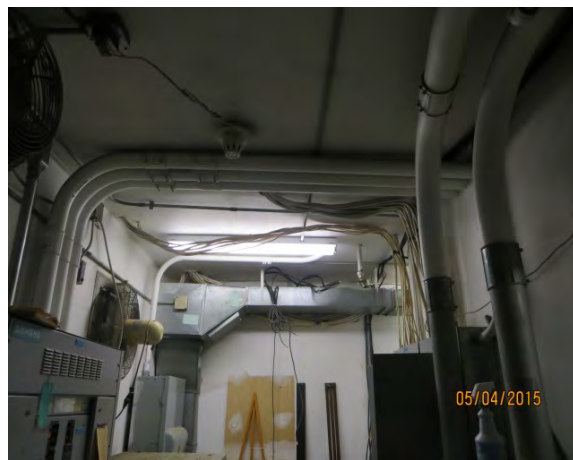
The electrical rooms in general are in good condition. Some general maintenance and cleaning of the rooms is required. Some loose wires should be neatly trained and supported properly. Proper labeling of equipment, conduit, cables etc. is required. (Figure 8)

Figures 8 – Wires dangling in ceiling

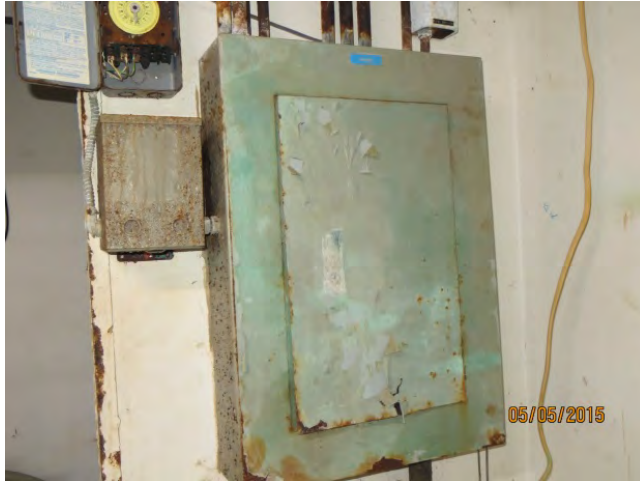
The electrical panels serving the inside swimming pool are corroded. All electrical equipment including conduit and wires in this area should be replaced. Electrical equipment subject to this environment should be rated NEMA 4X. Refer to the Pool Section of this report for additional details (Figures 9 and 10).

Figures 9 – Indoor swimming pool panelboard

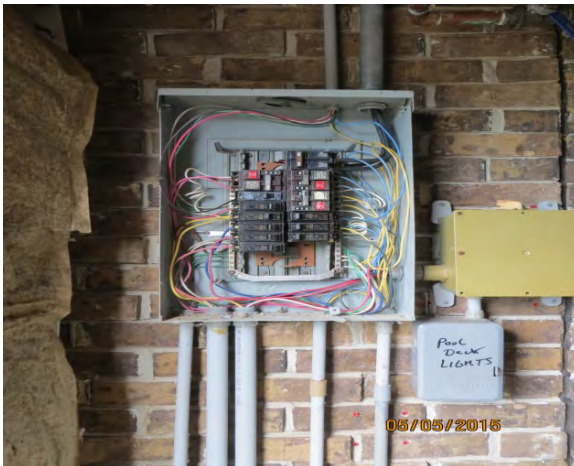
The electrical panel serving the outdoor swimming pool is corroded and its cover is missing. All electrical equipment including conduit and wires in this area should be replaced. Electrical equipment subject to this environment should be rated NEMA 4X. Refer to the Pool Section of this report for additional details. (Figures 11 through 14)

Figure 11 –Outdoor swimming pool panelboard

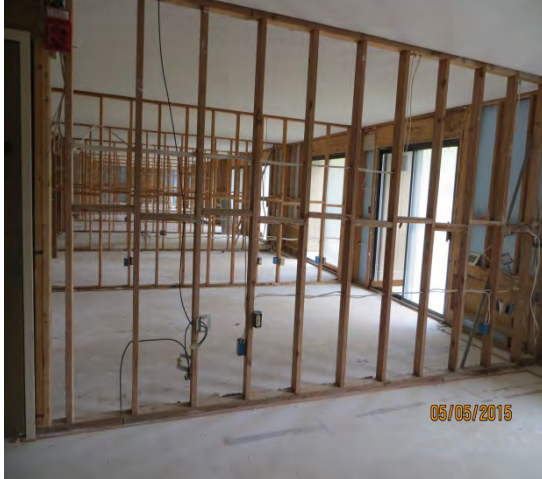
Figure 41 - Typical open wall for every hotel room – electrical outlets with non-metallic sheathed cable installation
