**BIOTIC CHARACTERIZATION OF THREE STREAM SEGMENTS
MACON COUNTY, ILLINOIS**

SPRING OF 2006

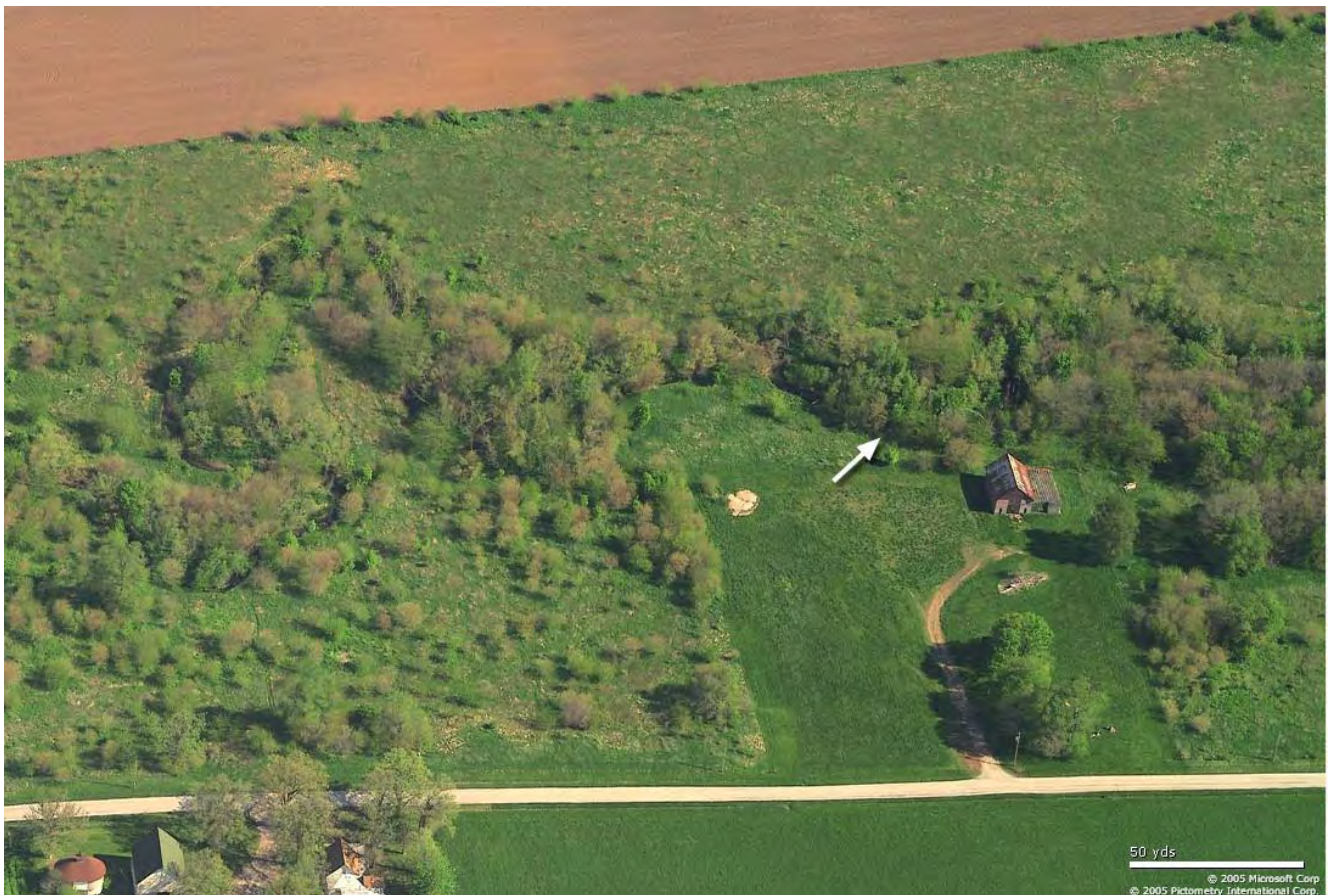
The arrow marks the general location where sampling began. The grain bins visible in the 1998 aerial photograph have been removed (the remaining barn shown here was demolished this past spring).

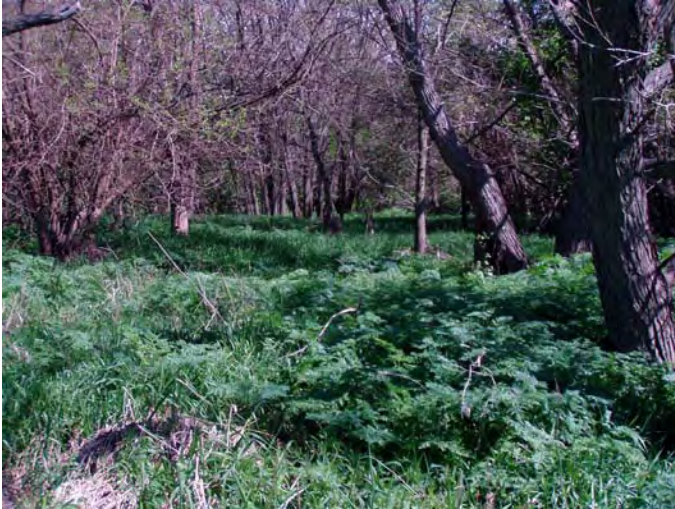
Portions of property starting to form closed canopy

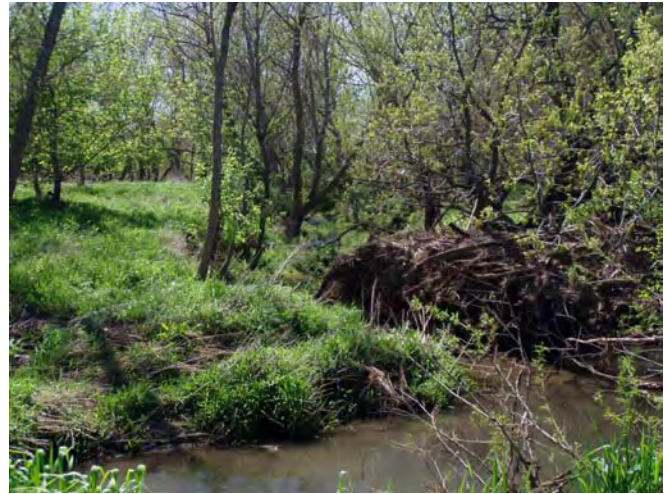
Vegetation dominated by grassy understory

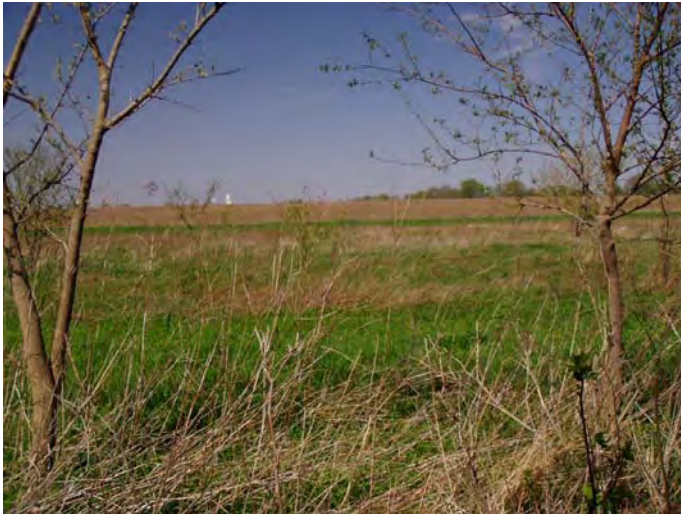
Portions remain relatively treeless

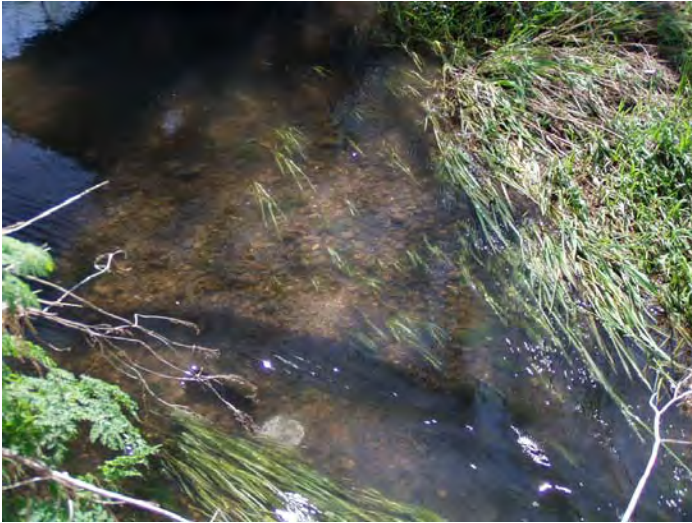
Typical view of in-stream vegetation

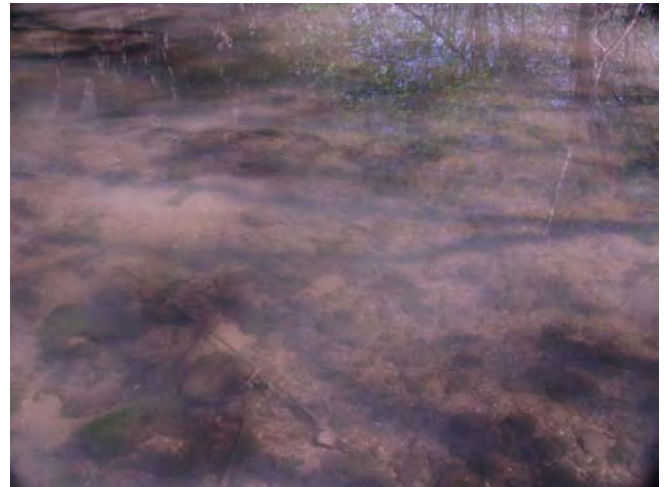
Typical view of pool

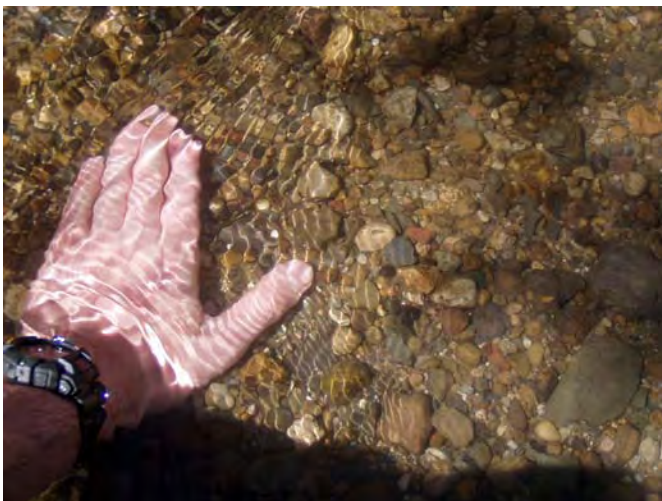
Typical riffle substrate

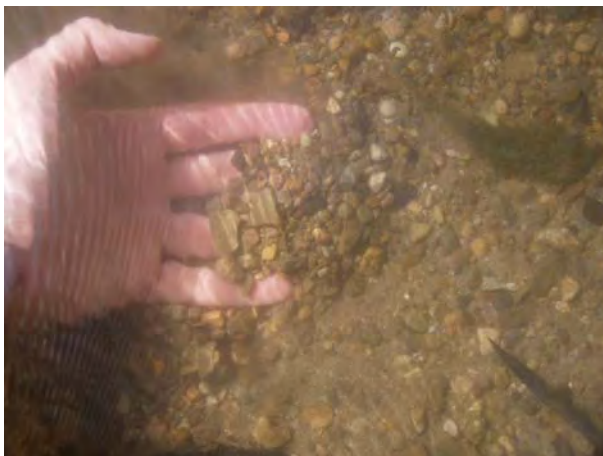
Typical run substrate – low embeddedness

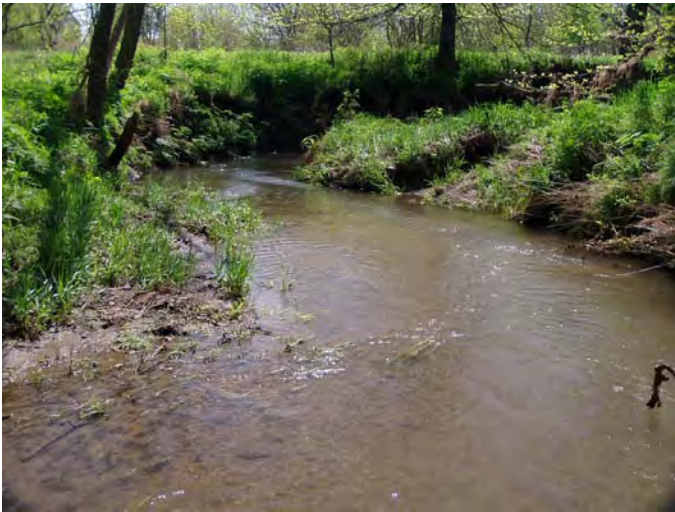
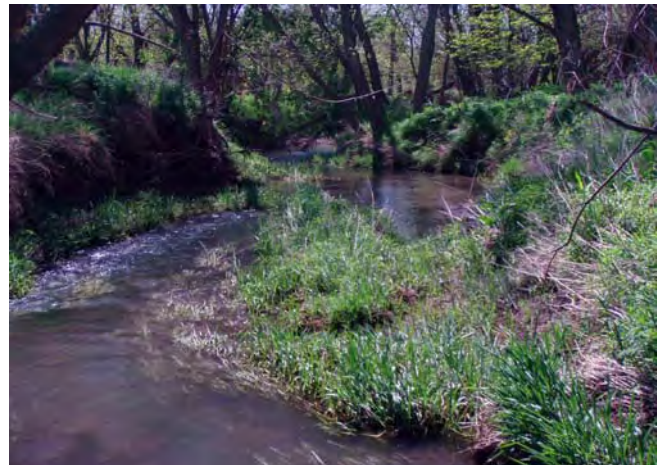
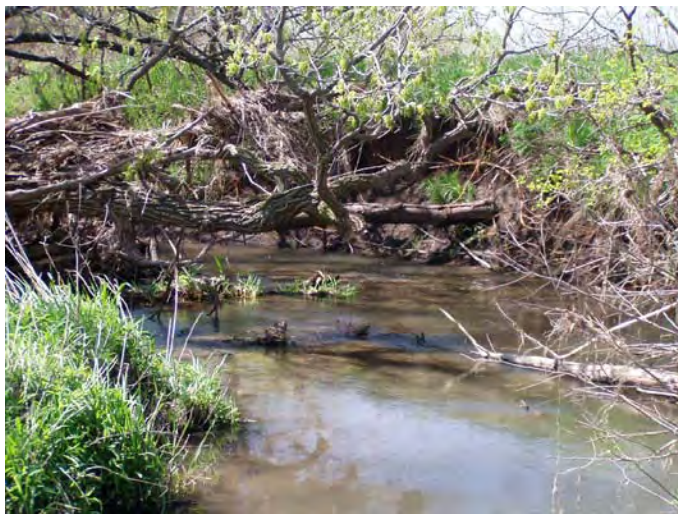
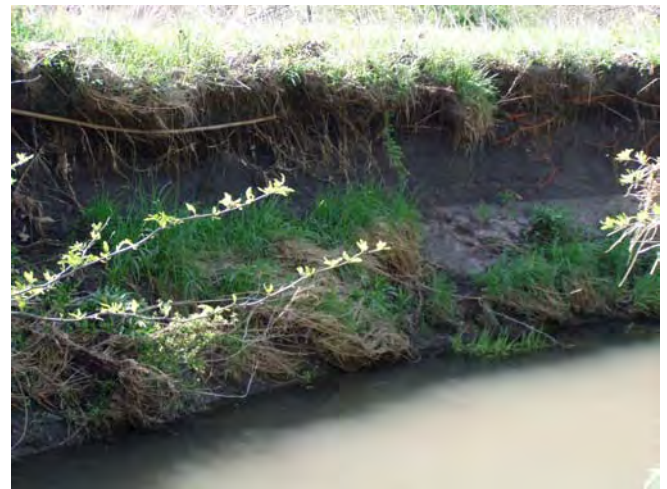
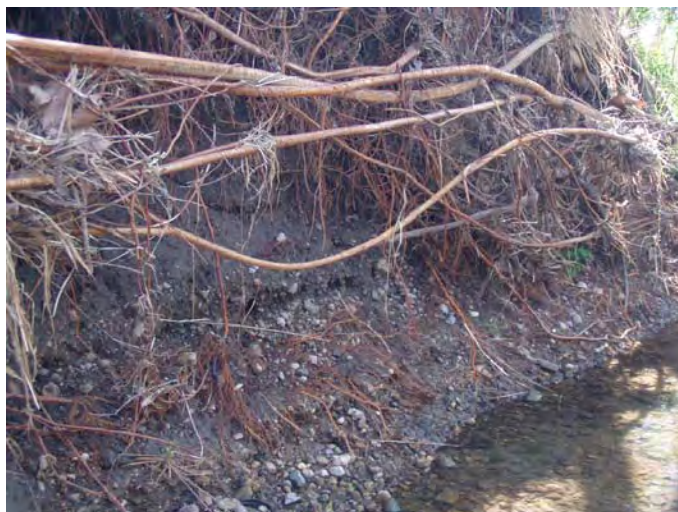
The stream has a high degree of sinuosity (top left and right) and a good development of riffle-run-pool complexes. The stream is incised approximately seven feet and the banks are actively eroding. Large sections of the outside bends have potential for mass wasting (above right). There is an abundant amount of woody debris (above left) which is contributing to both pool and habitat variability. Although the stream is incised and the banks are eroding, there are large sections of till exposed (left) which is contributing substrate to the stream.

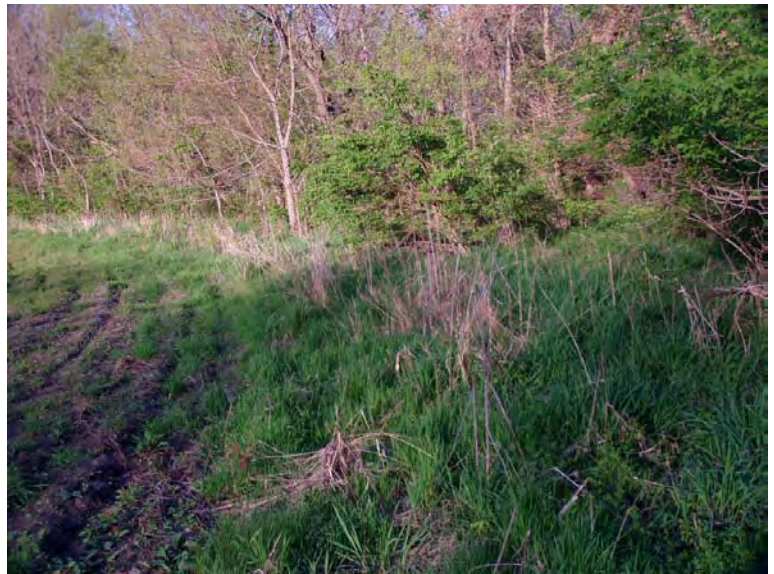
The areas where the agricultural field immediately abuts the stream have a buffer less than 25 feet

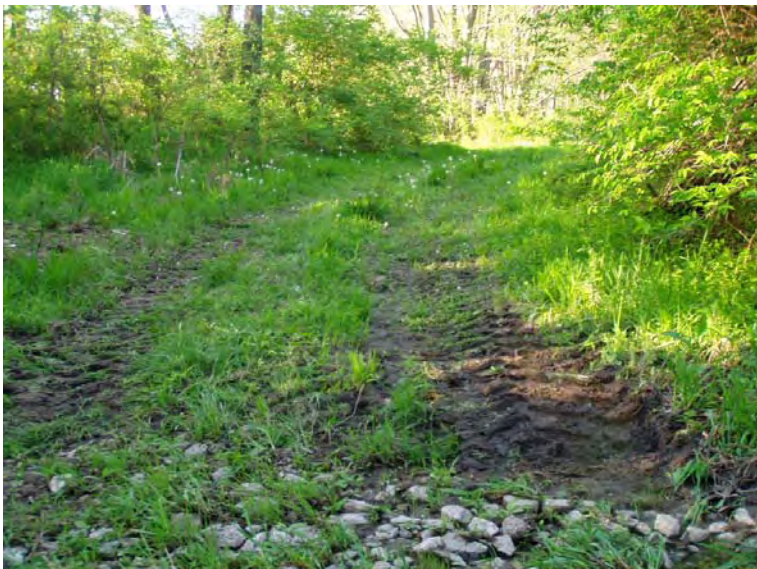
A farm lane cuts through the forested section to allow access to the adjacent field via the stream crossing

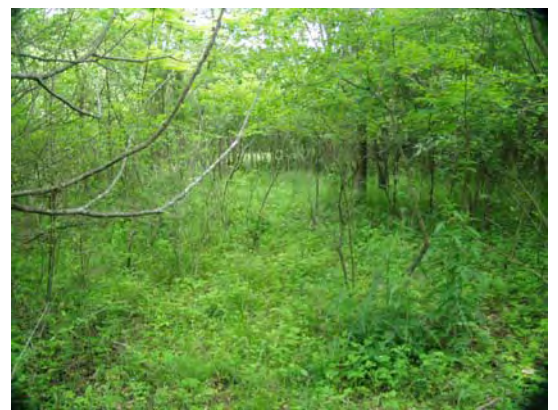
The forested areas are irregular in shape and are composed mostly of early successional species

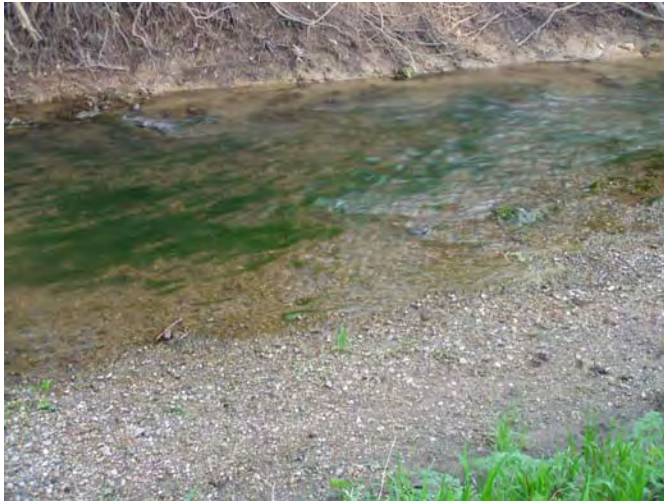
Gravel bars prevalent along system

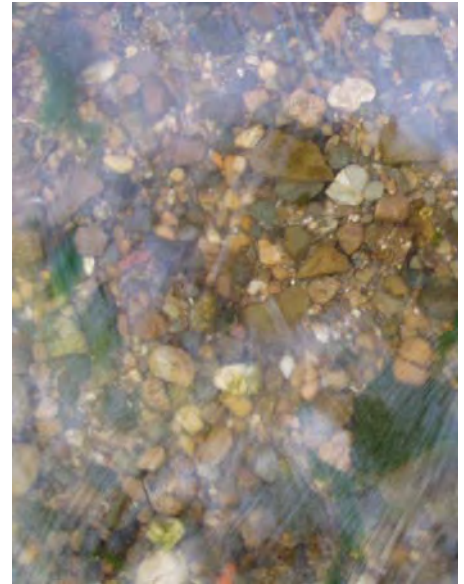
Embeddedness low in riffle-run

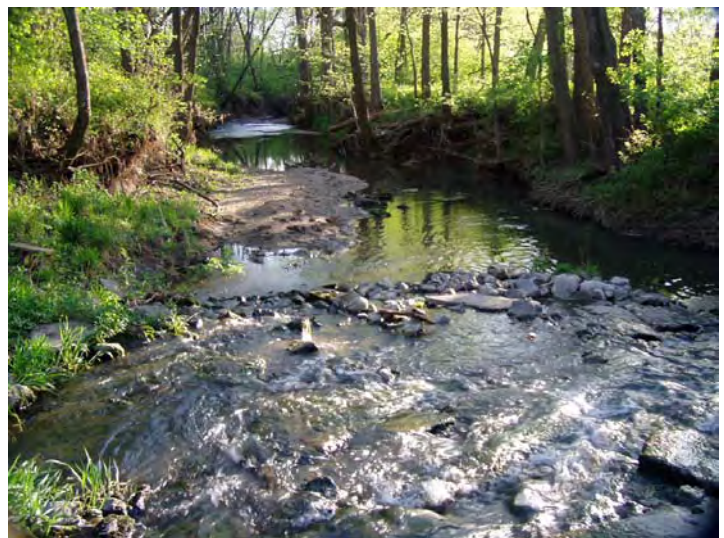
Looking downstream from top of artificial crossing

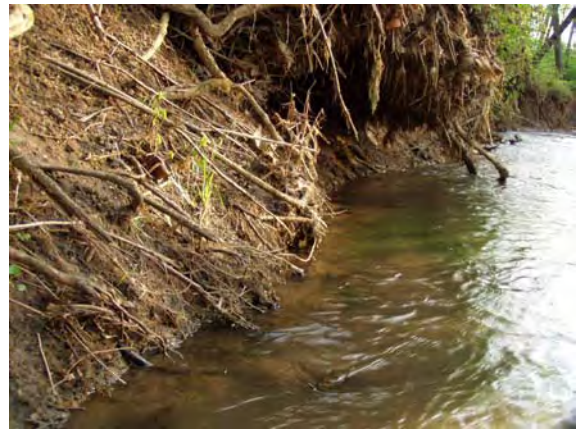
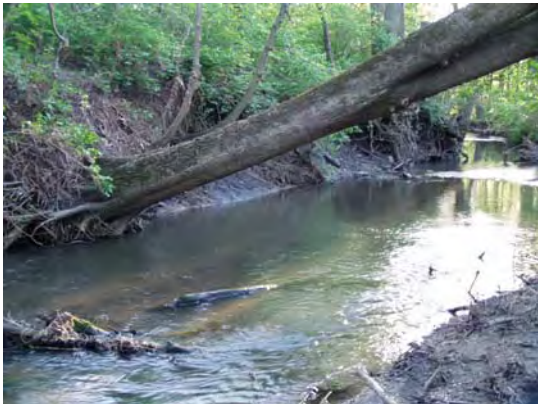
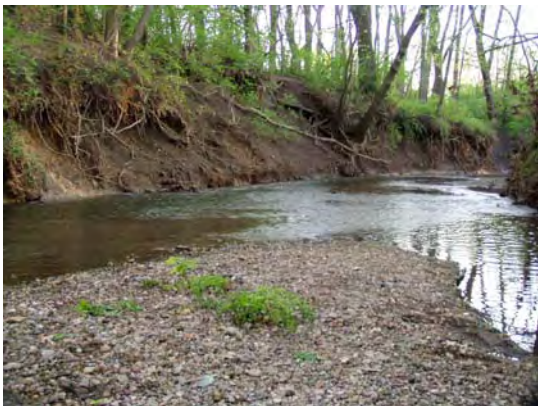
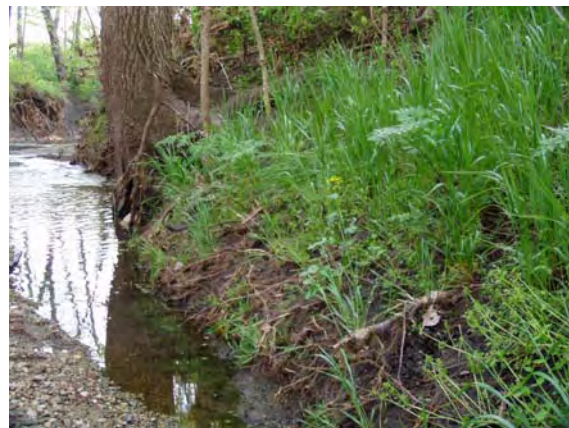
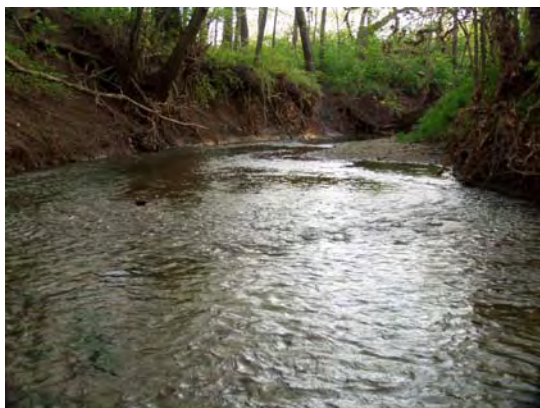
Channel sinuosity is on the low side of moderate. Access to the floodplain is limited due to the incision and the channel is rather trapezoidal in shape (two photos below left). There is very little streambank vegetation present, limited to small pockets (photo below). Rootwads and rootmats provide a fair amount of macroinvertebrate habitat (photos above left and above). The stream does dry down during droughty summer periods; however, the deeper pools do retain water leaving isolated aquatic communities. Although overall the erosive potential of the banks is quite high, the banks appear to eroding but not mass wasting.

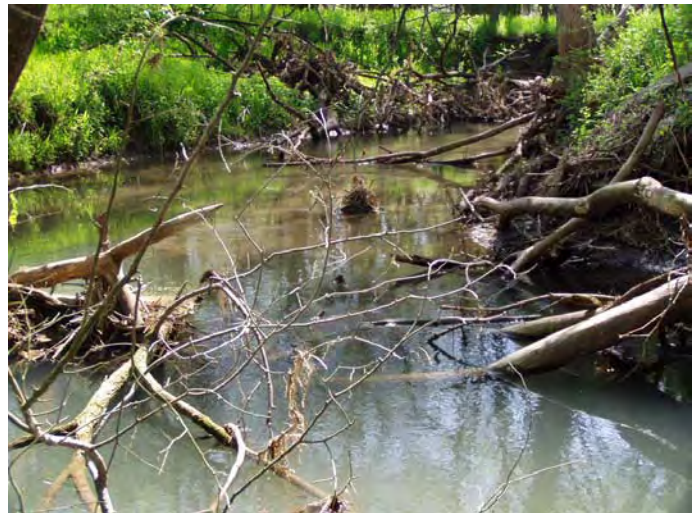
The stream has an abundance of woody material in channel

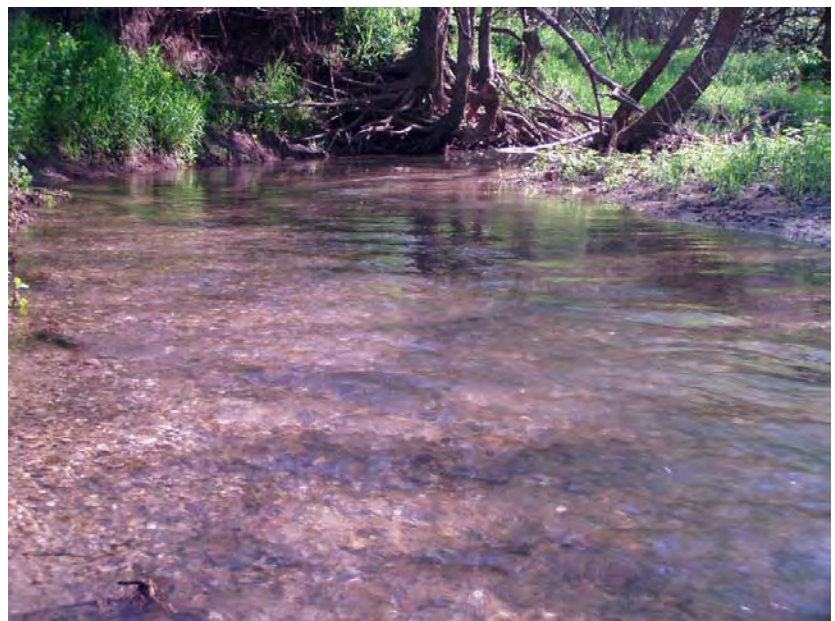
The riffles are fairly confined and long runs between the pools are typical

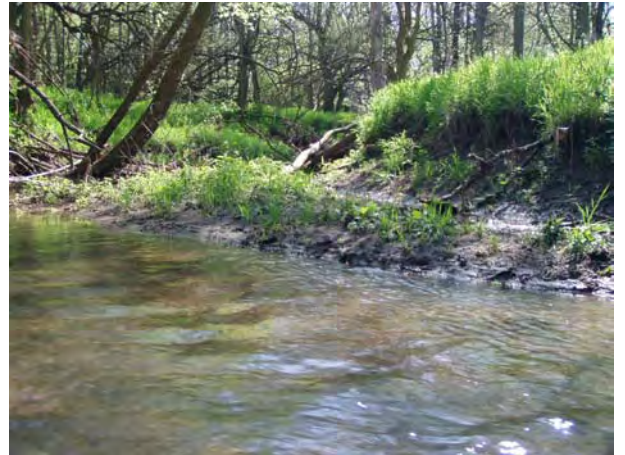
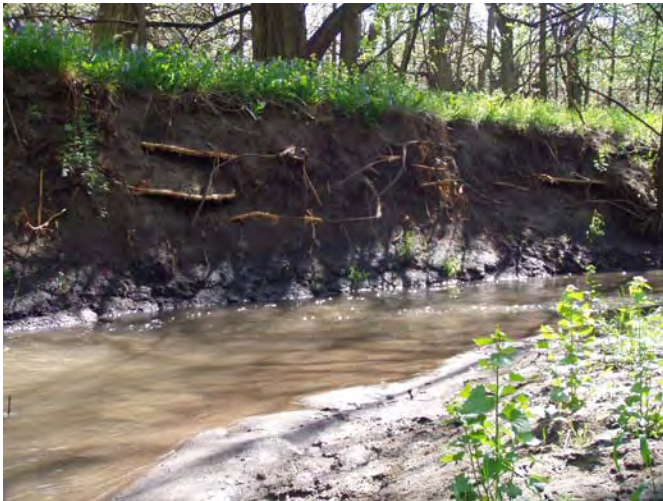
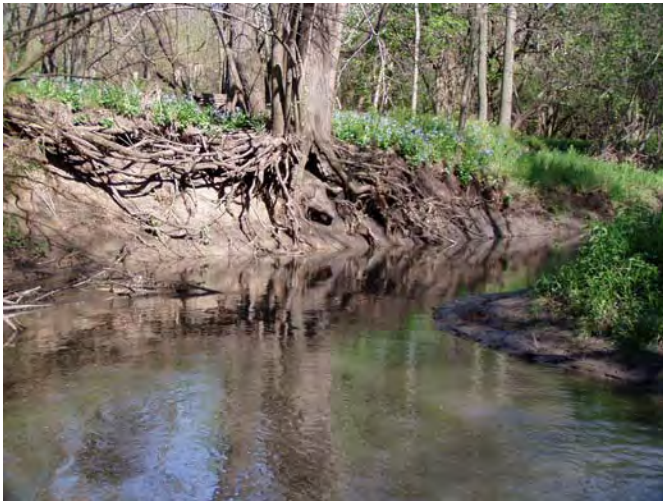
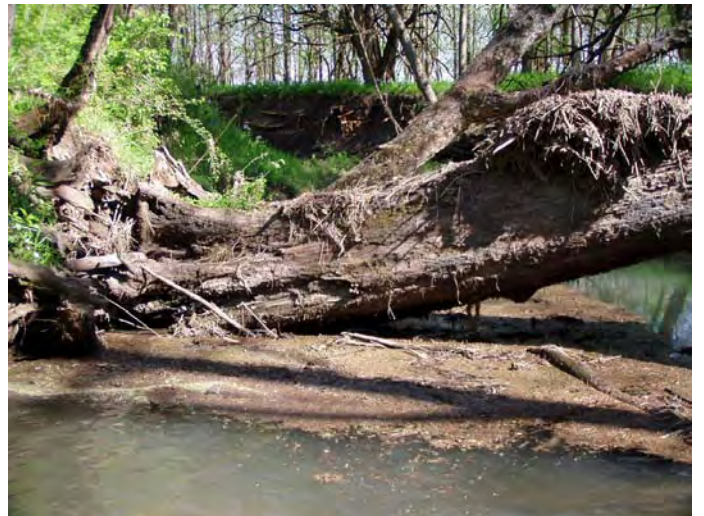
The three photos on the left are typical outside bends; they represent a high potential for mass wasting. The amount of logs within the channel is a direct result of bank instability (see below) as the banks are undercut. The channel has a very high degree sinuosity with sharp bends. The point bars located at the bends (see above) are generally enlarged from deposition. Rootwads are abundant from fallen trees but rootmats are generally not present. The stream is entrenched approximately seven feet. Riffles are fairly condensed and long runs and pools are the dominant features within the stream.

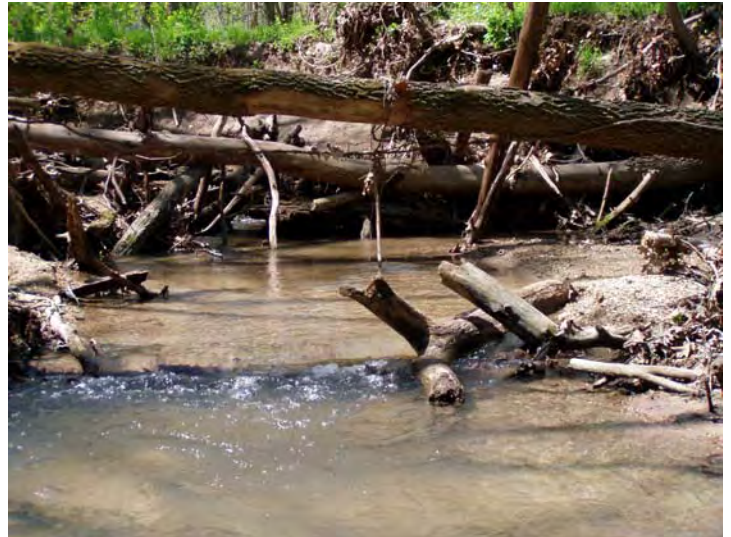
Log jams are present along the length of the stream

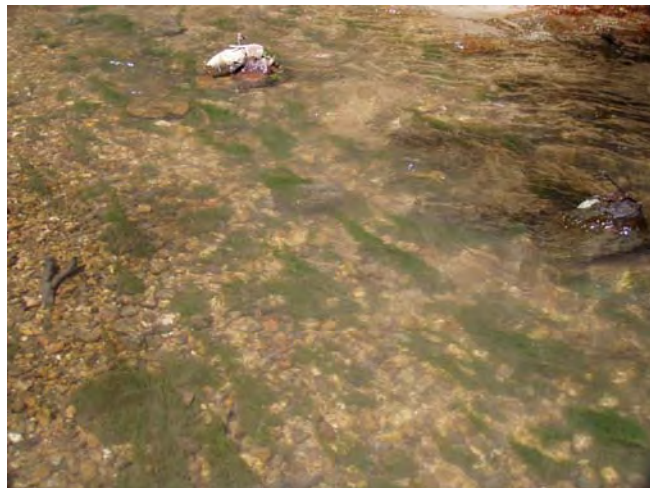
Algal mats are attached to cobble within the stream

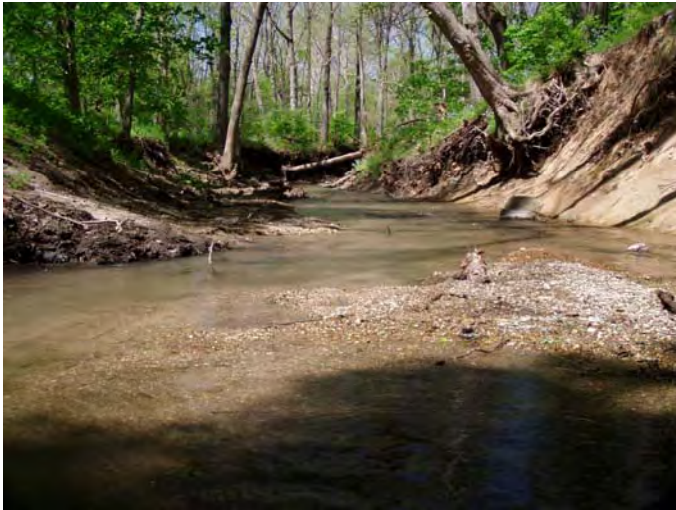
Stream has braided areas along length of stream

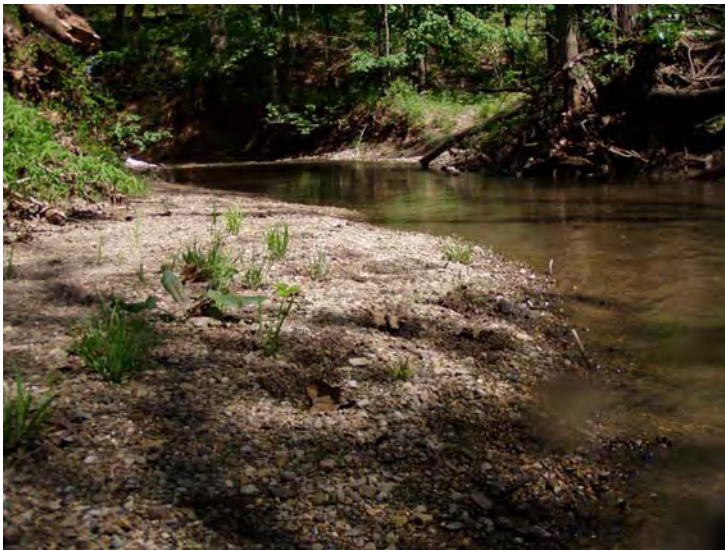
Wide gravel bars are present throughout

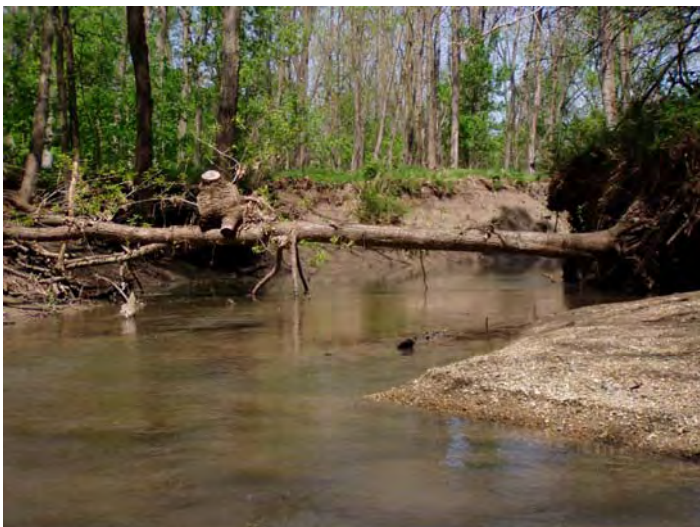
The stream is quite meandrous and has undercut both inside and outside banks in areas

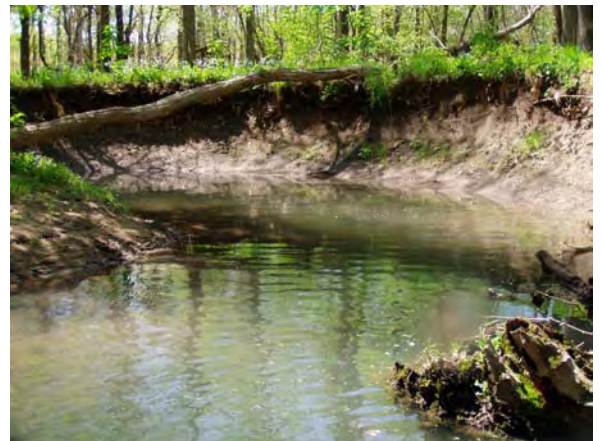
The stream is entrenched approximately seven feet and both banks are actively eroding. The stream has a well developed riffle-pool system and is apparently passing much of the bed-load as the pools are not silt dominant.

Tight meander bends have steeply cut outside banks
