STATE WILDLIFE GRANT

FINAL PERFORMANCE REPORT

PROJECT TITLE: Raccoon Creek Restoration and Reconnection

LOCATION: Within the Nygren Wetland Preserve, 2810 W. Rockton Road, Rockton, Illinois, Section 22, T. 46 N, R 1 E, 3 PM, Winnebago County, Illinois.

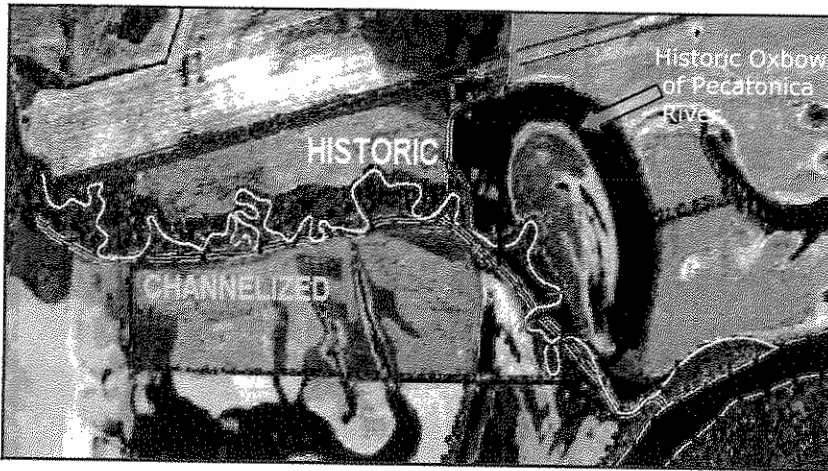
Above: Aerial photo depicts high sinuosity of historic meandering Raccoon Creek (channel in yellow) compared with the channelized ditch (depicted in blue). Channelization reduced the stream length from approximately 12,000 linear feet to 5,500 linear feet. (Note remnant oxbow of the Pecatonica River located northeast of the Project Site.)

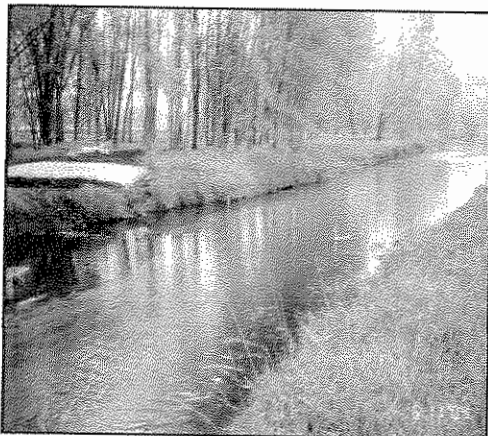
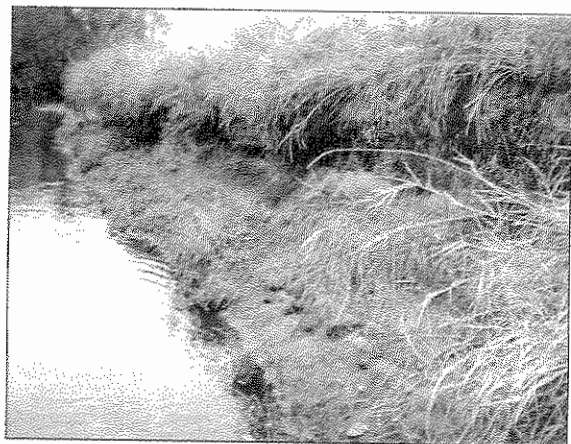
Photos: Channelized (pre-restoration) conditions included moderate to severe bank erosion, typical 1.5-ft thick sand deposits, downcutting, uniform velocity distribution and water depths, lack of deep pool habitat, lack of in-stream vegetation, and other habitat impacts.

Since the 1970s channelization, significant instability had occurred along the channelized ditch. For instance, moderate to severe bank erosion, significant sediment deposits on the channel bottom, and lack of desirable aquatic habitat were apparent. Typical eroding bank slopes ranged 0.25:1 (H:V) to 1:1 (H:V). Severe downcutting had occurred along the channelized ditch. Due in part to downcutting and channelization, the remnant meanders of Raccoon Creek were essentially dry except during significant flood events. Even though T/E fish species such as Iowa Darter occur upstream in Raccoon Creek, the fish population at the channelized site was significantly degraded.

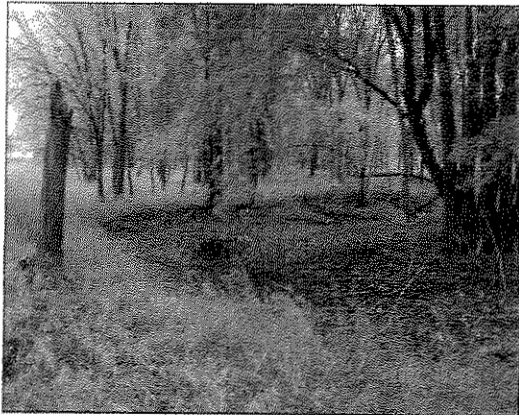
Photo: An example historic meander north of the channelized stream. Field analysis indicates that the historic meandering channel had significantly better aquatic habitat than the channelized ditch. One of the primary goals of the restoration project was to divert flows back into the historic meandering stream channel.

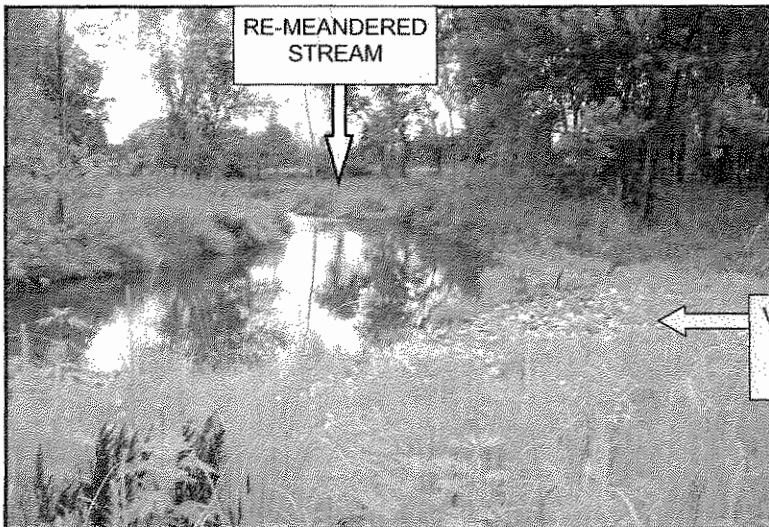
Photo: Phase 1 diversion berm to divert stream flow through the meandering channel (direction of flow is from foreground to background in photo).

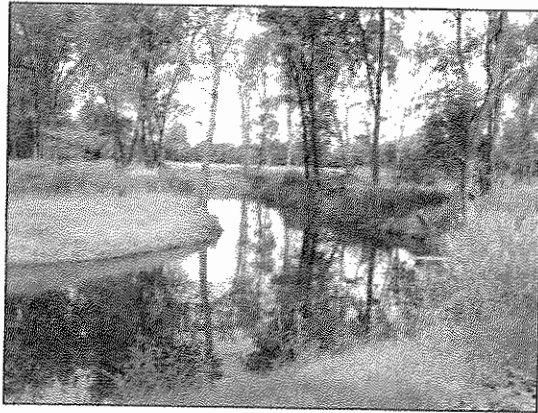
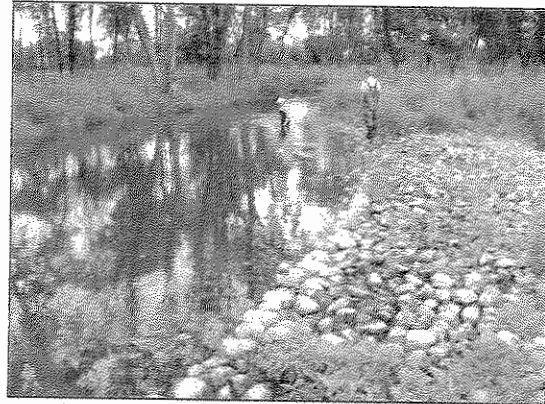
Photos: Left photo depicts flow through restored, meandering stream approximately two years after construction. Right photo depicts diversion berm. Note pool depths up to 3-feet or more. Diversion berms indicate outside bend areas, and they enhance scouring, sediment particle size sorting, and pool formation.

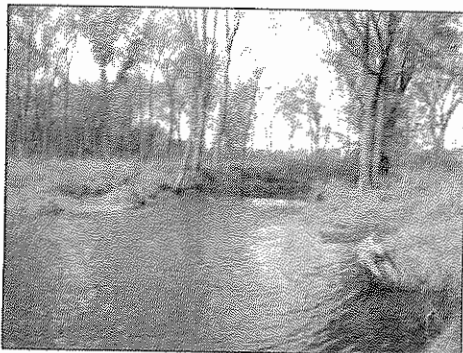
Photo: After restoration, desirable channel substrates such as gravel and cobble which previously were lacking had begun to increase. Moreover, naturally-forming riffles (depicted in photo) began to form.

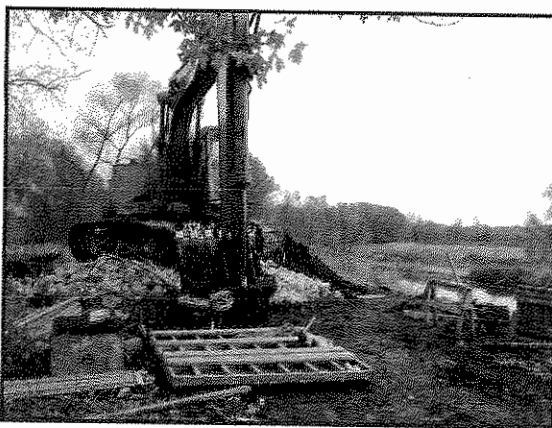
Site and Equipment at North Abutment

Christian Smith of our office visited the site on October 20, 2009 after the bridge abutment location was determined and the initial abutment formwork was being installed. The following photographs provide a general sense of the nature of activity being performed relative to initial placement of formwork and reinforcing for the bridge abutments.

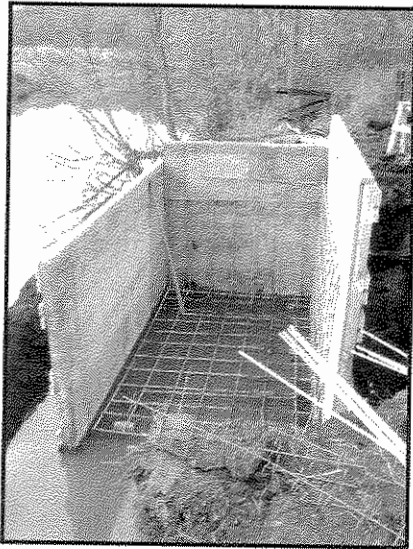
North Abutment Formwork and Reinforcing Bar Initial Placement

After the site visit and co-ordination with Reed Sjostrom of Sjostrom Construction, Reed indicated that they were intending to pump out the formwork and confirm bearing soil strength prior to concrete placement.

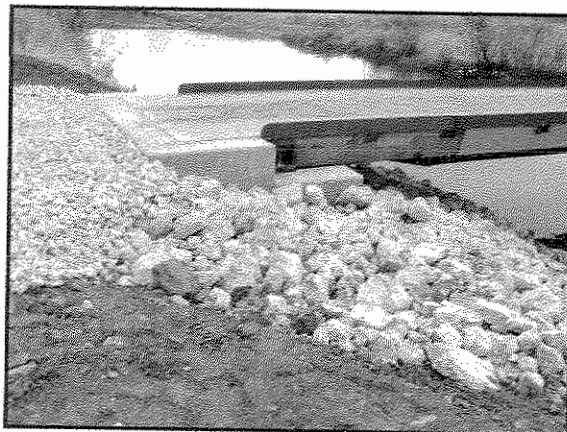
North Abutment Looking East

Subsequent to placement of the flatcar on the constructed abutments, Christian Smith of our office visited the site on November 17, 2009. The approach stone and abutment scour protection had been placed and seal protection at the interface of the bridge ends and the concrete abutments had been installed. The following photographs provide a general sense of the nature of the bridge abutments and Railcar installation.

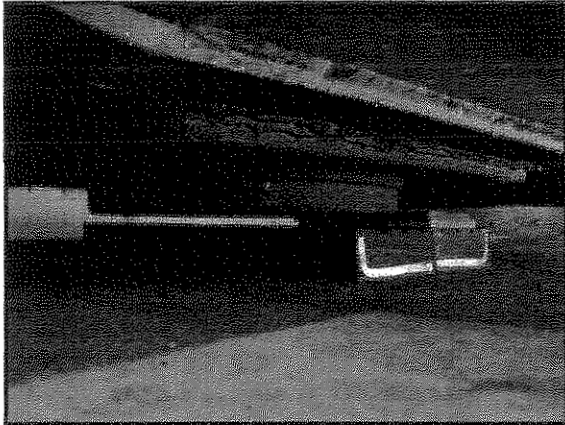
S. Abut. Bearing Pad and Truck Support S. Abut. Bearing Pad and Shim Detail

After the site visit and co-ordination with Reed Sjostrom of Sjostrom Construction, Reed indicated that they were intending to replace the metal shim under the south abutment truck support ring with an appropriate shim support and bearing pad width(s) to support the entire truck support ring. Subsequent to this co-ordination effort with Sjostrom Construction, it was our understanding that Sjostrom replaced the south abutment shim with a more appropriate shim but had not, as yet, increased the bearing pad width for the entire truck support ring. Reed has indicated that they are waiting for better weather to finish the bearing pad modifications.

Our office will follow-up with Sjostrom regarding the necessary final modifications to the bearing pads and shims for complete support of the Railcar truck support ring.

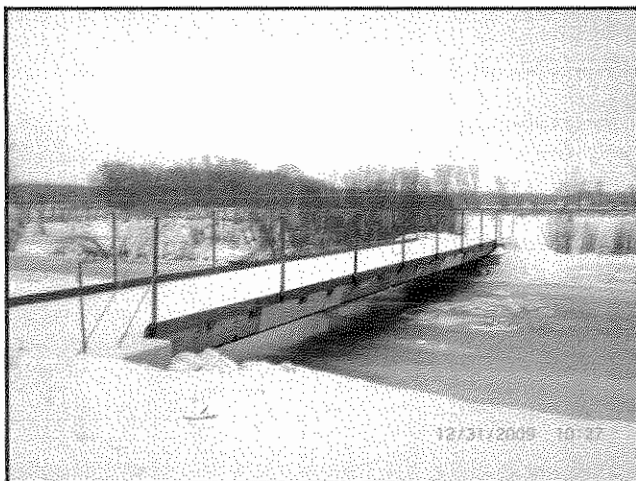
Railcar Handrail Installation Looking South

The photograph below was supplied by Sjostrom Construction and shows the handrail installation.

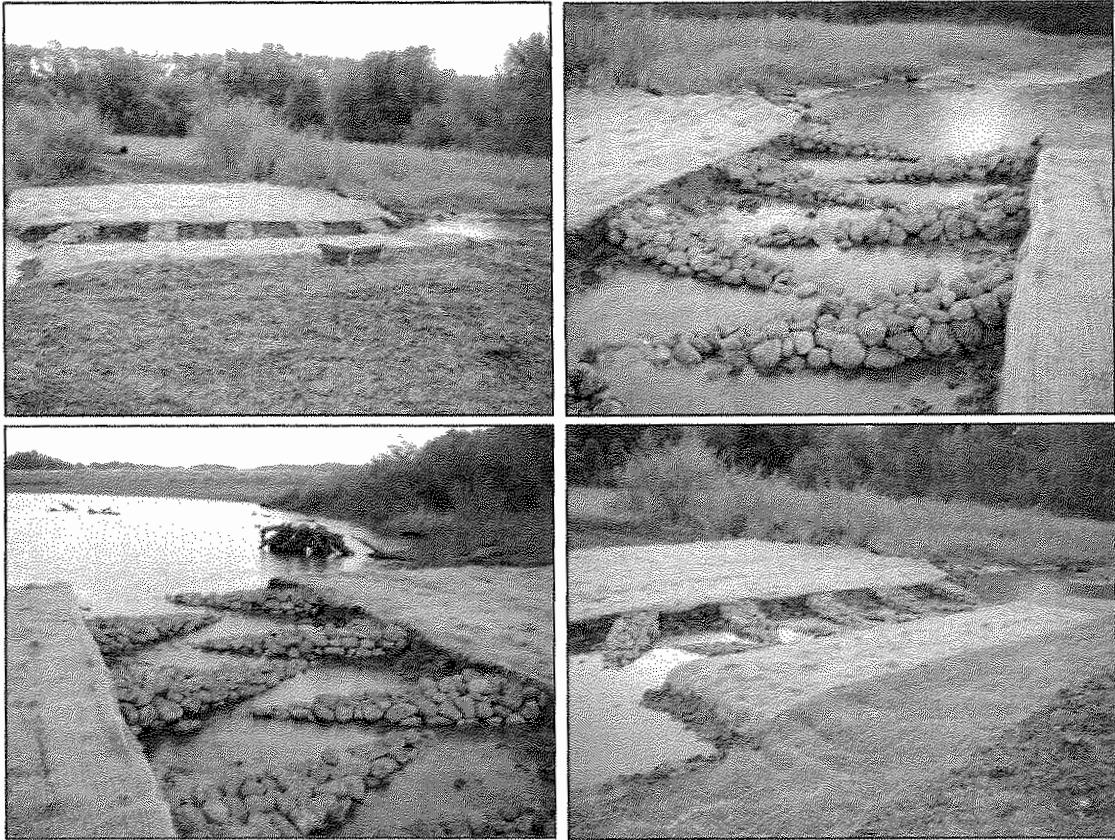
V3 completed a final site visit on October 1, 2009. The following photographs show the installed inline water control structure and constructed fish passage structure.

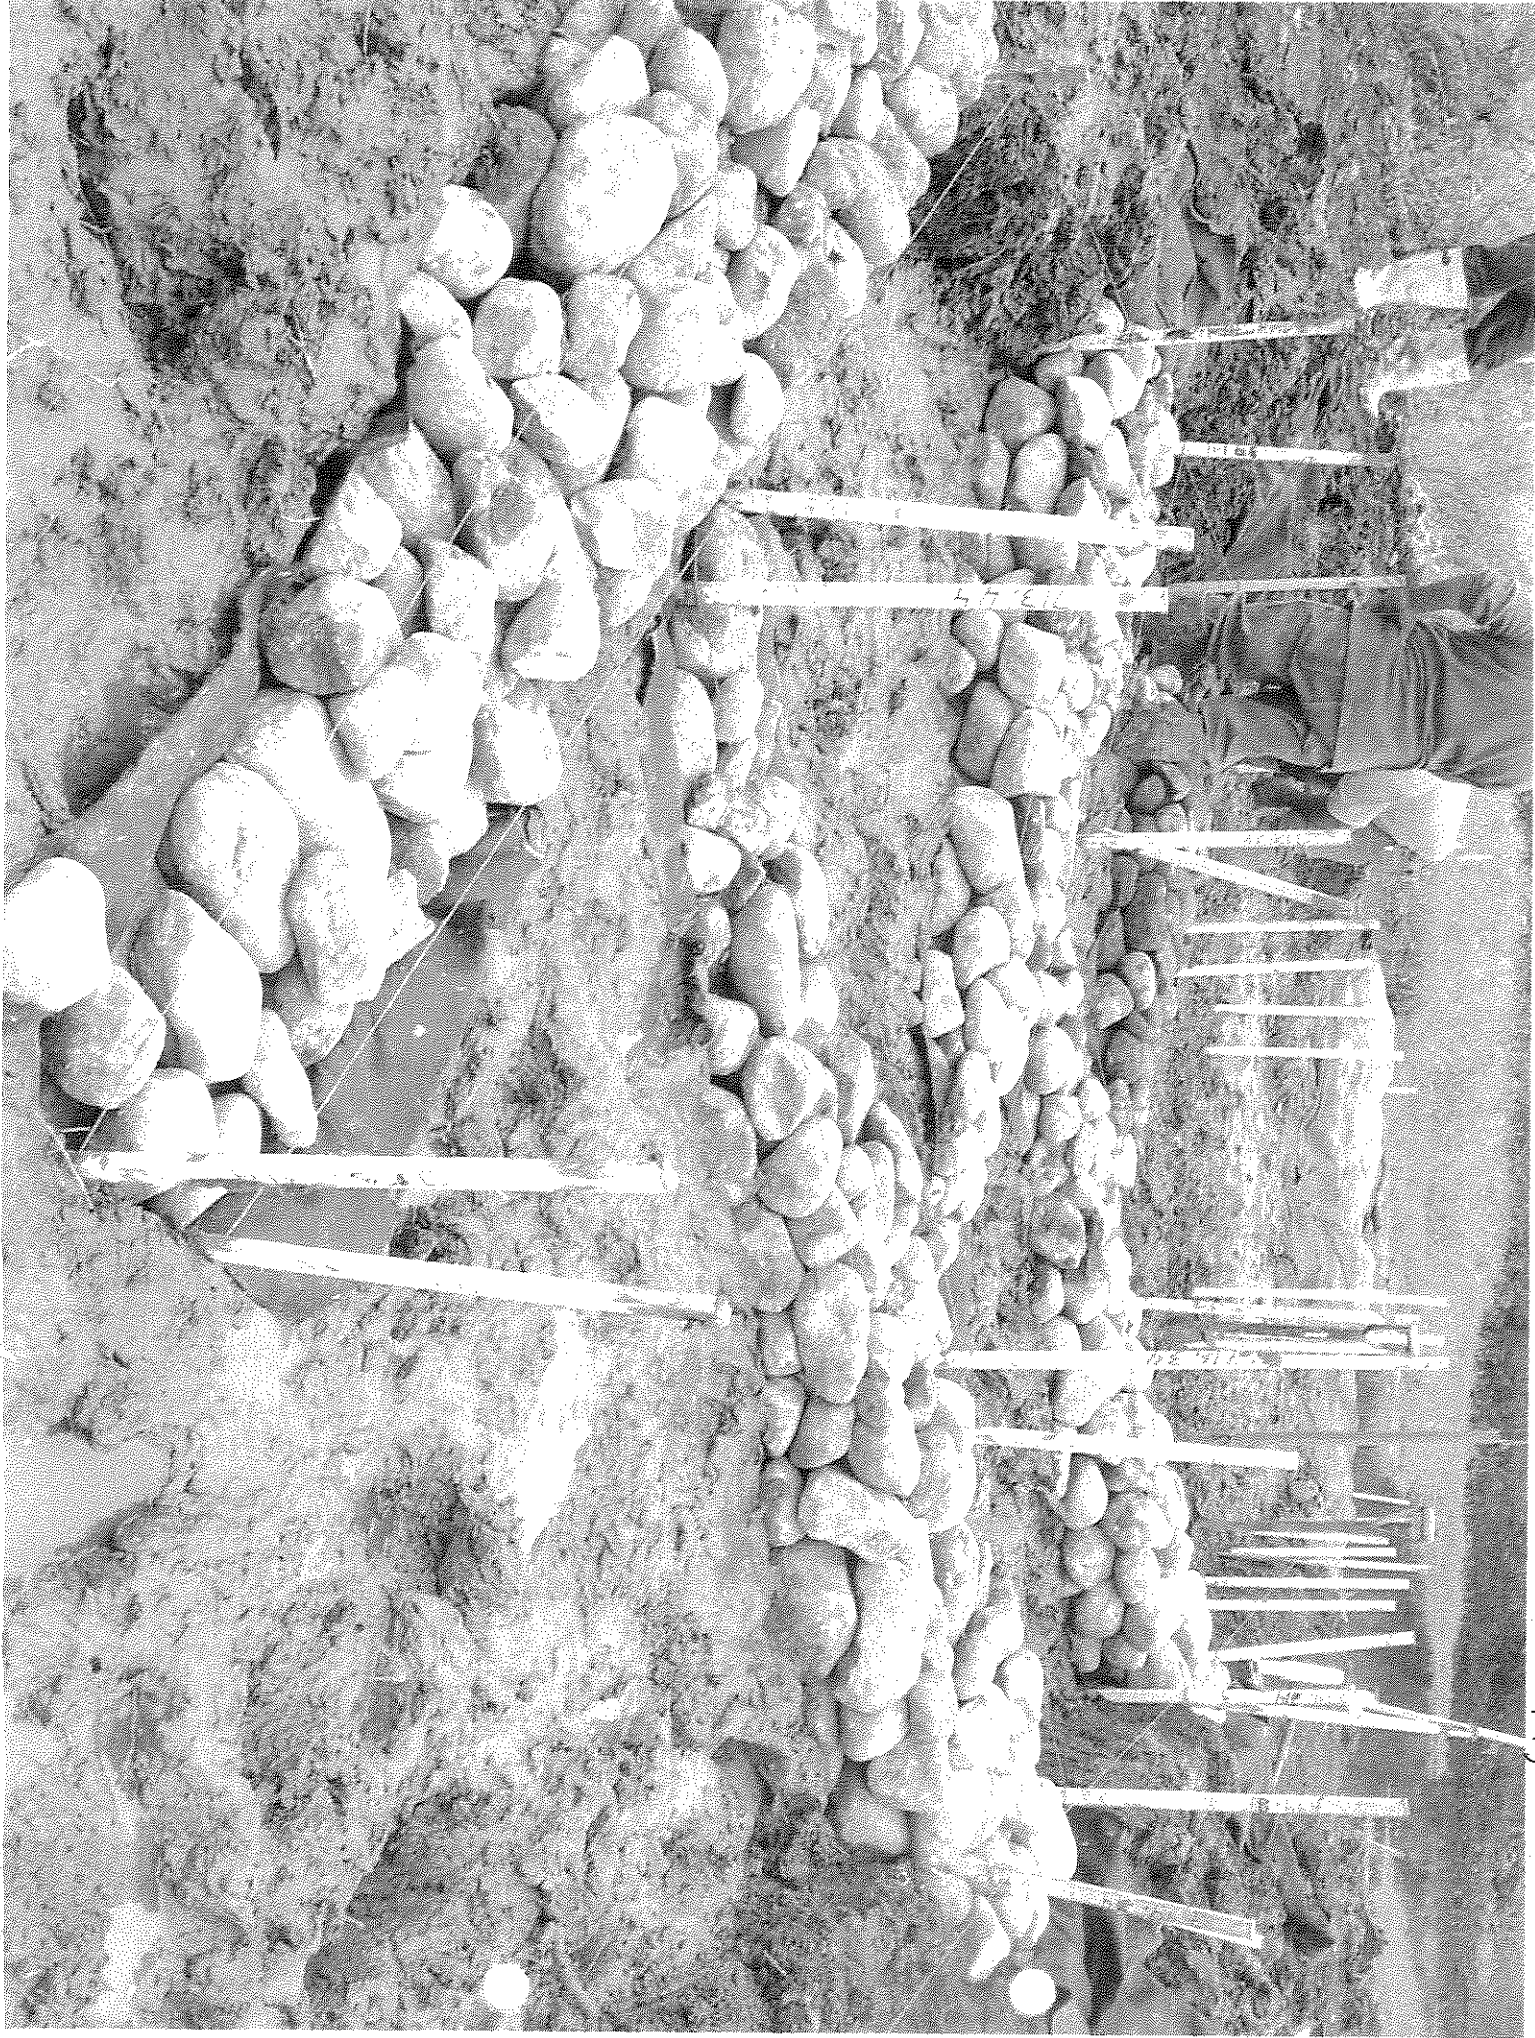
Figure 1

On November 11, 2009, NLI contacted V3 with some concerns with regards to the fish passage structure and the cobble within the rock riffles shifting and washing downstream. NLI provided some further clarification that approximately 15% of the cobble had been displaced and that this area was being used by wildlife (i.e. deer, raccoons...etc.) and bird watchers as a place to cross the water. It should be noted that the water level was also above the top of the rock riffles at this time.

Since the fish passage structure had only been installed a little over a month, it would be expected that some shifting of the cobbles would take place due to lack of vegetation or sediment build up within the riffles themselves to help with natural stabilization of the structure. V3 (Carrie/Didi) recommended to NLI to monitor the structure through the winter and if the overall stability of the structure is still in question, a wire mesh could be installed to prevent additional displacement of the cobbles. V3 and NLI will coordinate after the spring melt to determine the appropriate course of action.
