Sangchris Lake Aquatic Vegetation Restoration Project – 2019 Planting Report

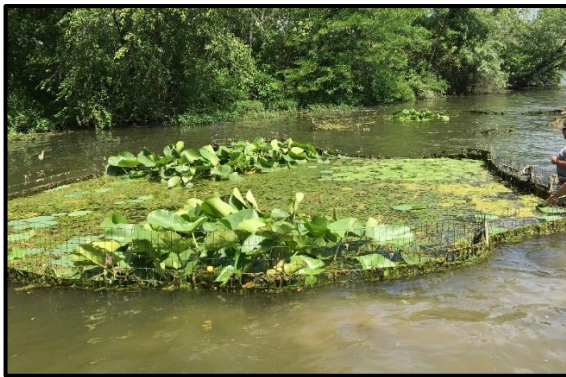
Before moving fencing on 6/4/19, the enclosure is full of spatterdock, white water lily, American pondweed, and a number of large American lotus leaves

The enclosure fencing was expanded to stretch from the western shoreline around the planting site to the northern shoreline. This would greatly expand the planting area and would utilize the shoreline as a barrier for aquatic herbivores. Unfortunately, extremely high water levels created a pathway for animals to get into the expanded enclosure. Once the water receded, many of the plants, primarily pondweed and white water lily, were destroyed. To better protect them, the fencing was moved to create two large adjoining circles. This configuration allowed additional room for the plants to grow while maintaining stronger protection from wildlife.

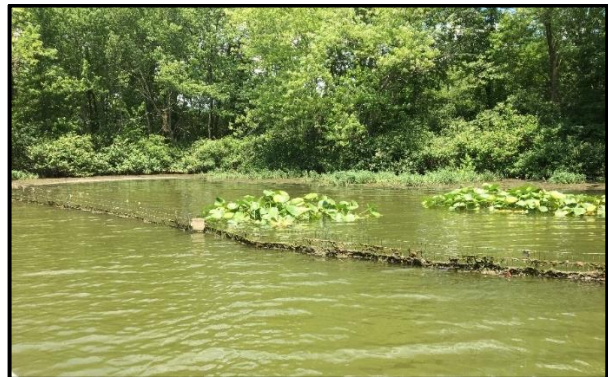
After flooding at the site receded, only spatterdock remains visible above the water.

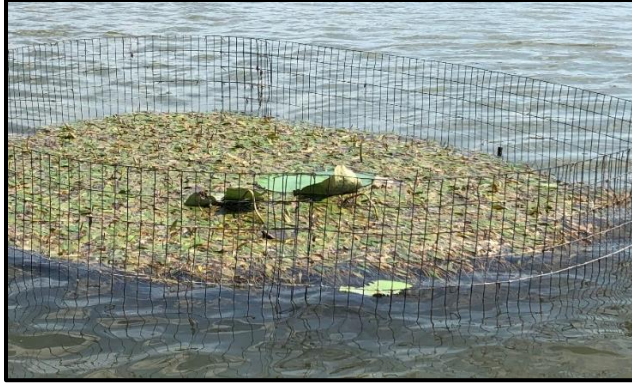
7/2/19 A large colony of American pondweed with several large American Lotus leaves growing in the middle observed on July 2.

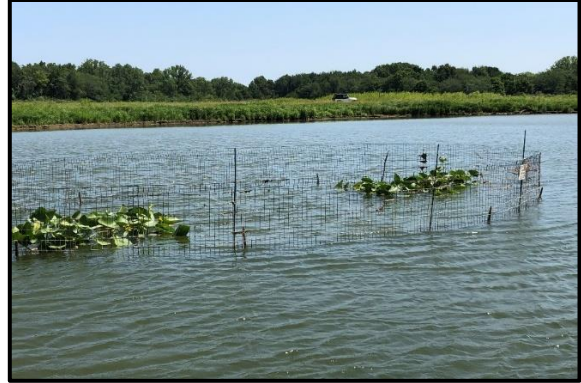
Two colonies of spatterdock seem to be holding up well against the wind and wave action in the North Refuge. This species is slow growing so it will take some time to expand and fill this enclosure.

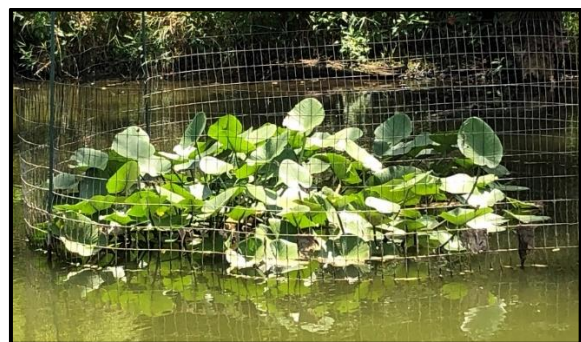
This dense colony of spatterdock is doing very well and is quickly filling this enclosure, which is approximately 12 feet in diameter.

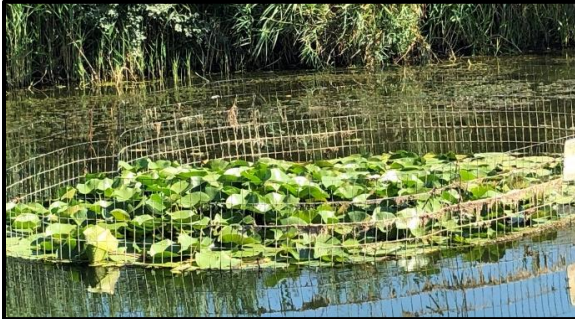
Although much of the vegetation at this location did not return, this 3-year-old colony of white water lily is still looking great. Hopefully this colony will continue to grow and will eventually spread beyond the enclosure.

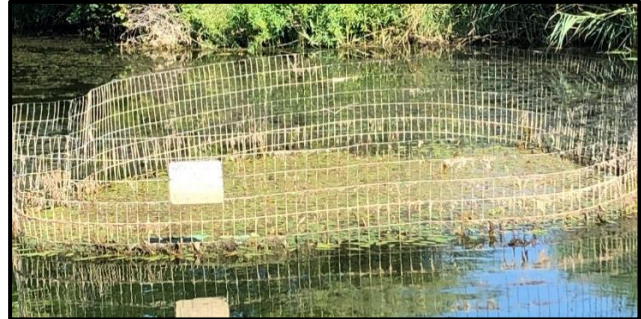
The American pondweed grew rapidly in late spring and early summer, filling the enclosure. This species has been observed along the shoreline in several locations in this part of the lake. This colony will provide a source for more plants to grow and spread in the area.

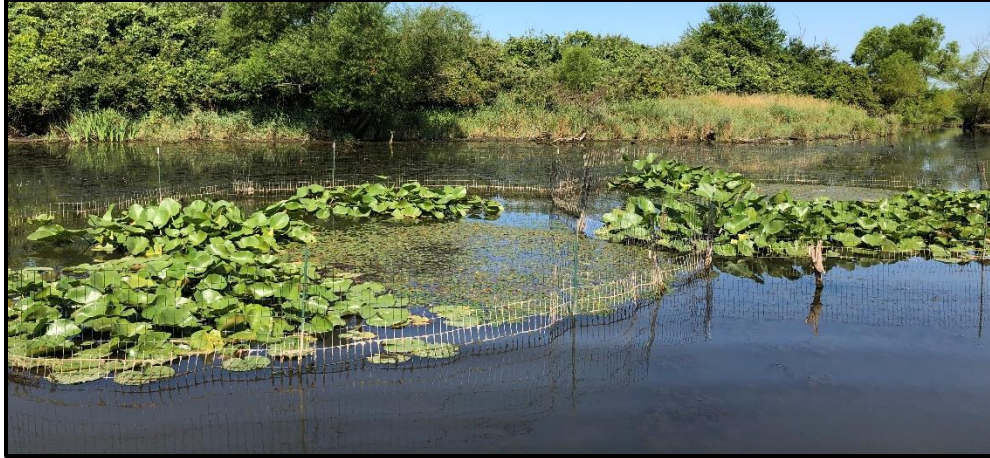
All three species can be seen here, growing well and filling these large exclosures.

The West Cove South site was added in 2018 and is located in a very well protected, shallow cove in the western branch of the lake. It consisted of 10 small enclosures containing white water lily, spatterdock, or American Pondweed. In 2019, these enclosures were disassembled and rearranged into two large conjoined circles, each containing a mix of all three species.

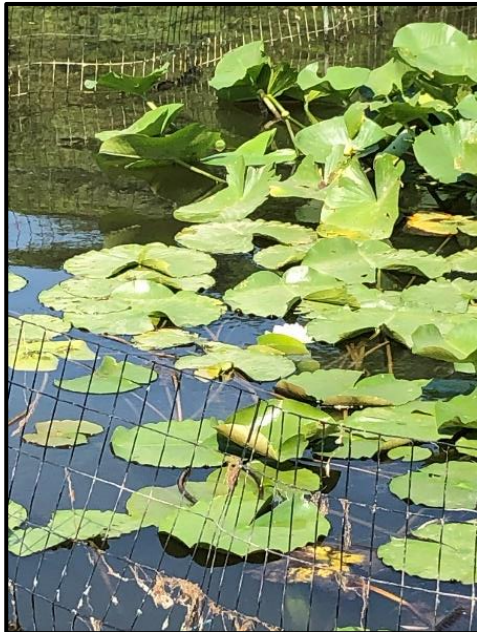
The white water lilies grew very large leaves at this location and even had a few flowers in July (Left).

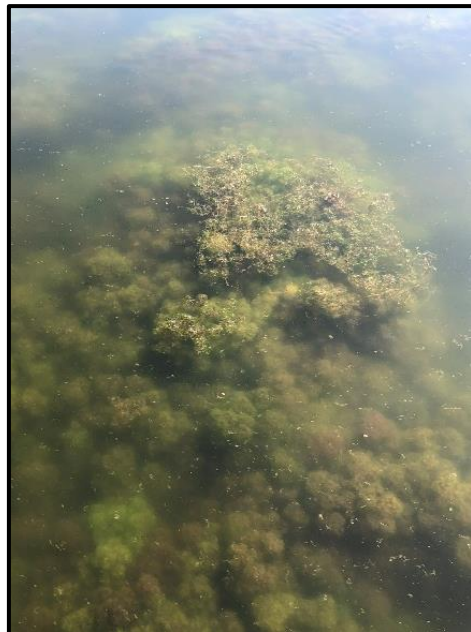
Brittle naiad can be seen here, creating a large dense mass just below the surface of the water (right).

All of the species appear to be thriving in this location. They are well protected from wind and wave action and no breaches appear to have occurred. One issue at this location is an abundance of the nuisance species brittle naiad (*Najas minor*). This species grows in very dense mats that can grow so thick, making it difficult to access the site. Fortunately, the restoration species have leaves that grow at or above the surface of the water and appear to prohibit the naiad from growing in close proximity. Once these species become established, they may actually reduce the abundance of this bothersome species.

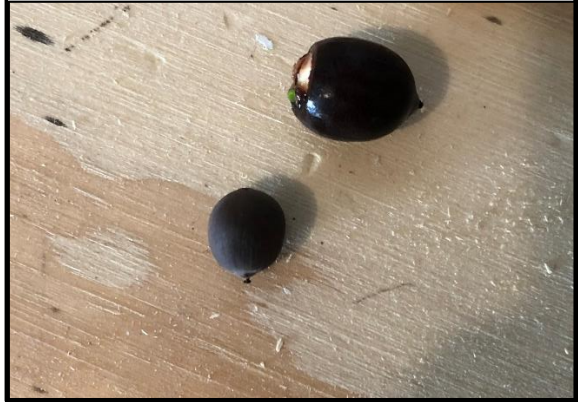
Figure 5. After 4 days, the lotus seed has grown to nearly twice its original size.

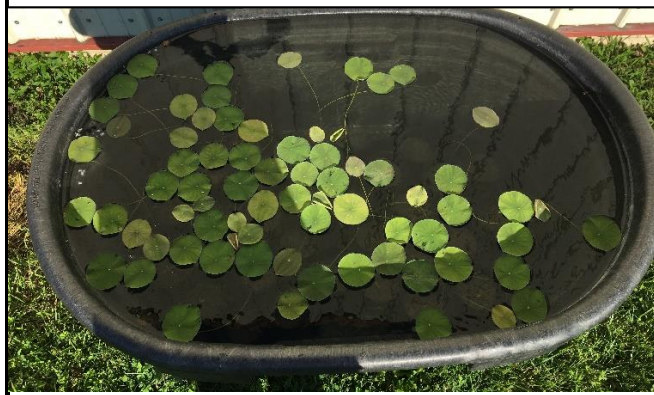
Figure 8. Young lotus plants growing in a 100-gallon Rubbermaid tub young lotus plants

To scarify the seeds, the concave end was sanded or filed until the white endosperm, the seeds food source, became visible (Figure 3). Once scarified, the seeds were placed into a glass jar filled with water (Figure 4). The water was changed every few days to prevent bacterial growth. After a few days the seeds began to swell, almost doubling in size, and the outer shell became soft (Figure 5). After a few days, the sprouts began emerging from the seeds. Some of the seeds with less area sanded away took longer to break out of the shell. Once sprouted, the shoots grew rapidly, reaching 1-6 cm in 7 days and up to 10 cm in 10 days (Figures 6 & 7). After 2 weeks, most of the shoots were around 12 cm long. They were then planted just below the soil surface in 1-quart plant pots. The pots were then submerged in water in a 100-gallon Rubbermaid tub. They were allowed to grow in the pots and develop leaves and roots for several weeks before being transplanted into the lake.
