Kickapoo Creek Restoration Project, Charleston, Illinois

Final Report Agreement Number 3190902

STREAM RESTORATION ASSESSMENT FOR KICKAPOO CREEK NEAR CHARLESTON, ILLINOIS

Kickapoo Cr Instream Restoration Project Maintenance Summary

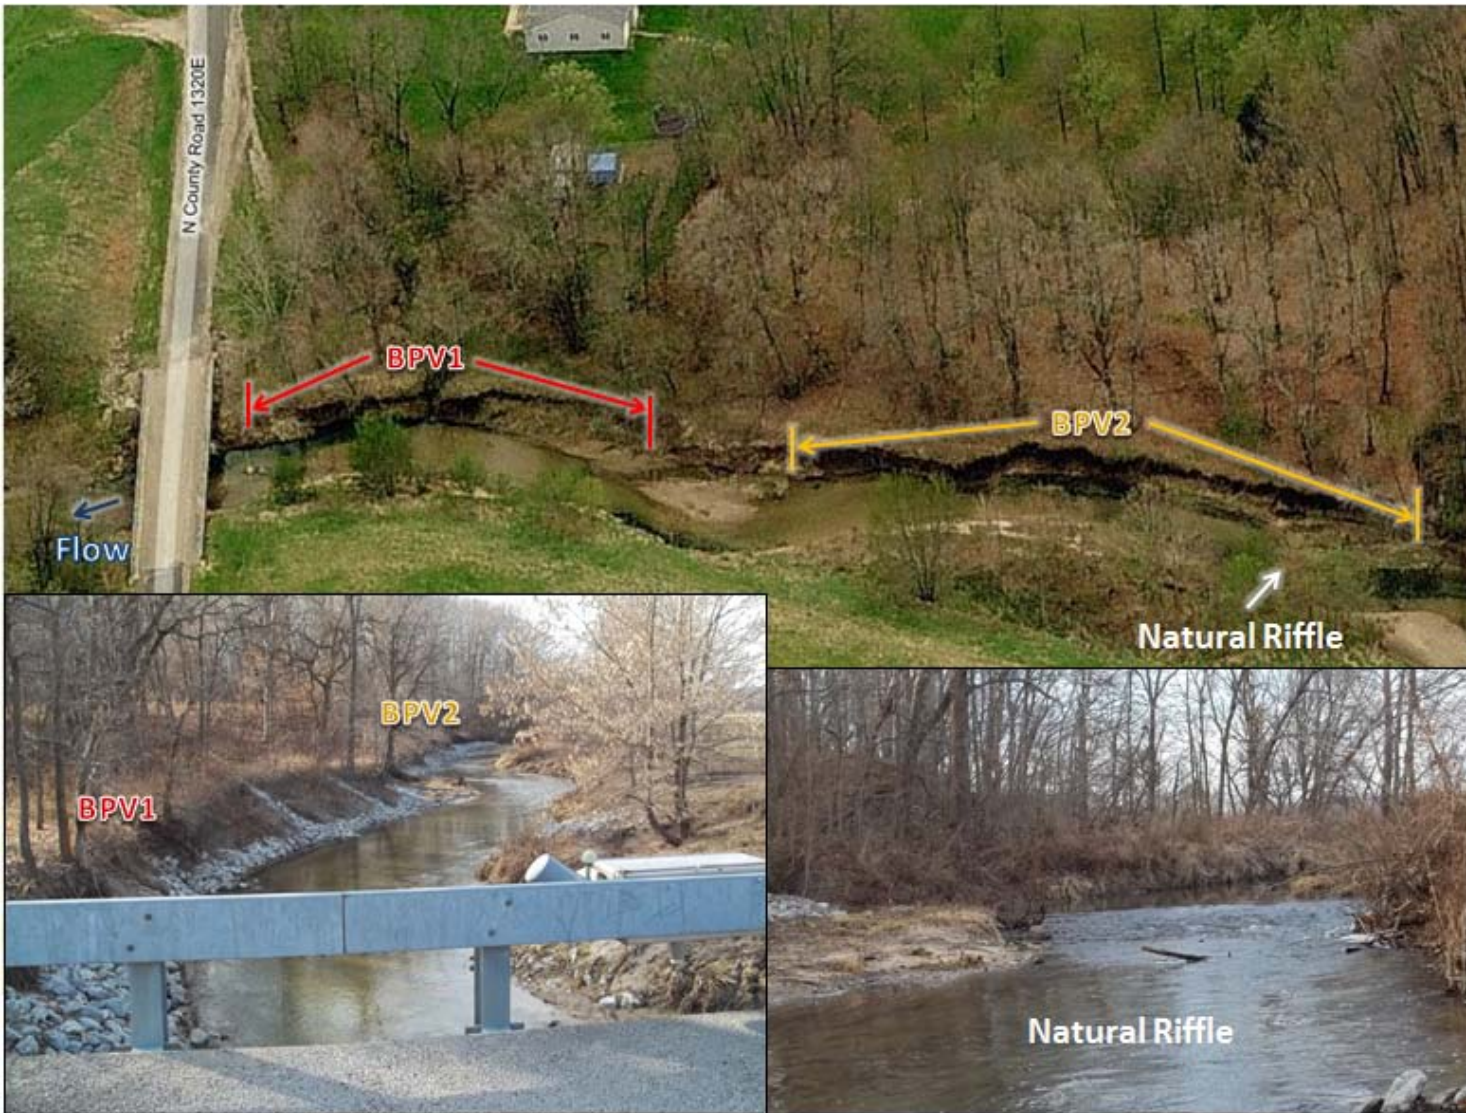
Figure 2. Condition of banks before peak stone installation at BPV1 and BPV2 (top-looking south) and after installation (bottom left-looking upstream). The single natural riffle in the restoration reach is shown in the bottom right (looking upstream) (natural riffle was undisturbed during construction).

Only one natural riffle with a downstream pool was observed in the demonstration reach (Figure 2) (just downstream of BPV3 with a failed bank stabilization of concrete debris). On the steep cobble natural riffle, the cobble was not covered with sand or gravel and a deeper pool was maintained below the riffle.

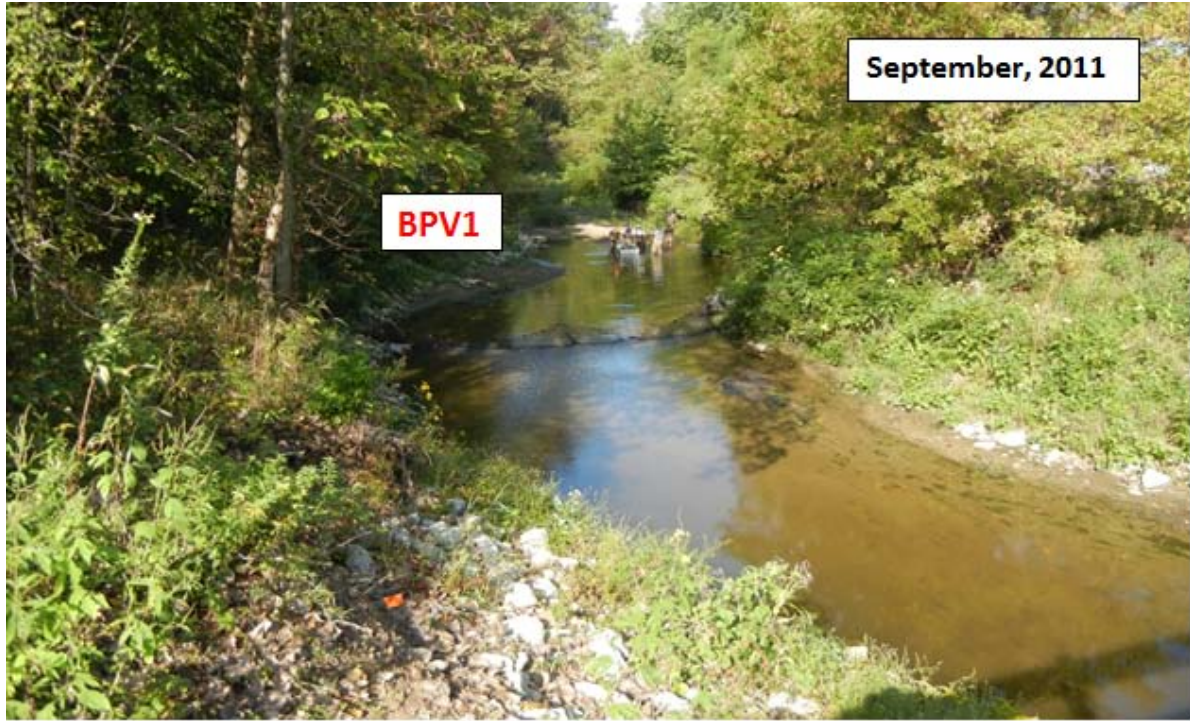
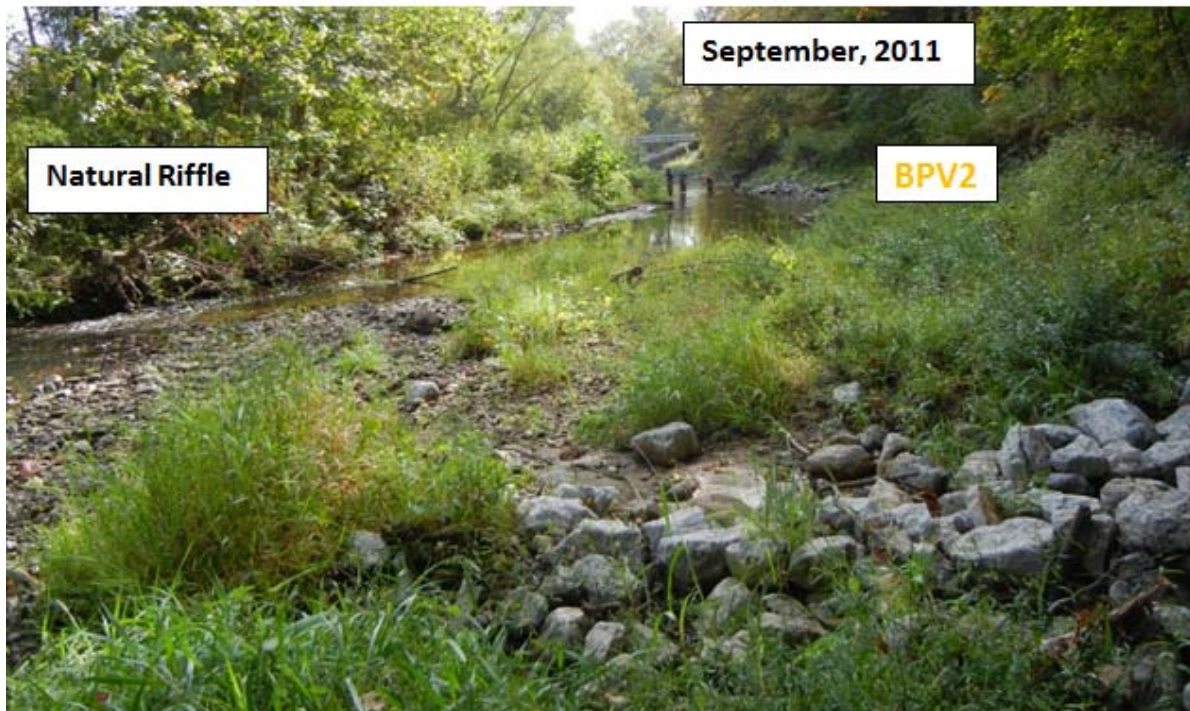
Figure 3. Conditions of banks BPV1 and BPV2 and natural riffle in September 2011.

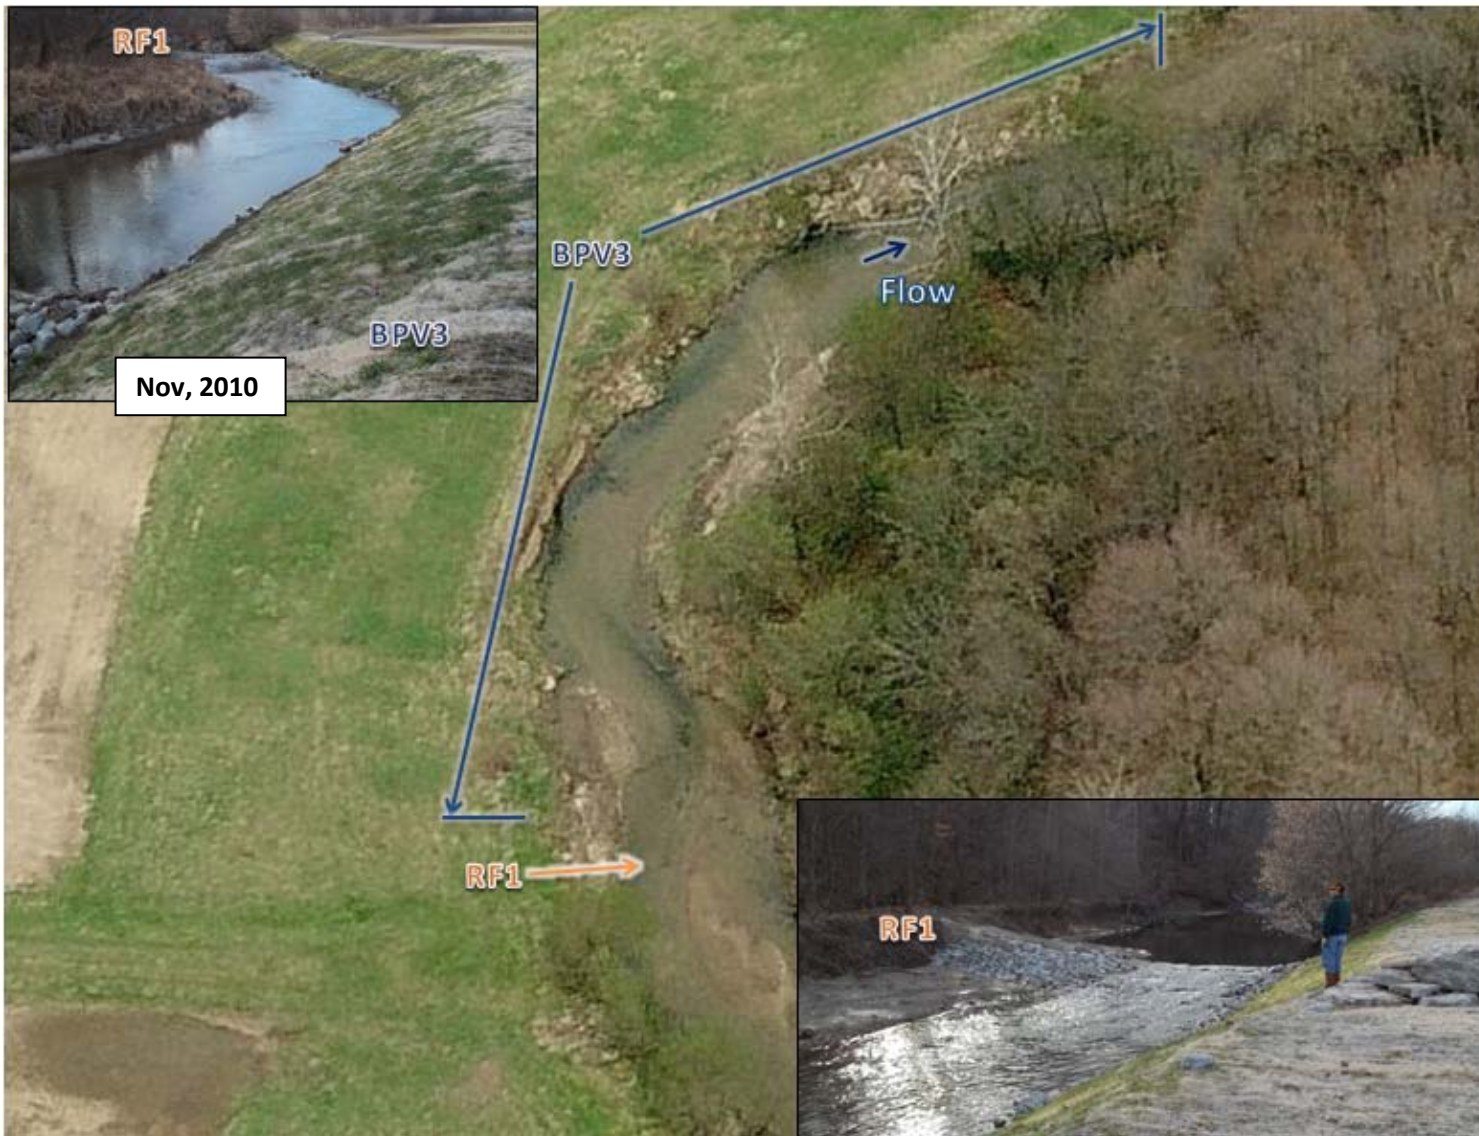
Figure 4. Condition of banks and stream before riprap sloped bank and riffle installation at BPV3 and RF1 (center-looking east) and after installation (top left and bottom right-both looking upstream).

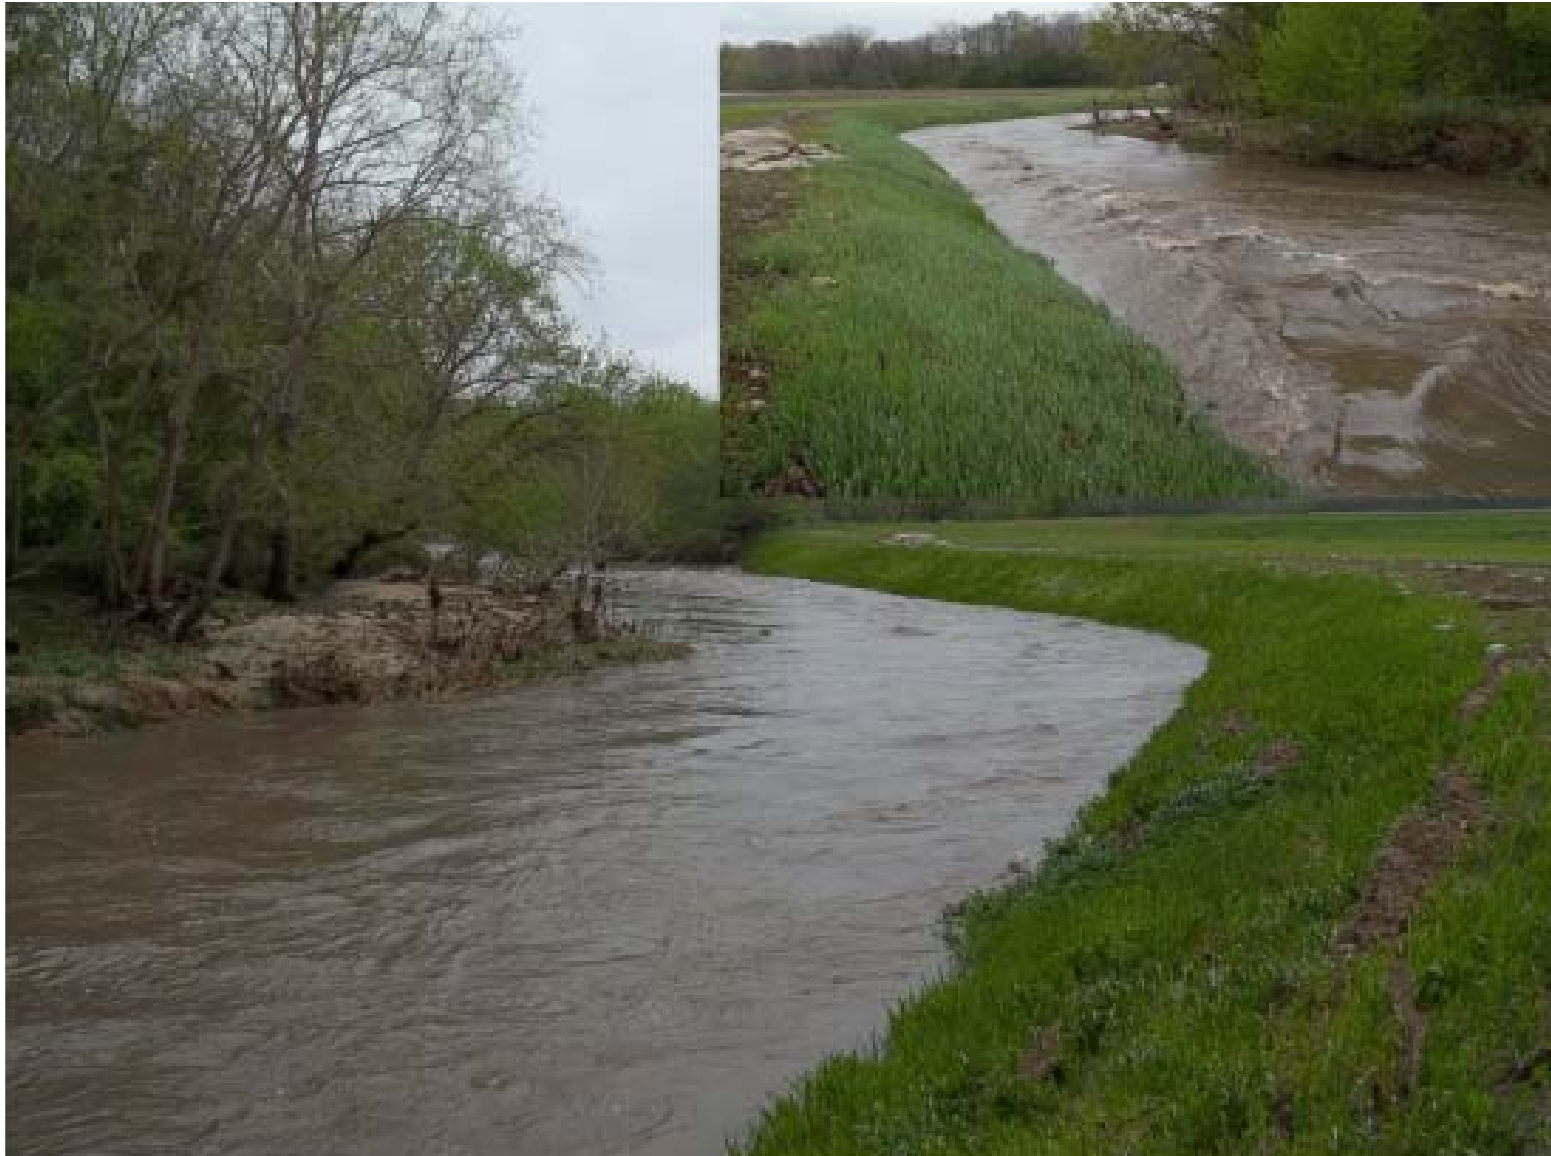
Figure 5. Photo looking upstream at BPV3 and RF1 in flood conditions spring 2011. Top right photo looking downstream from RF1 at BPV3.

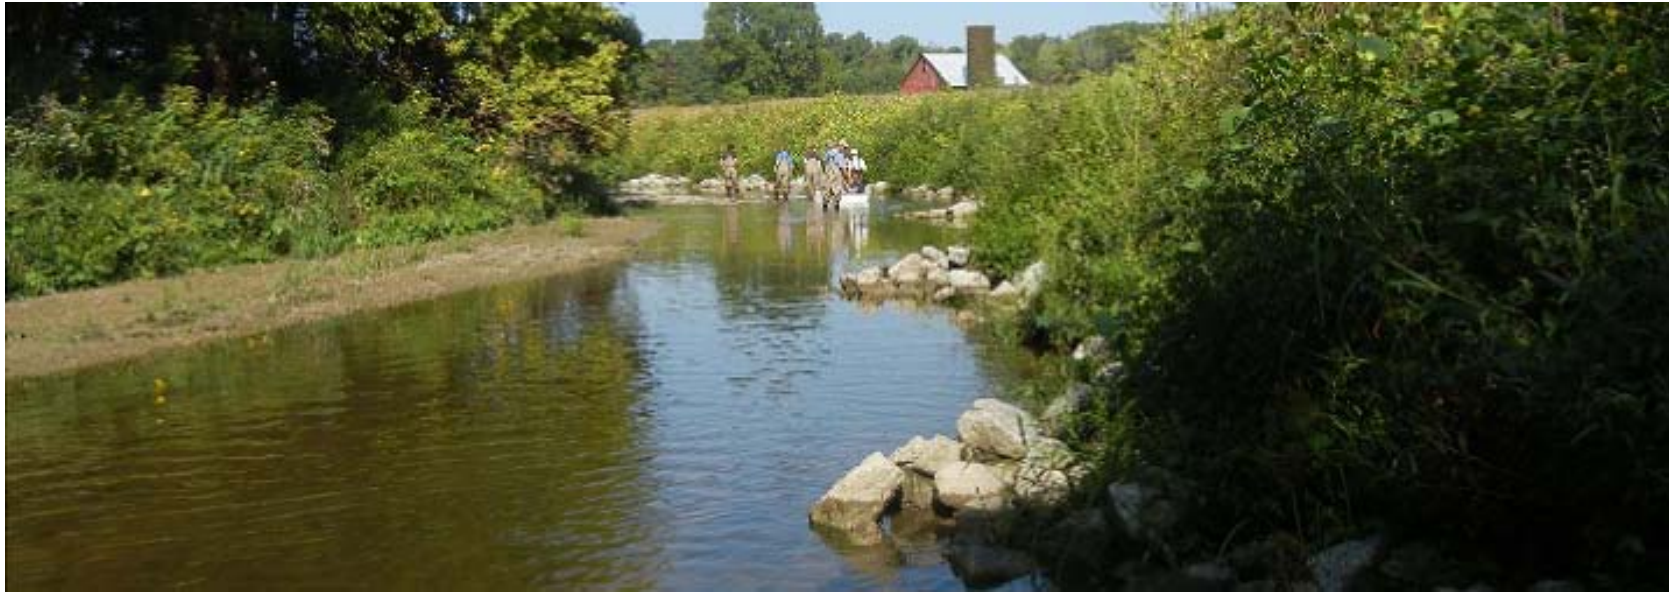
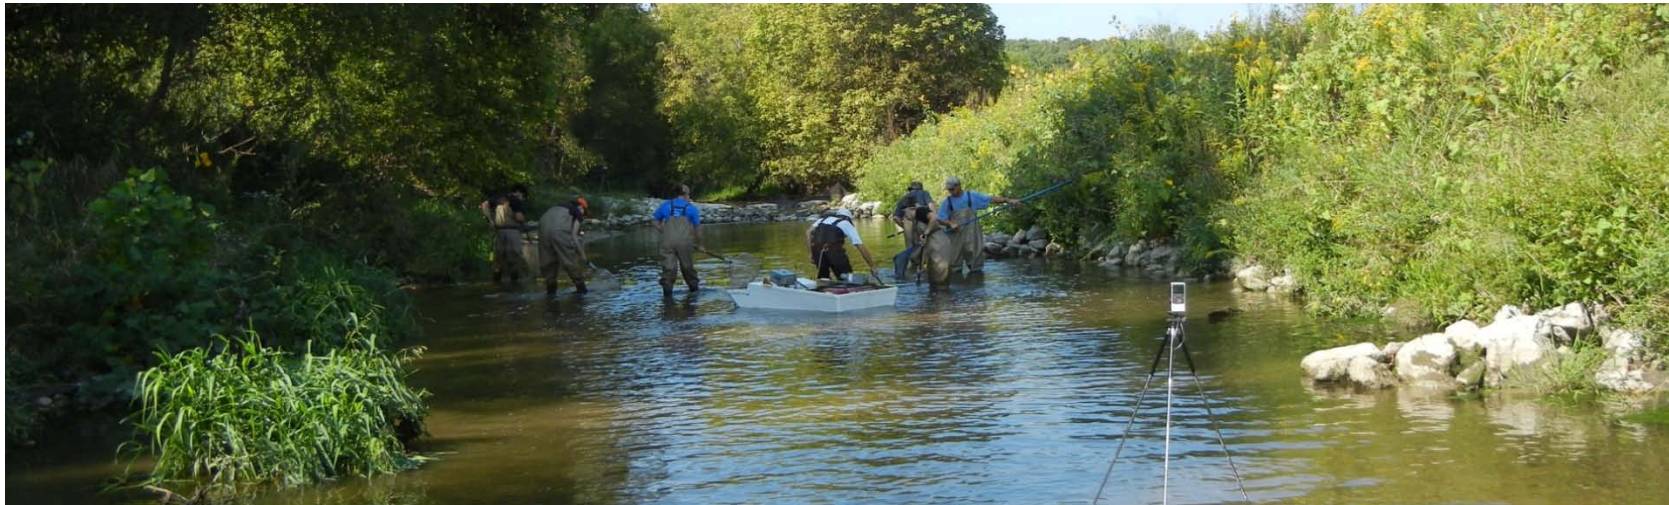
Figure 6. Conditions of banks BPV3 (looking upstream in top and bottom photo) and RF1 (looking upstream in bottom photo) in September 2011.

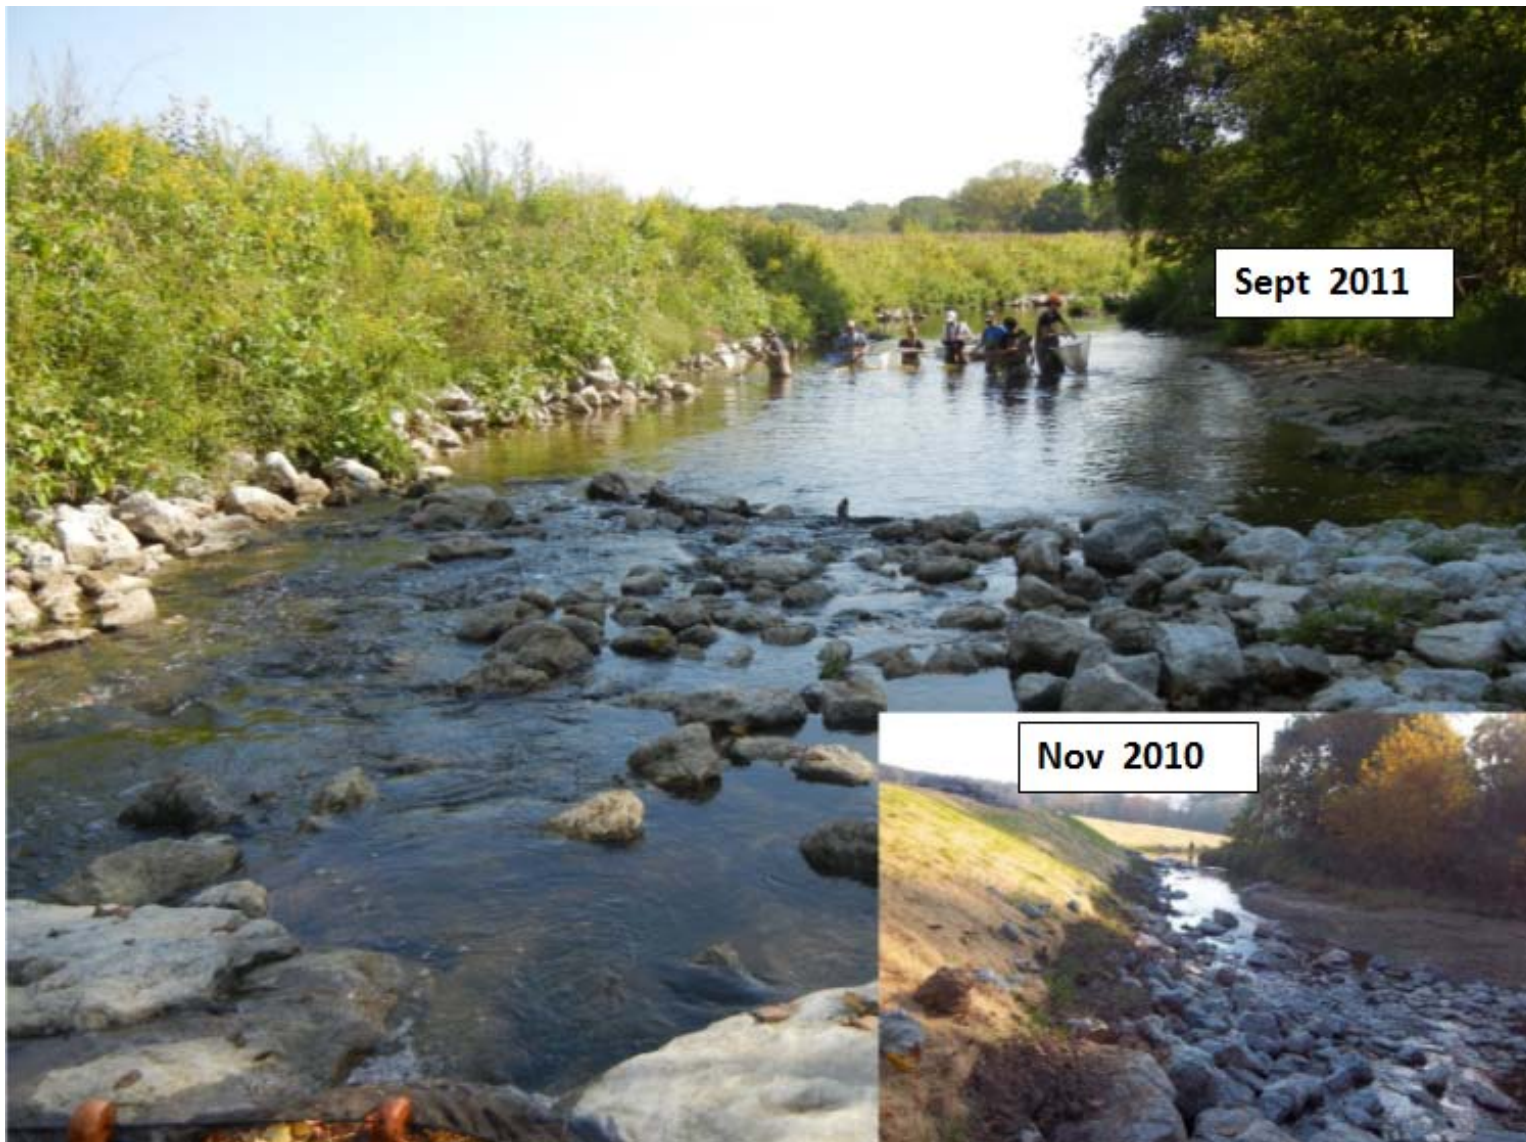
Figure 7. Both photos looking downstream from RF1 at BPV3

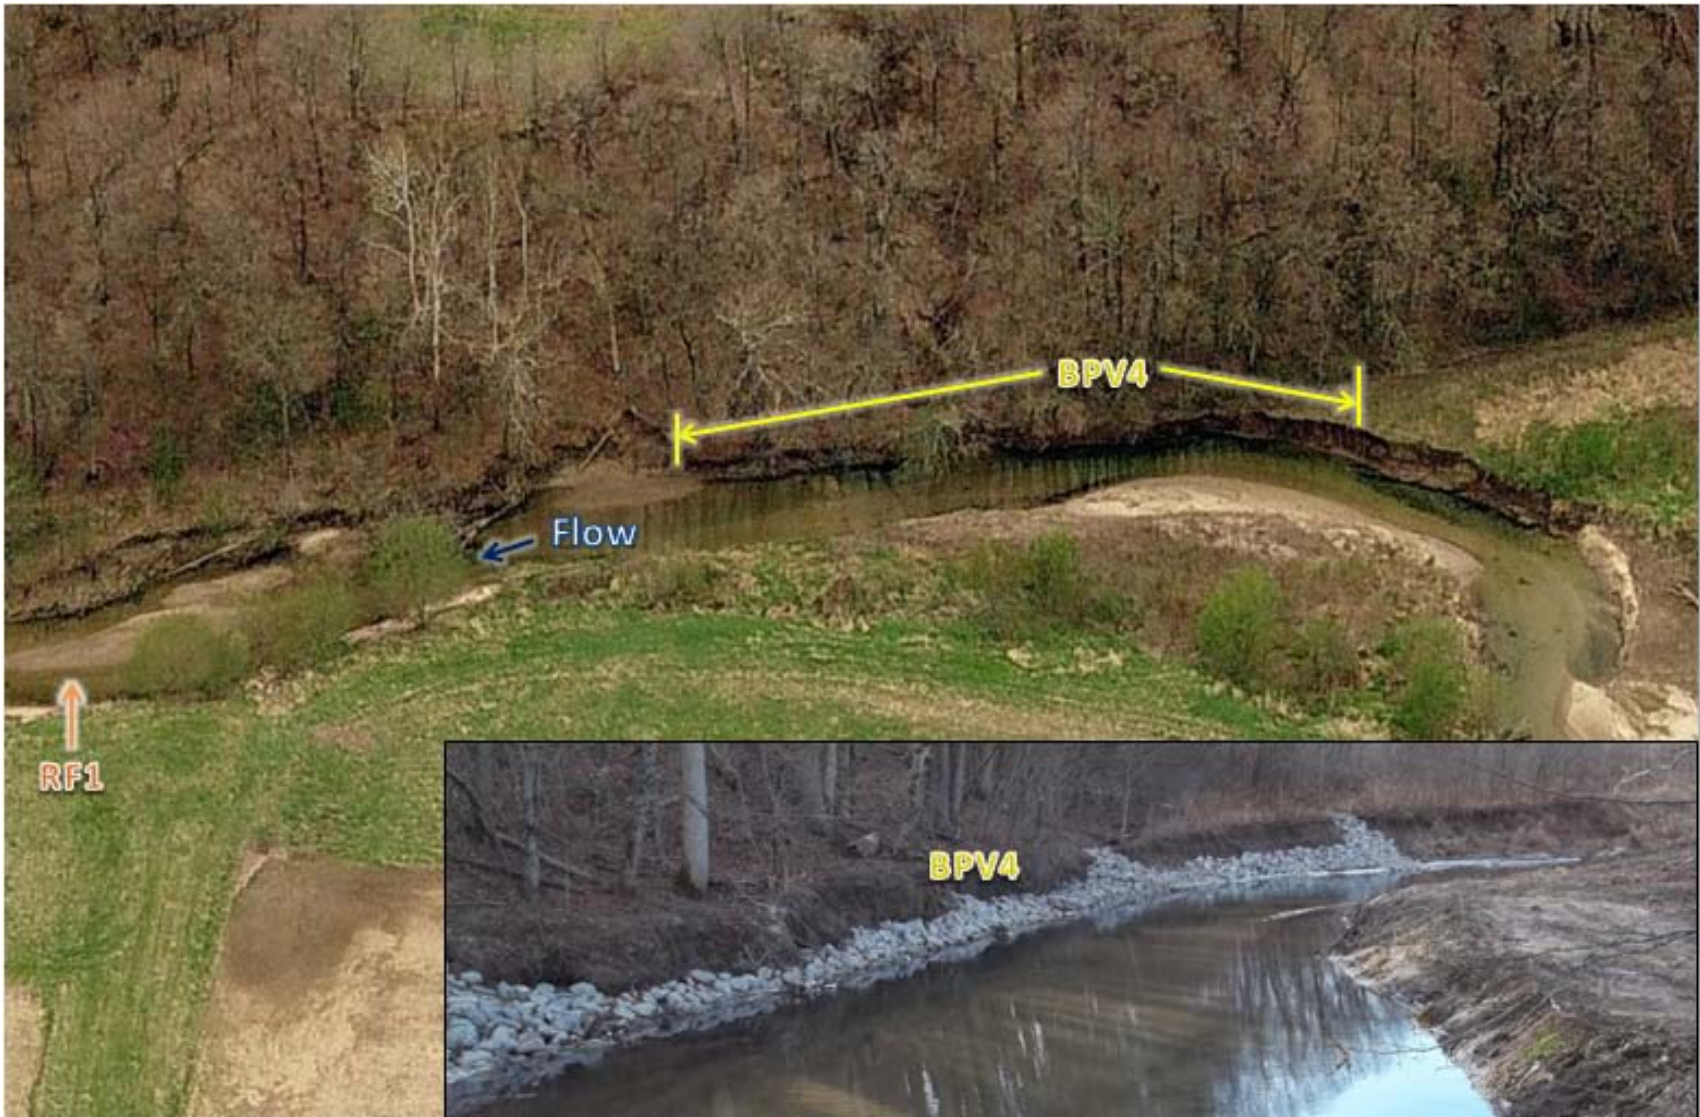
Figure 8. Condition of bank before peak stone installation at BPV4 (top-looking south) and after installation (bottom right-looking upstream).

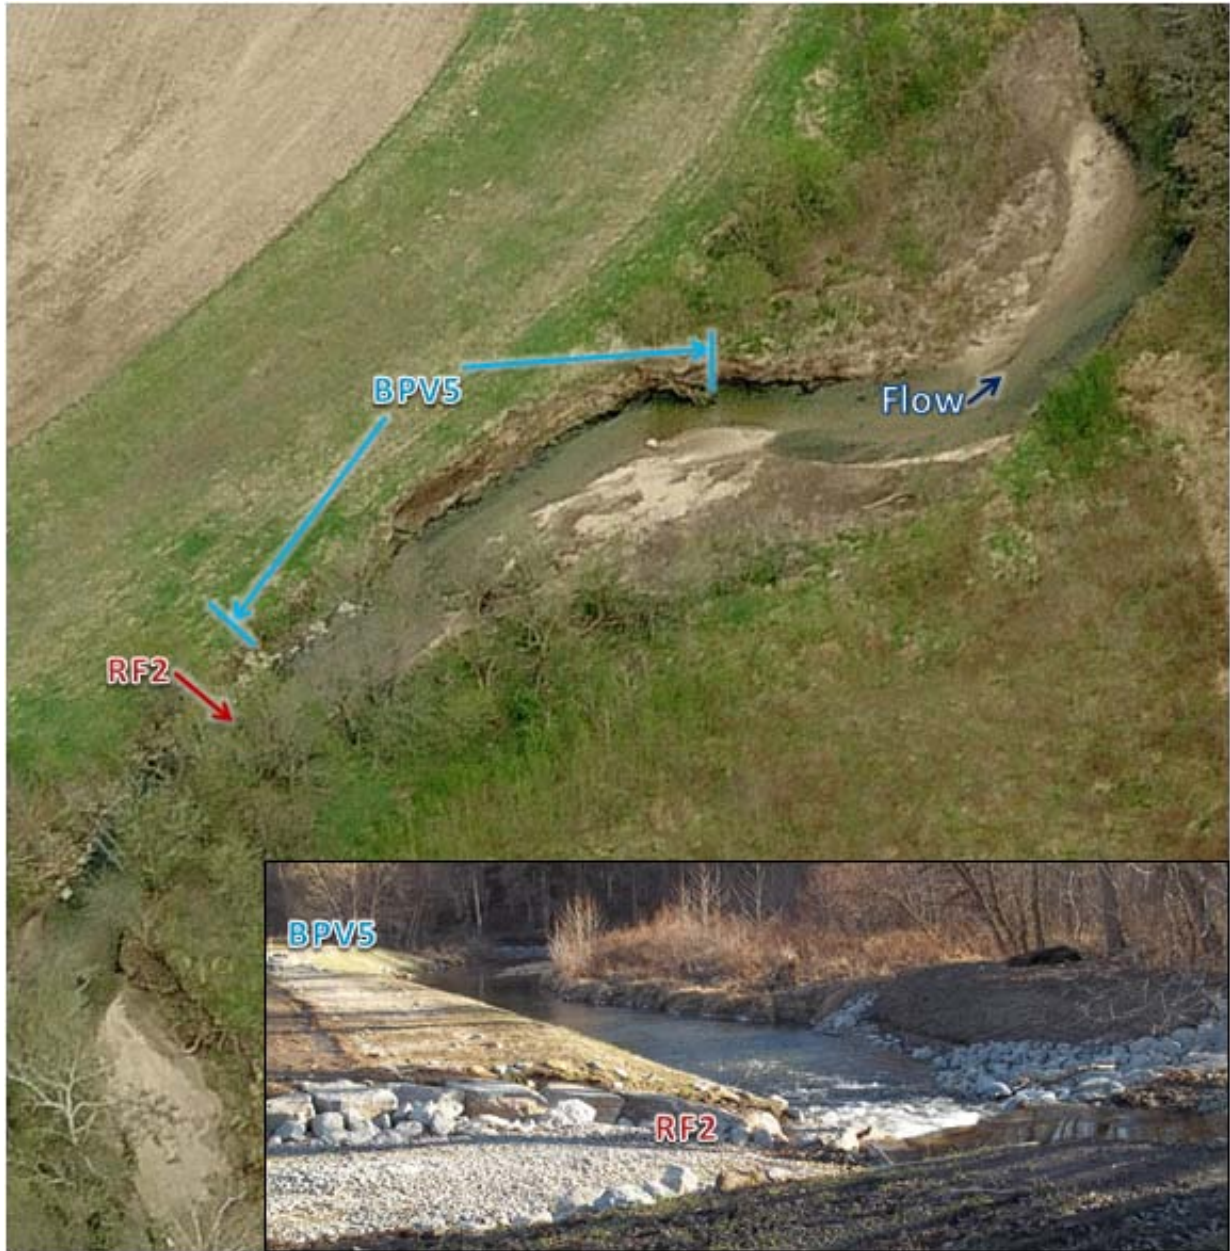
Figure 10. Condition of banks and stream before riprap sloped bank and riffle installation at BPV5 and RF2 (top-looking east) and after installation (bottom right-looking downstream).

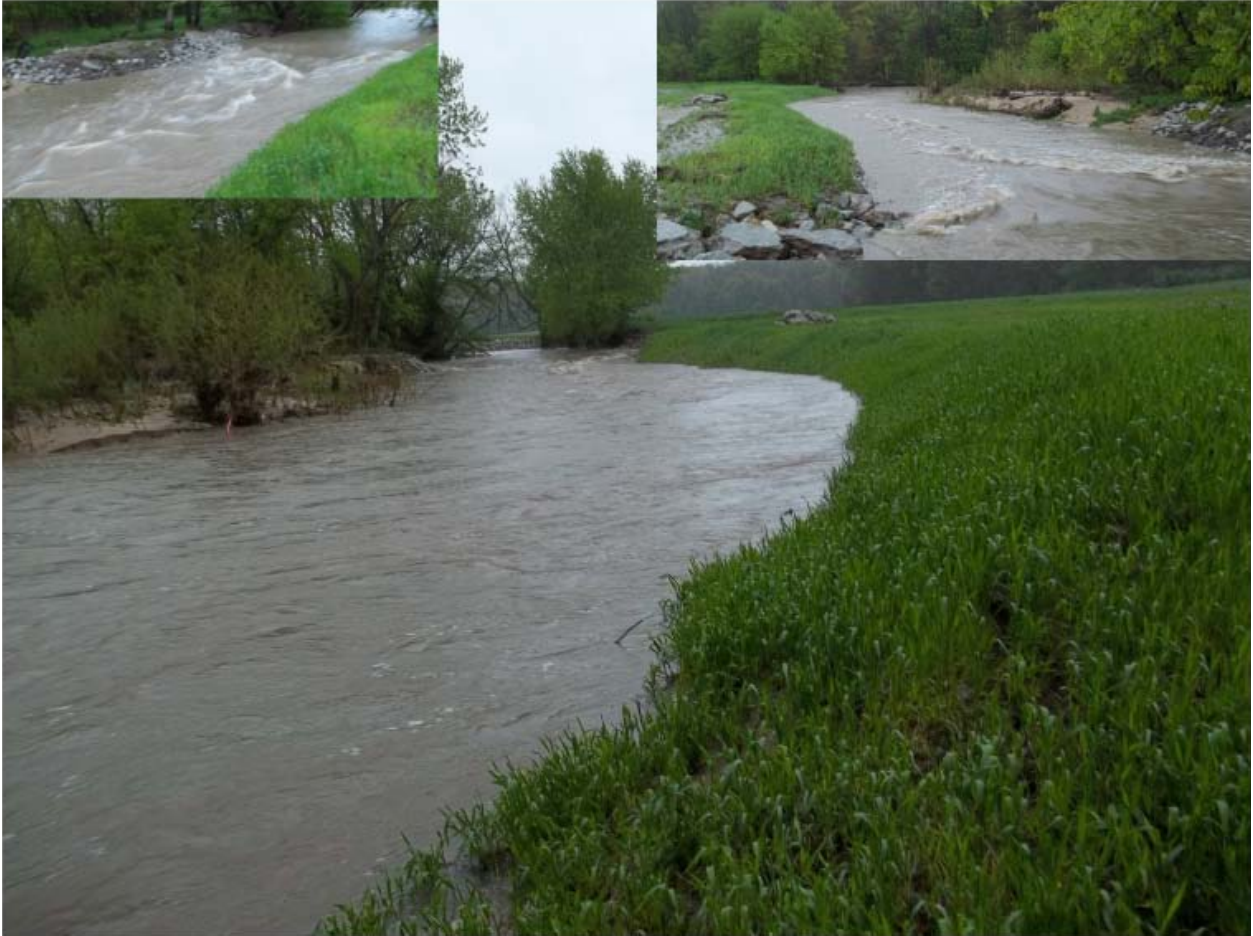
Figure 11. Top left photo looking at RF2 in flood conditions spring 2011. Middle photo looking upstream at RF2 and BPV5. Top right photo looking downstream at RF2 and BPV5.

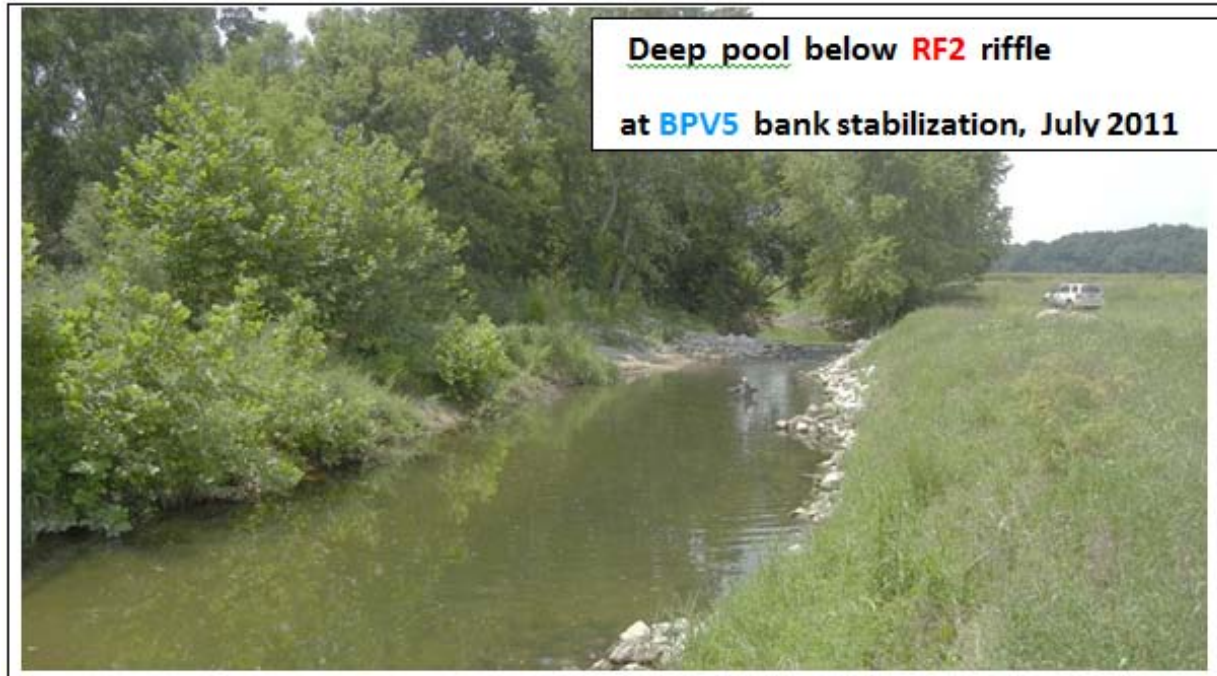
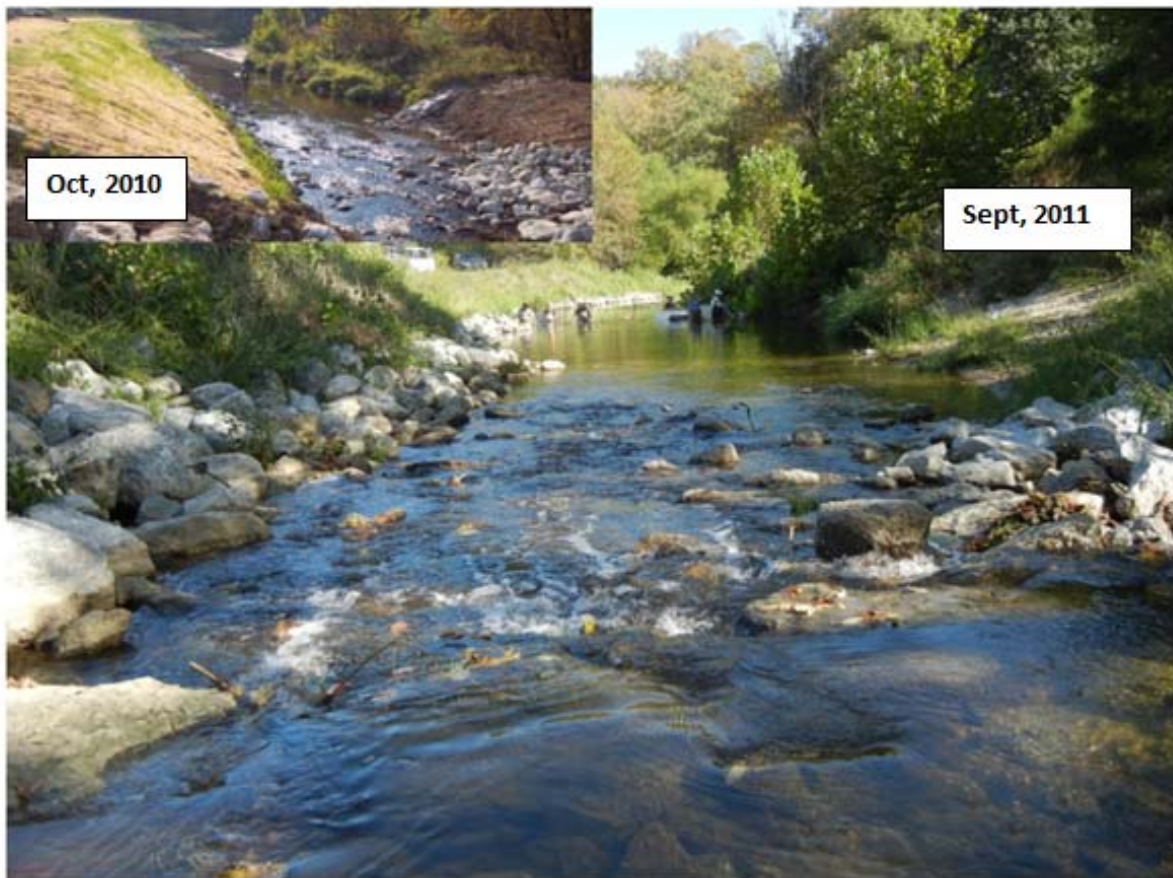
Figure 12. Conditions of BPV5 and RF2 after spring floods in 2011 (top photo looking upstream and bottom photos looking downstream).

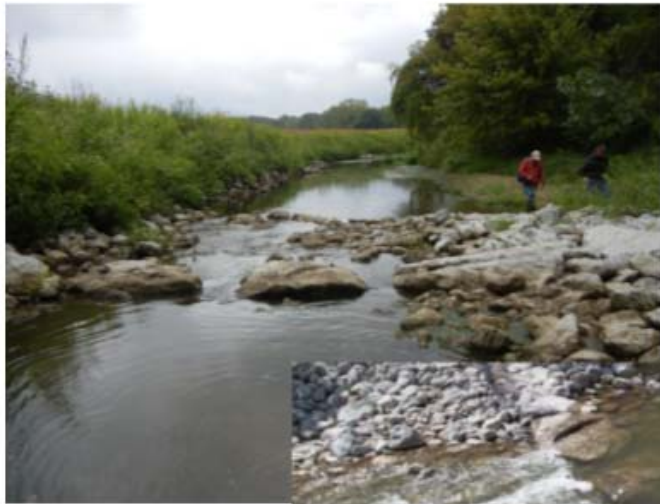
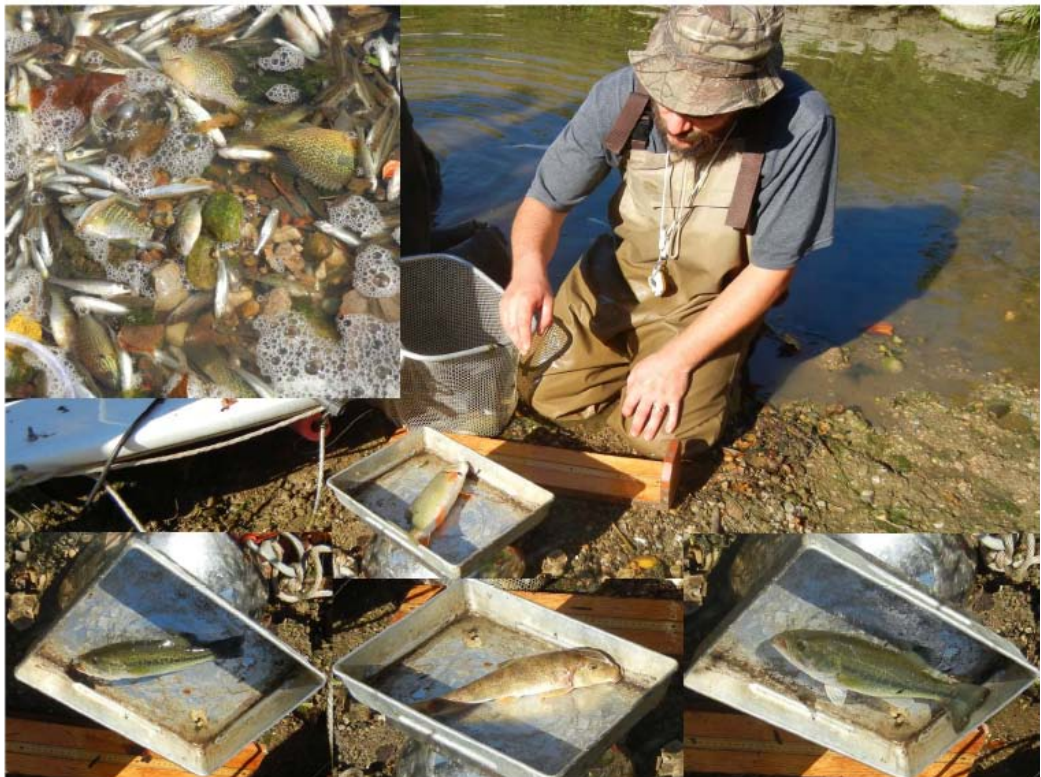
The higher crest stone elevations increased hydraulic jumps during floods to scour deeper pools and create larger substrate

Large gaps were left between crest stones to promote fish passage at low stream flows

Figure 13. Photos and text discussing linkage of physical properties of riffles and fish habitat and passage (top). Fish survey results of deep pool below RF2 along the BPV5 bank in Sept of 2011(bottom photos).

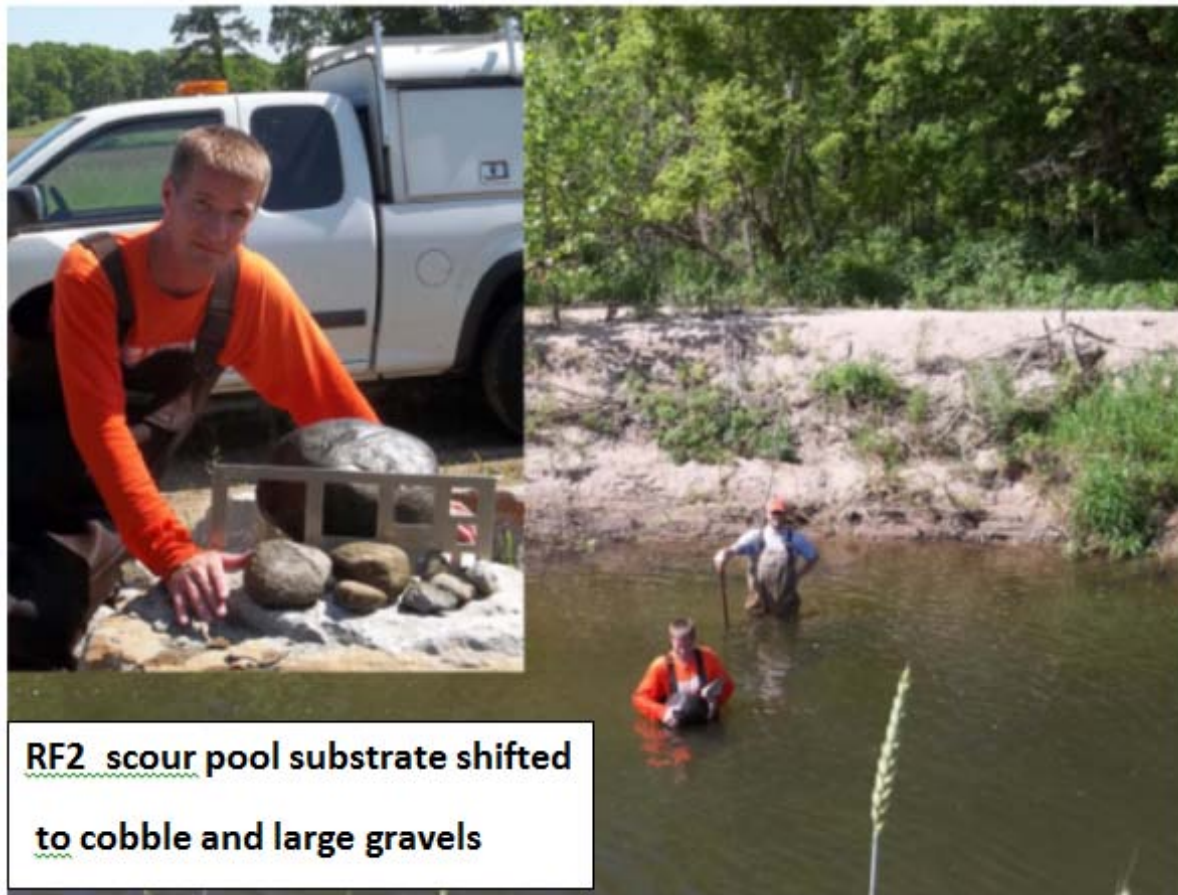
Figure 14. Bed material downstream of RF2 in May 2011 after spring floods.

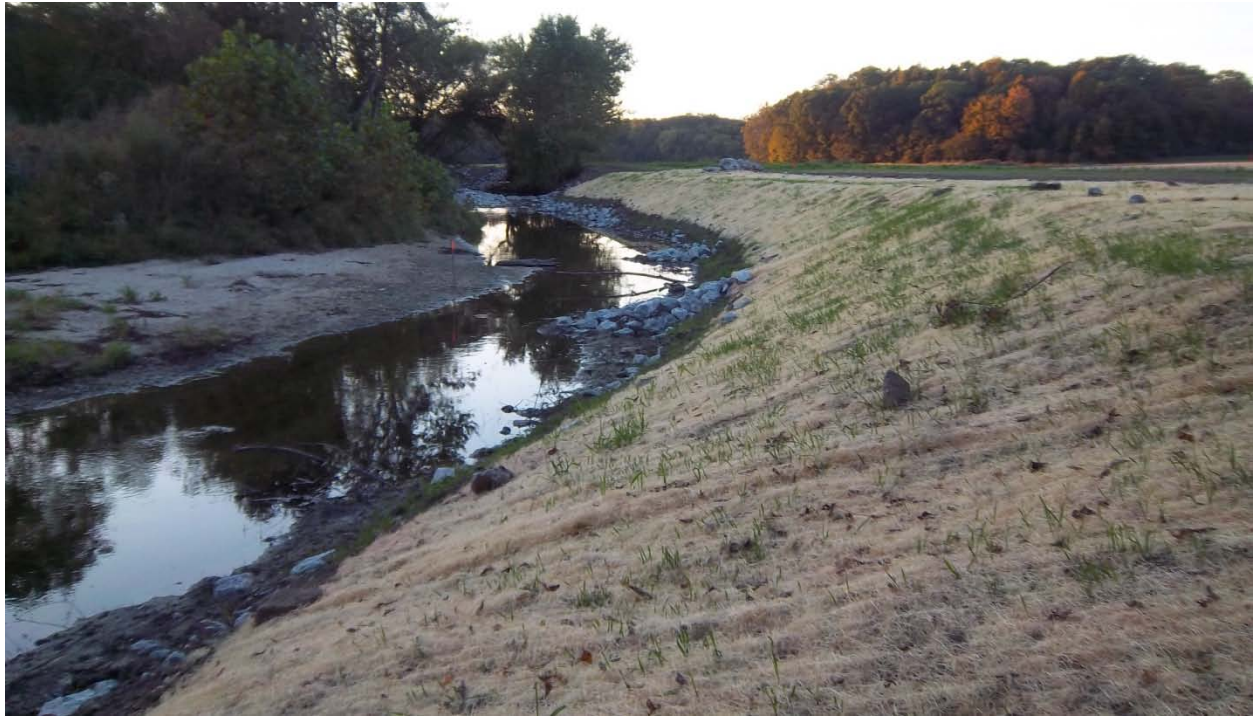
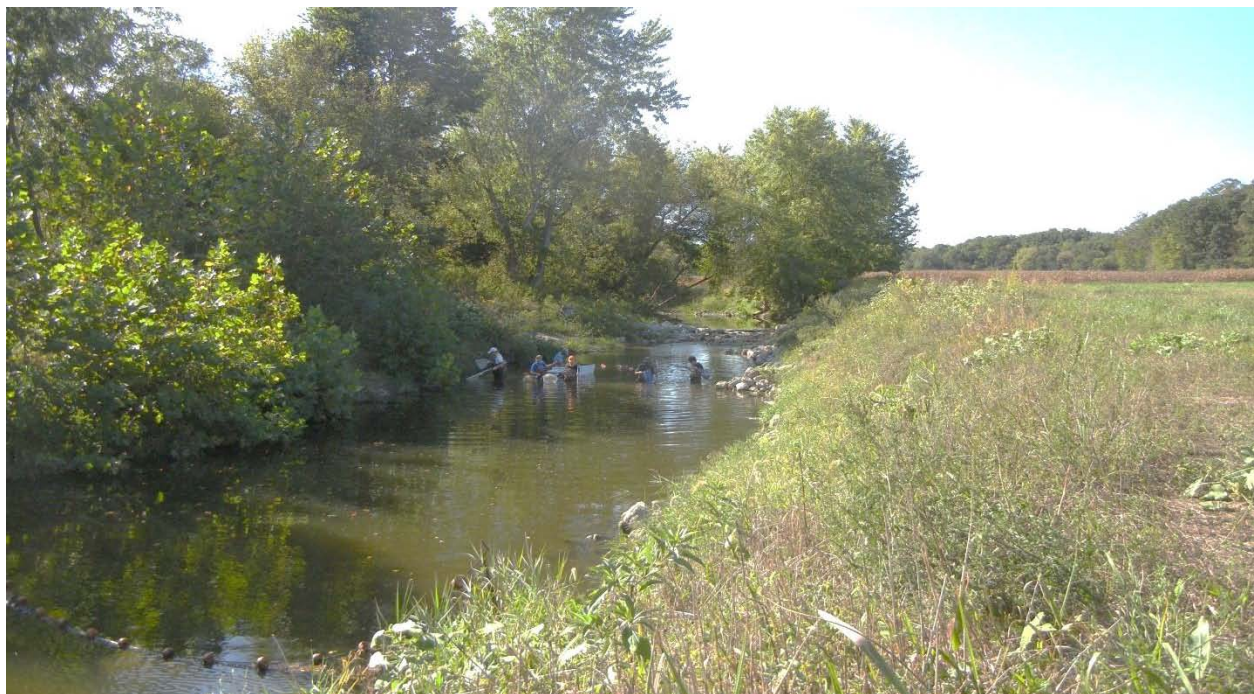
Figure 15. Conditions before (top) and after (bottom) spring 2011 floods (photos taken looking upstream at BPV5 and RF2).

However, the wider channel along the sloped bank will decrease the rate of scour pool formation below the spurs until bedload deposition increases the point bar size and narrows the stream channel against the stabilized bank. As vegetation increases on the point bars, more of the flood flow will be deflected against the spurs to increase scour pool size and depth below the spurs. Note that vegetated point bar at the stream barbs narrows the channel and causes high velocity flood waters to scour deep pools below barbs (Figure 15).

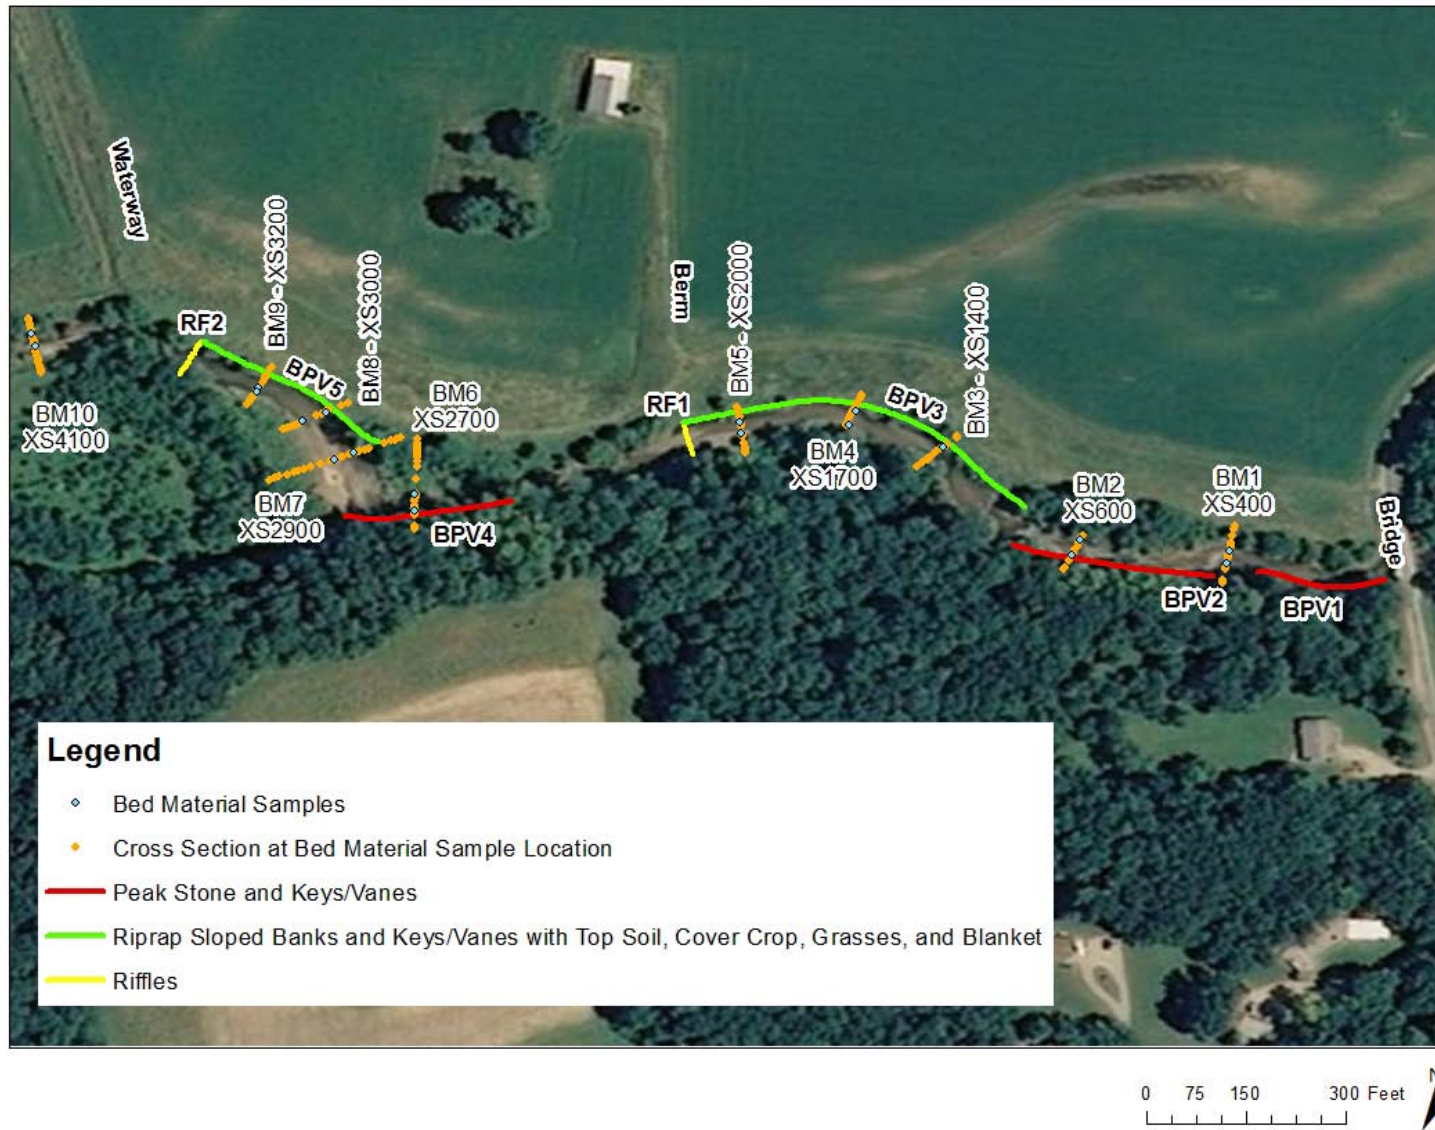
Figure 17. Location of bed material samples and surveyed cross sections at bed material locations.
