Kickapoo Creek Restoration Project, Charleston, Illinois

Final Report Agreement Number 3190902

STREAM RESTORATION ASSESSMENT FOR KICKAPOO CREEK NEAR CHARLESTON, ILLINOIS

Kickapoo Cr Instream Restoration Project Maintenance Summary

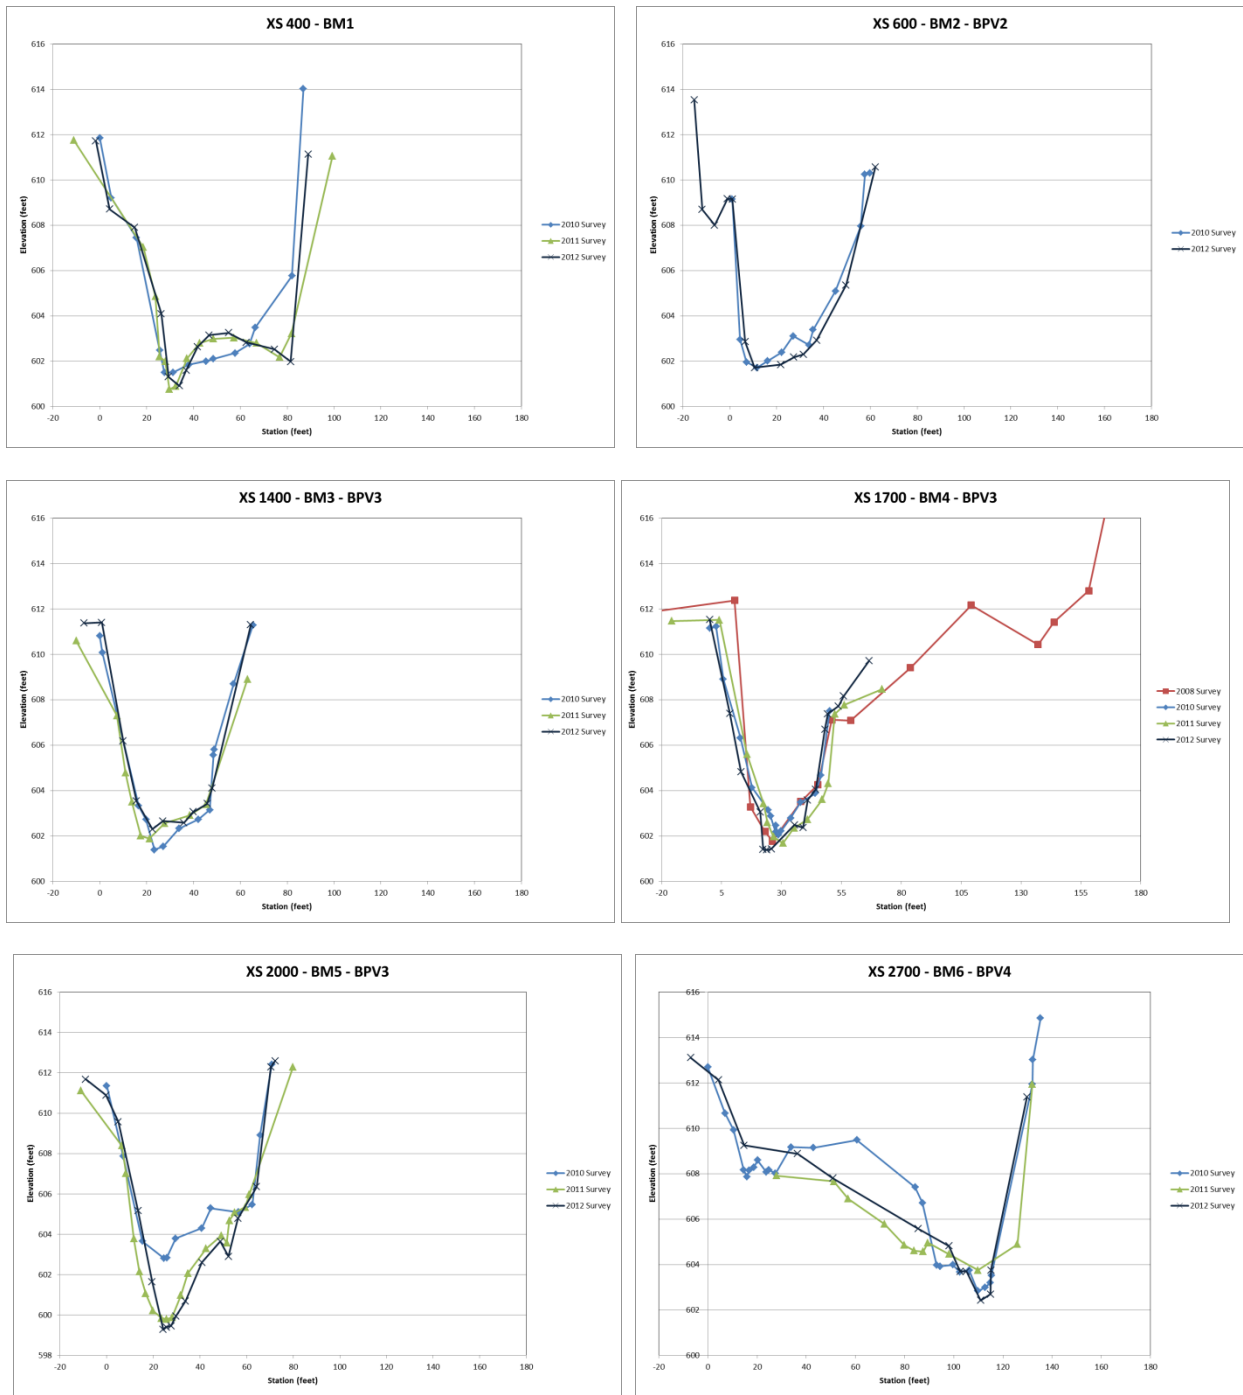
Figure 18. Graphs of 2010 through 2012 surveyed cross sections at bed material sample locations.

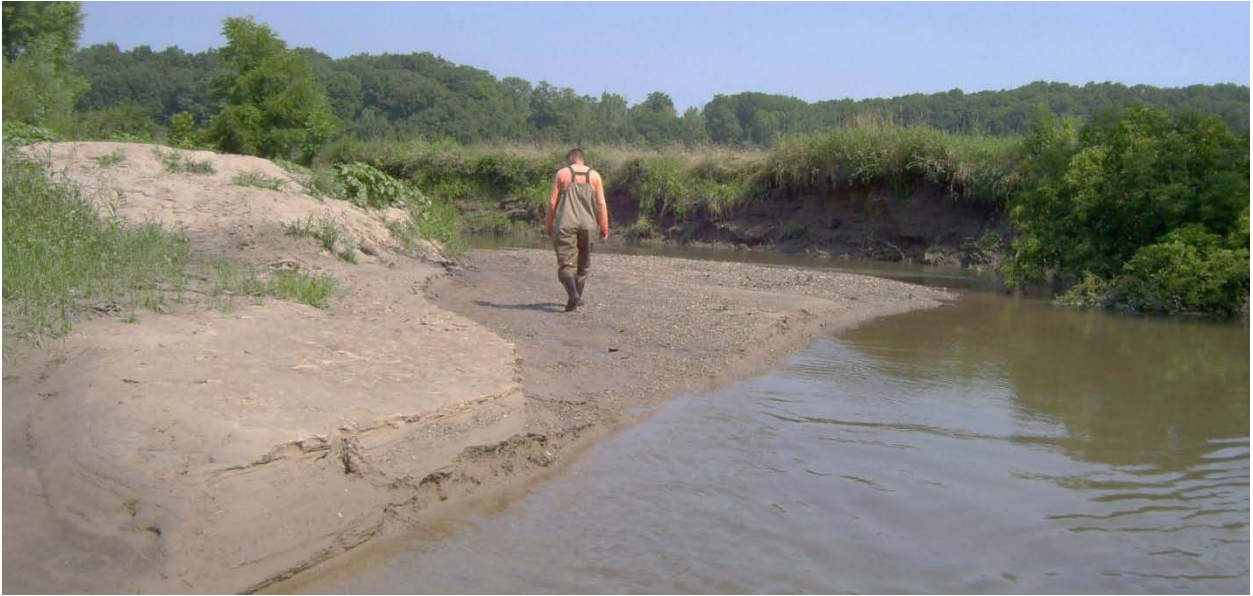
Bed material deposition on point bar adjacent to eroding bank (BPV5) below upper riffle (RF2) prior to restoration.

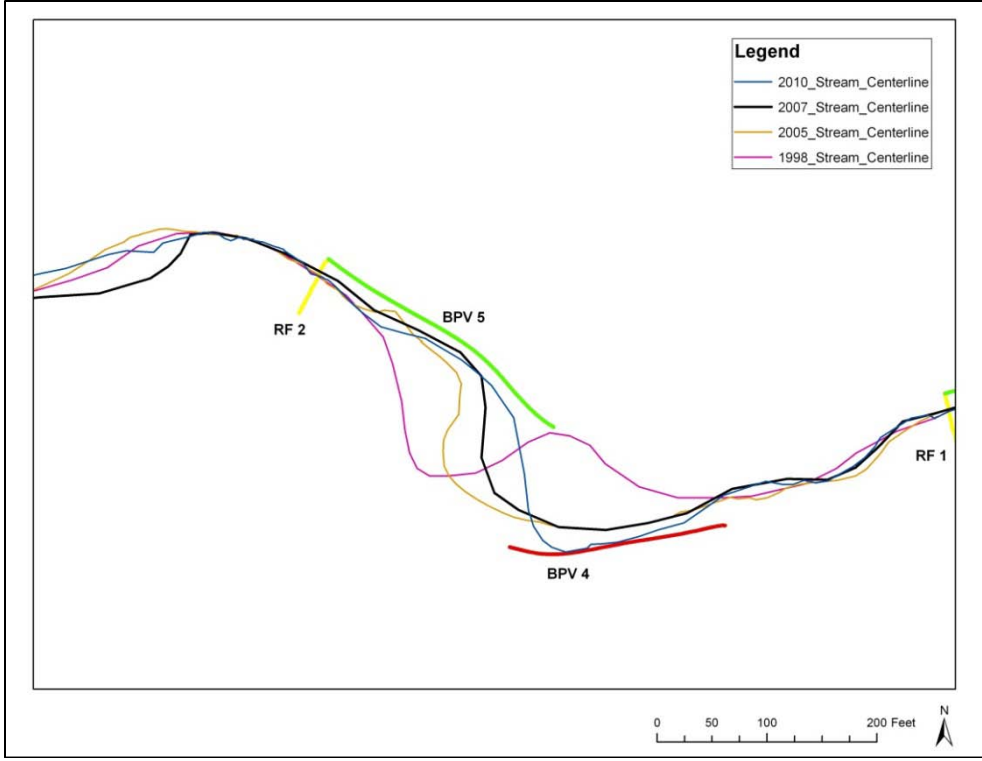
Historical bank erosion within the restored reach (also for perspective, the 1938 Aerial is presented in Appendix B).

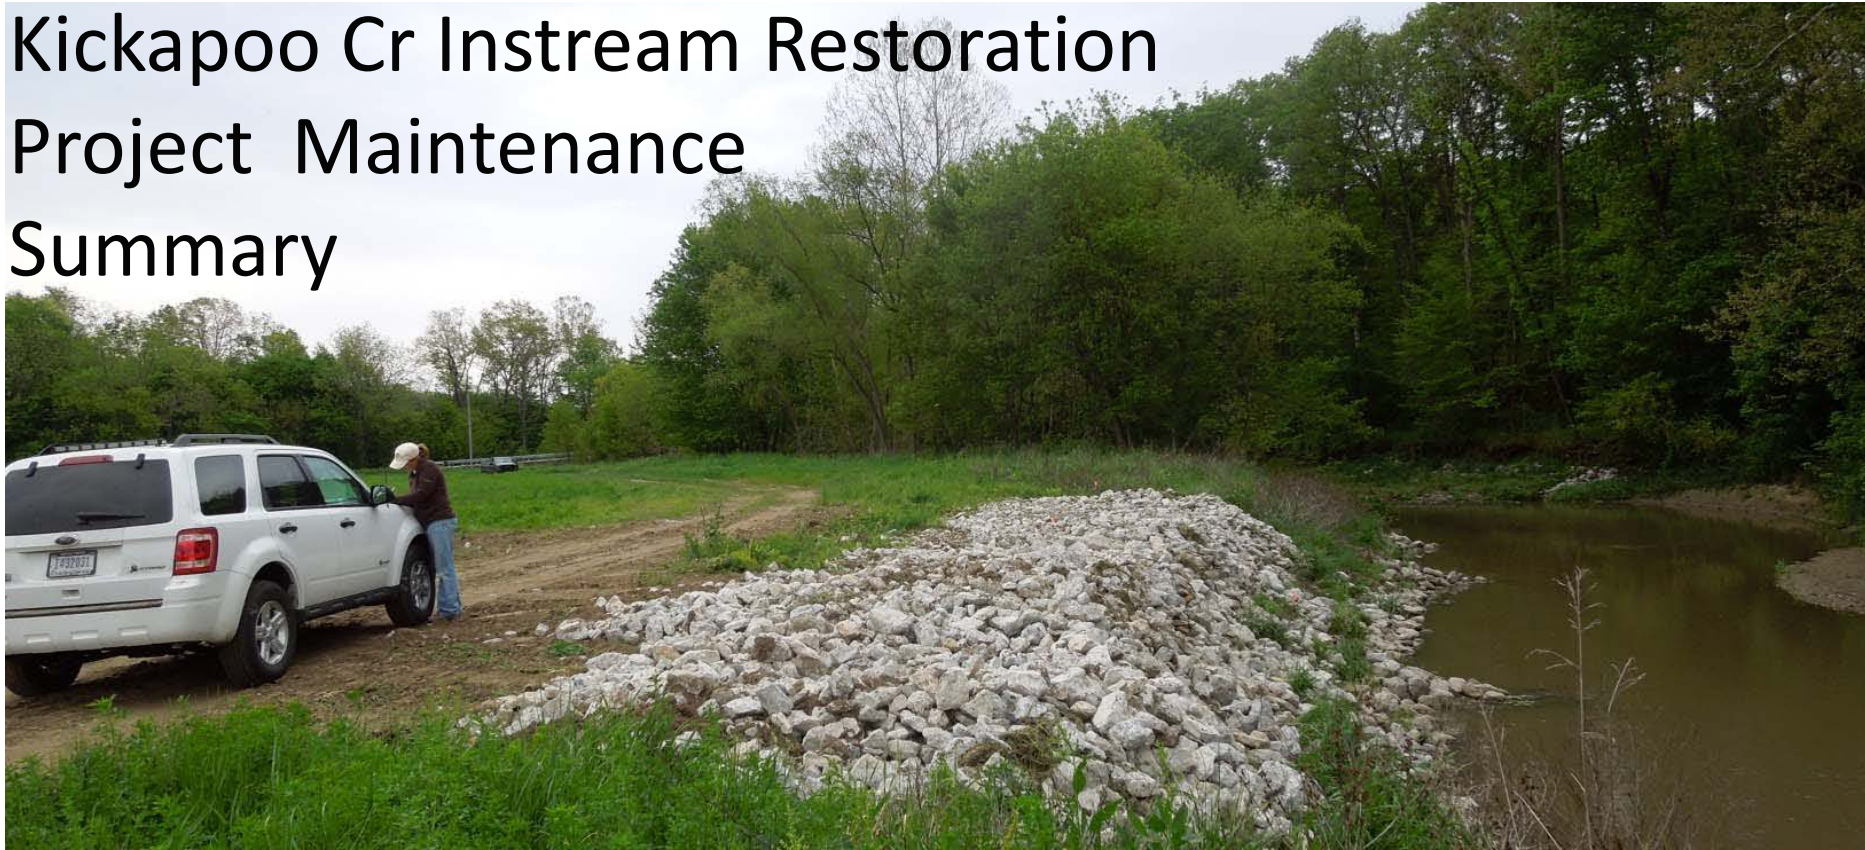
Maintenance components:

- Rock was added to the streambank and riffles to further secure the structures in preparation for flood events.
- Approximately 220 feet of additional bank protection was constructed upstream of the project reach to further secure the stream.
