The Sandra Miller Bellrose Stream and Wetland Restoration Monitoring Summary

Prepared by:
Illinois Natural Resource Trustees:
Illinois Department of Natural Resources and
Illinois Environmental Protection Agency

August, 2015

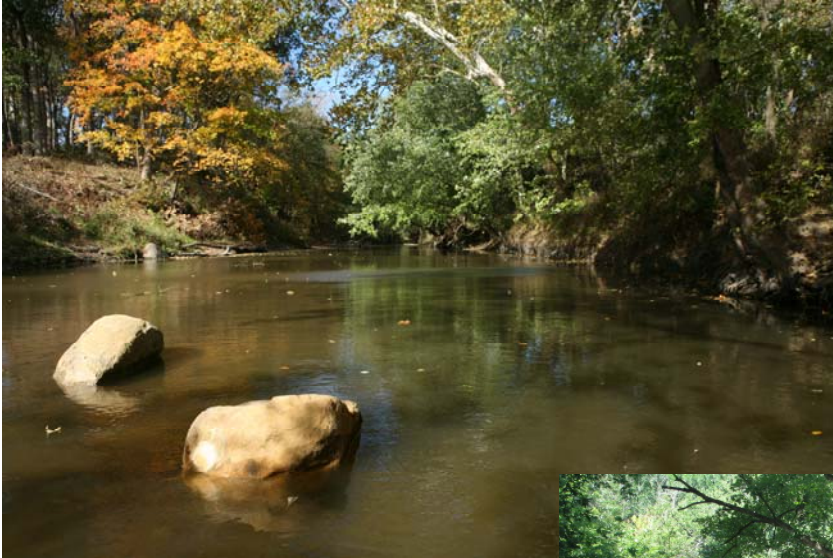
Boulder Clusters: A cluster of rocks (3 - 6 ft in diameter) that generate flow turbulence and create scour holes on the downstream side of the clusters to create additional fish habitat. The clusters also increase the dissolved oxygen content of the water, providing essential oxygen to aquatic life. The rocks themselves provide habitat for small fish and aquatic insects.

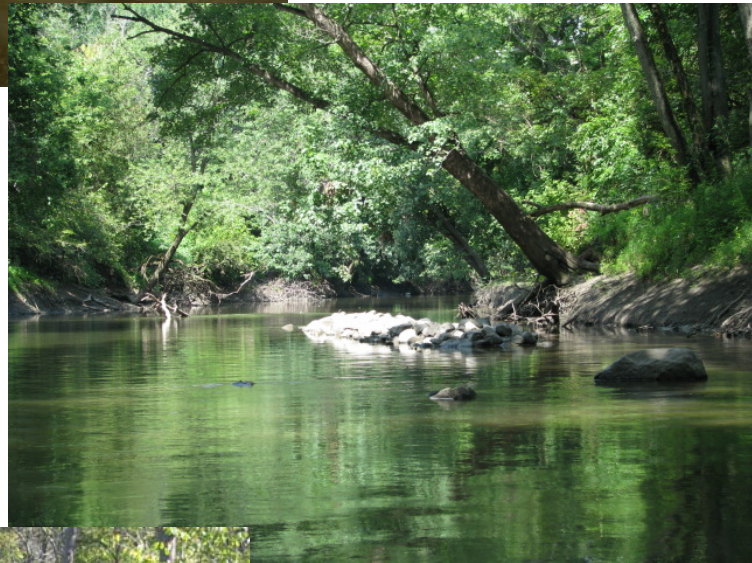
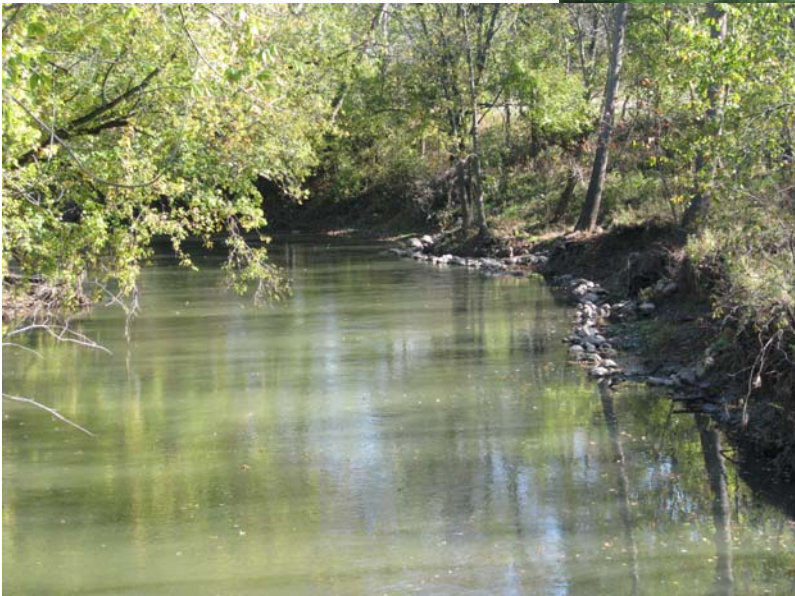
Longitudinal Habitat Stone: An elongated formation of 3-12 inch diameter rocks creates scour development and escape/spawning habitat for fish. The rocks themselves provide habitat for small fish and aquatic insects.

Stone Toe Protection: A series of 3-12 inch diameter rocks placed along the base of the streambank to stabilize the bank, limiting erosion; thereby reducing sedimentation and increasing overall water quality of the stream. The rocks themselves provide habitat for small fish and aquatic insects.

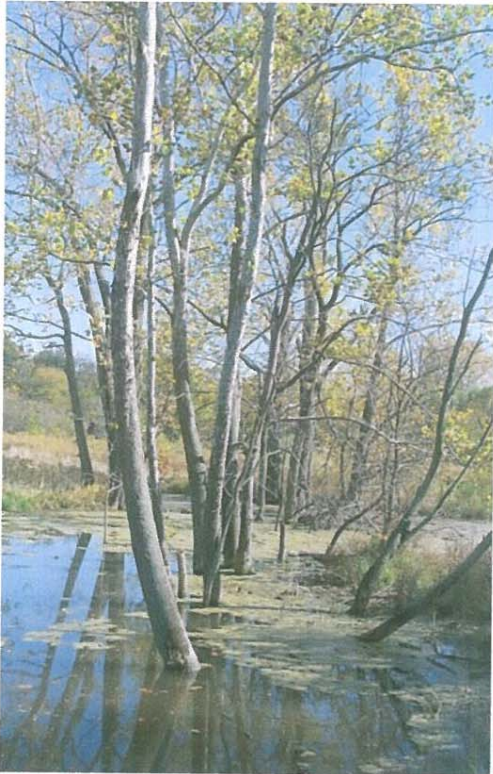
Wetland 1 is approximately 0.48 acres and is characterized as a partially forested, permanently flooded, shallow-water basin. Water levels are controlled by a small earthen embankment along the northwest corner of the site. Flood tolerant trees such as Sycamore partially shade the central portion of the wetland; however, the littoral margins along the southern half of the wetland receive full sunlight and are composed of dense stands of emergent species

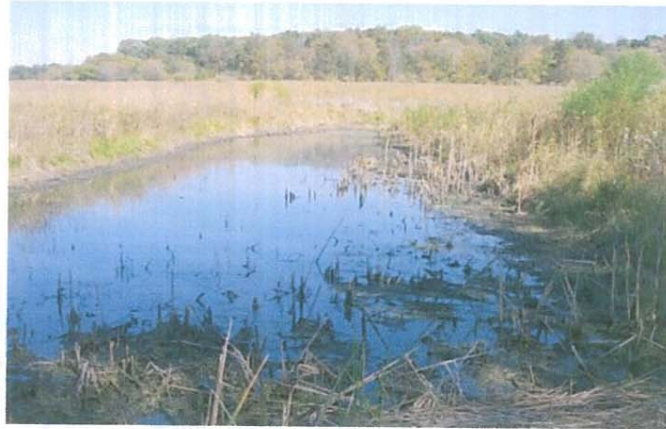
Wetland 2 is located just north of Wetland 1 and is characterized as an emergent, semi-flooded basin. This small (≈ 0.15 acres) wetland was created as the result of borrow activities for wetlands 1 and 3, and maintains a dense, diverse mix of emergent plant zones.

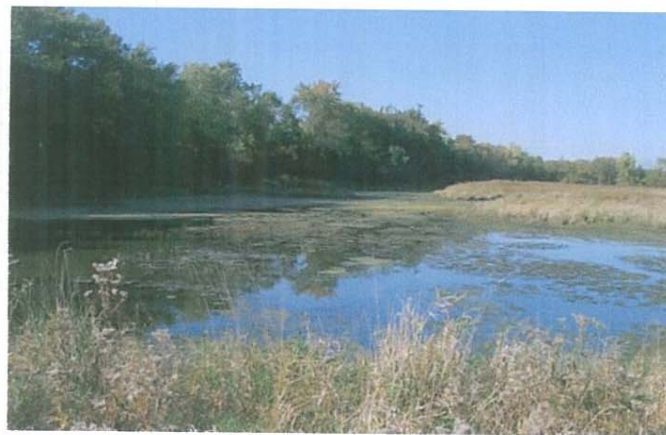
Wetland 3 is the largest and the most diverse sample site and can be characterized as a hemi-marsh. This wetland is approximately 2.48 acres and maintains permanently flooded conditions as a result of significant ground water input. A small earthen berm along the southern boundary helps maintain water levels. This hemi-marsh is dominated by a mix of submerged aquatic species, open water and emergent vegetation.

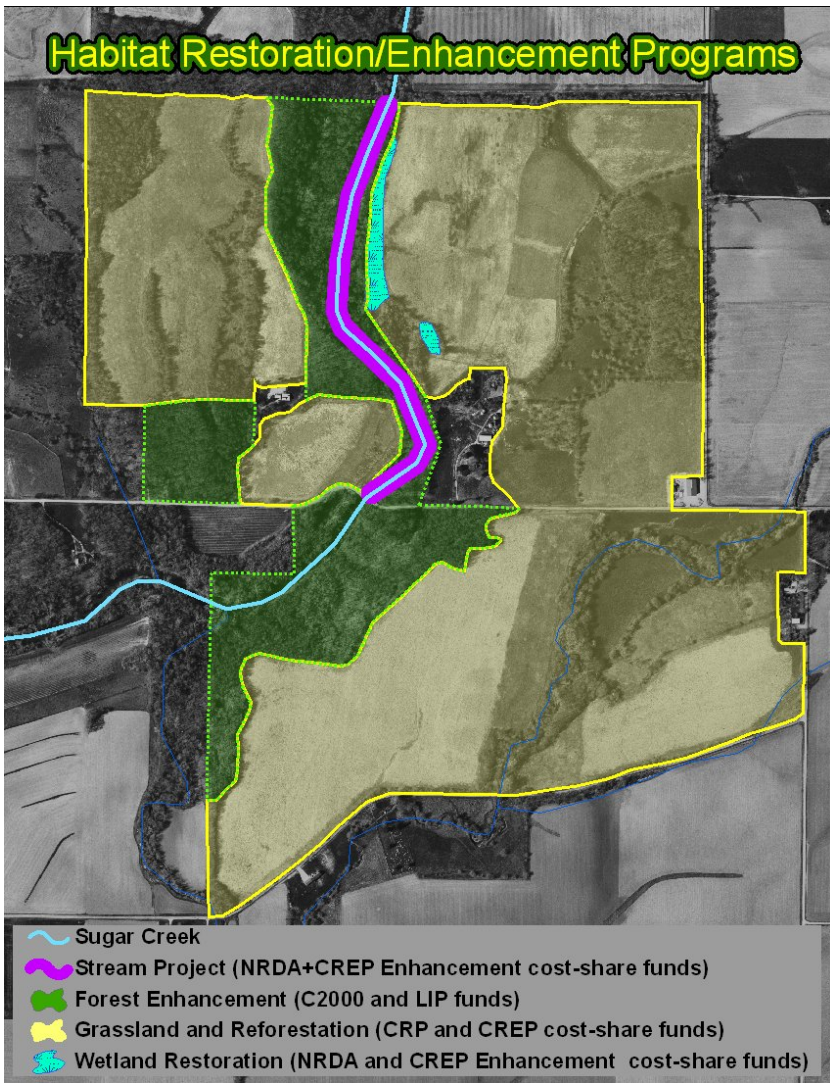
Figure 2. Digital Ortho map of the Sandra Miller Bellrose Nature Preserve (area in green) and implemented restoration projects. This map was obtained from IDNR's Office Resource Conservation.

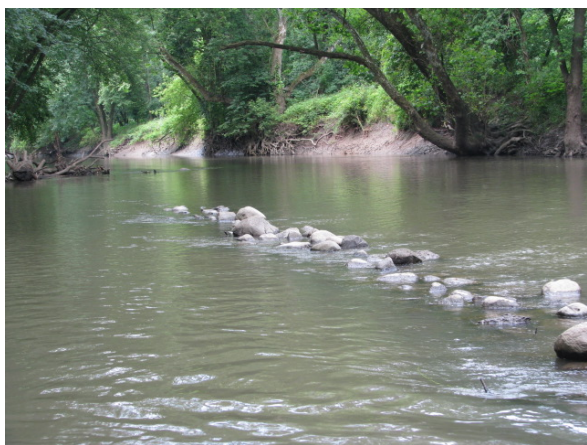
Figure 3. Instream Restoration Longitudinal Stone Habitat Structure (photo credit: IDNR's Contaminant Assessment Section).

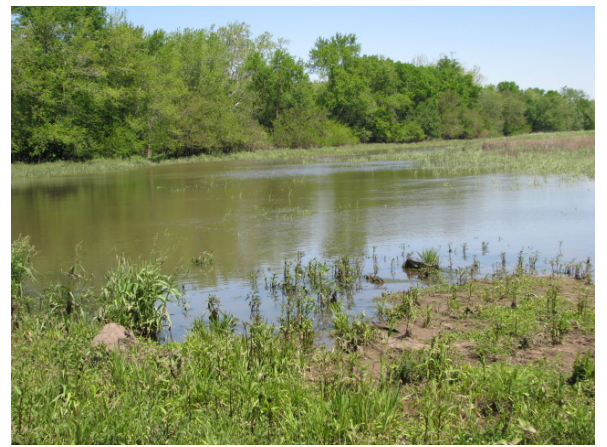
Figure 4. Wetland Restoration Project (photo credit: IDNR's Contaminant Assessment Section).

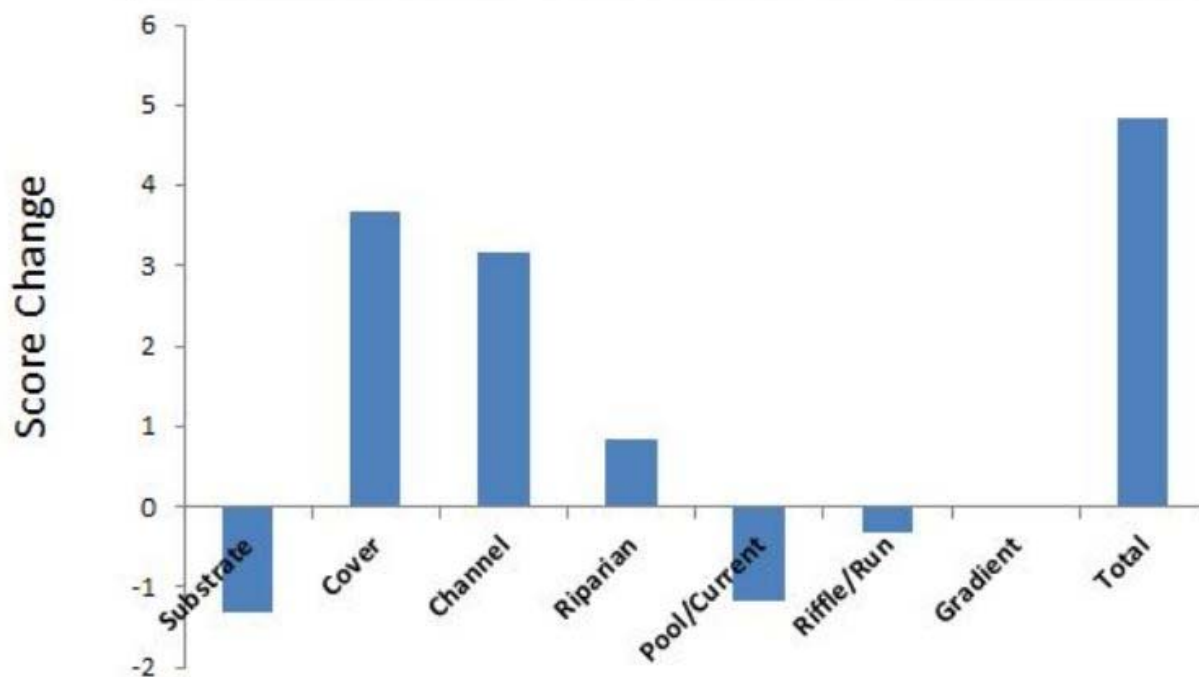
Habitat Composition Evaluation - QHEI

Figure 7. Post restoration score change from pre restoration values for various categories using the Qualitative Habitat Evaluation Index [graphic provided by Metzke 2015].

The 2008, 2009, and 2012 habitat surveys were all very similar to the 2007 survey prior to restoration work, which indicates a good to high quality stream (Table 2 and 3). Due to the instream enhancements there was an increase in instream cover and pool variability, which would indicate an increase in habitat for fish including an improvement of general stream conditions such as adequate temperature and varied depths. The habitat surveys increase was small, approximately a 2-9% increase for the QHEI and a range of a 7% increase to a 3% decrease for the SHAP (Table 3; Figs 7-8). This variability is most likely due to a difference in the scorer's rankings versus an actual ecological impact. With the large channel size there likely was not enough habitat structures put in the stream reach for there to be a detectable impact to the physical structure of the stream.

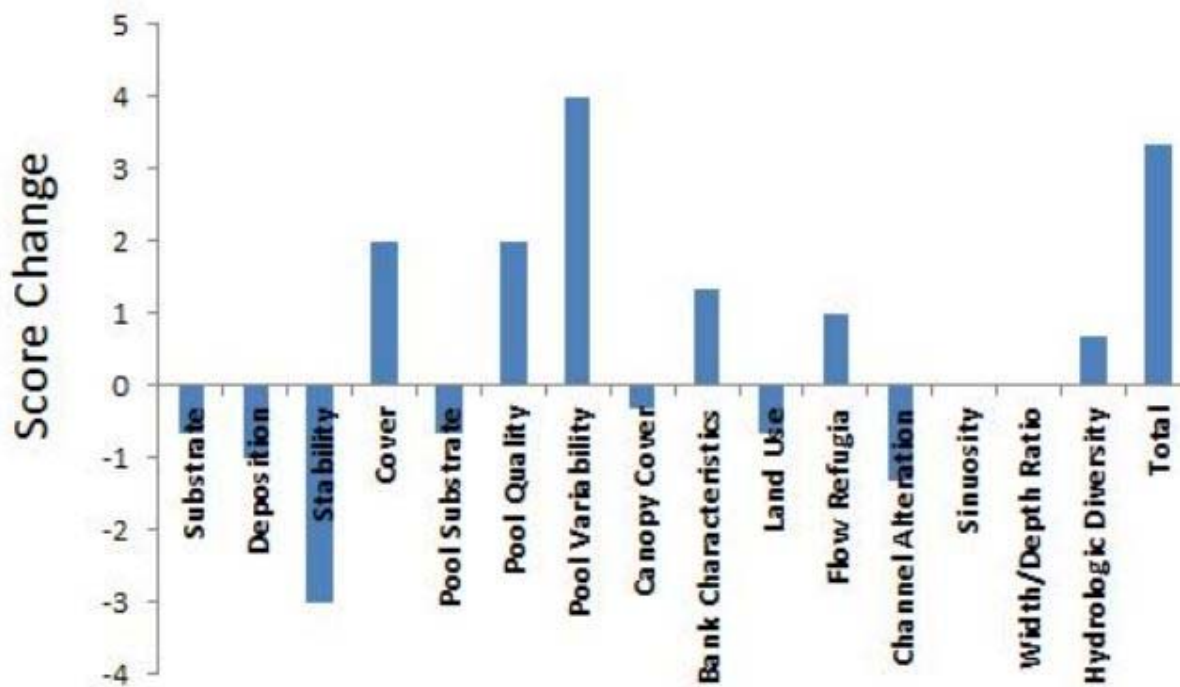
Habitat Composition Evaluation - SHAP

Figure 8. Post restoration score change from pre restoration values for various categories using the Qualitative Stream Habitat Assessment Procedure [graphic provided by Metzke 2015].

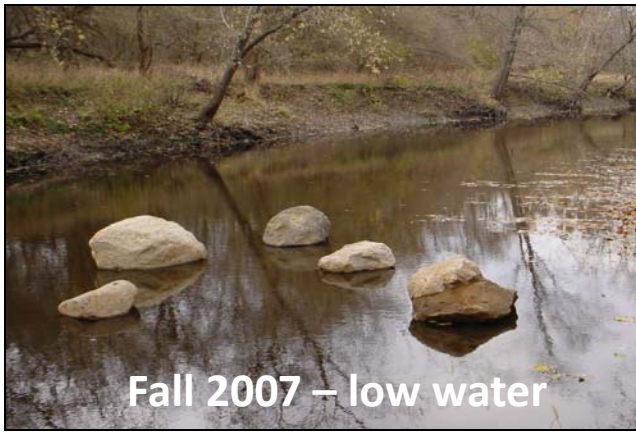
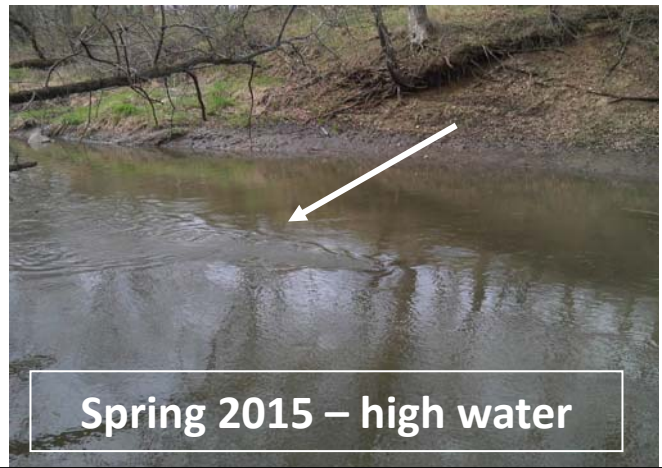
Figure 9. Boulder clusters immediately post implementation (left) and during high water flow (right). Increased turbulence is observable over the boulder cluster during high water levels (white arrow). Photos courtesy of IDNR and Illinois Natural History Survey staff.

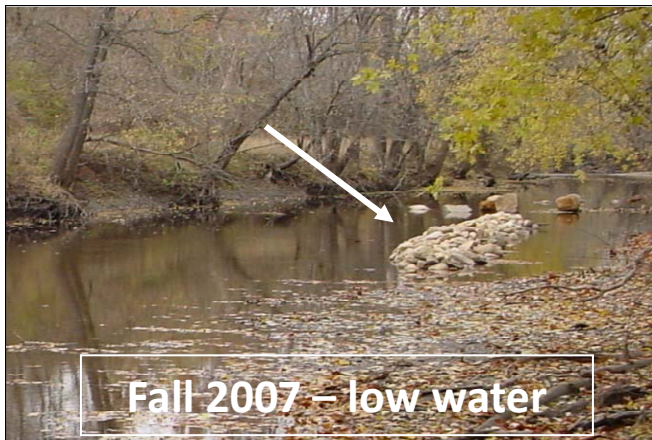
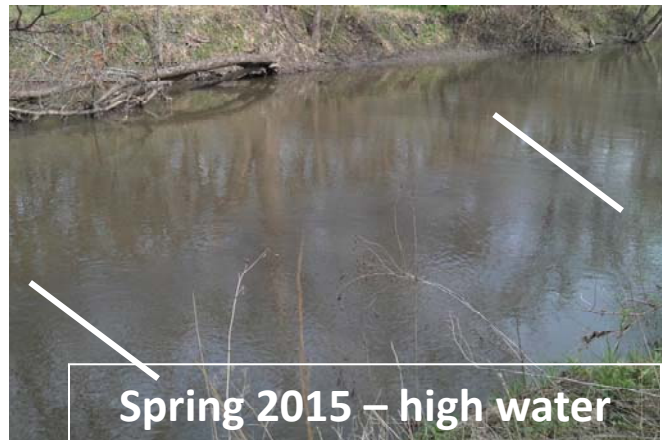
Figure 10. Longitudinal Habitat Structures immediately post implementation (left) and during high water flow (right). Increased turbulence is observable over the rock structure during high water levels (white lines). Photos courtesy of IDNR and Illinois Natural History Survey staff.

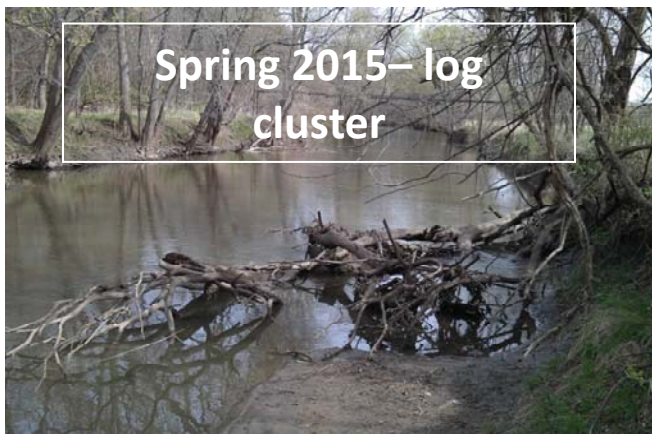
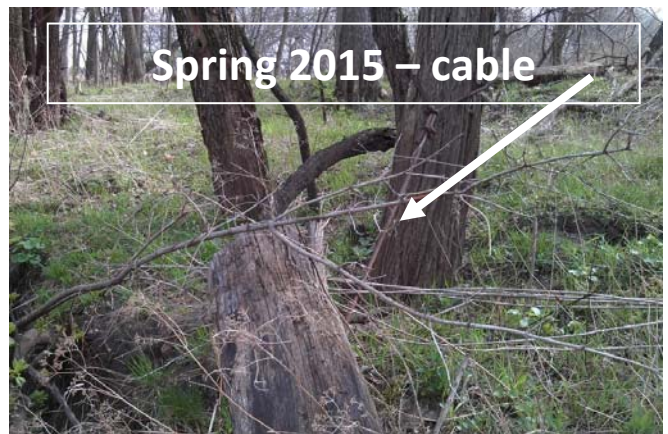
Figure 11. A Log Cluster, which provides a diverse complex of habitat. The woody debris is cabled to a tree along the streambank to secure it in place. Photos courtesy of Illinois Natural History Survey staff.

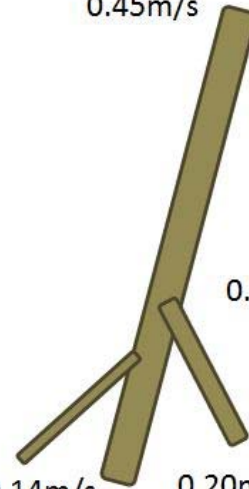
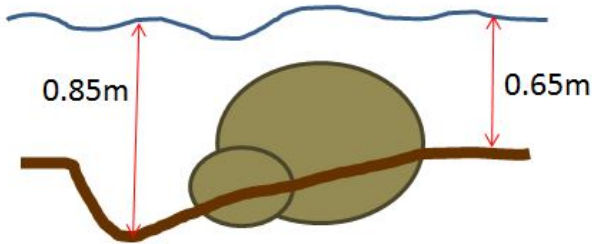
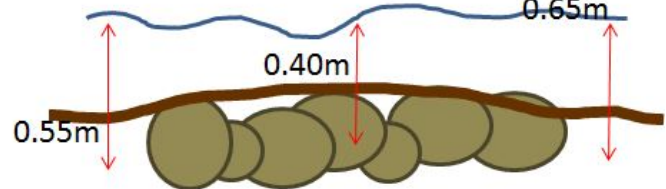
Figure 12. As a result of the velocity and depth evaluation it appears the structures should be providing flow refugia and habitat for multiple age classes [graphic provided by Metzke 2015].

However, flow and depth measurements collected around the instream structures indicate the structures should be providing flow refugia and habitat for multiple age classes of fish (Figs 9-12). For example, the boulders are creating slower water on the downstream end of the structure, which provides a good spot for adult fish to rest and wait for food. The longitudinal habitat structures are providing interstitial spaces for insects and smaller fish species. And the log jams are providing a complex of various flow types which should be benefiting both adult and juvenile fish. [pers. communication B. Metzke July 2015] The increased turbulence around the structures should also be aerating the water, increasing the dissolved oxygen, which is beneficial for the various aquatic life.

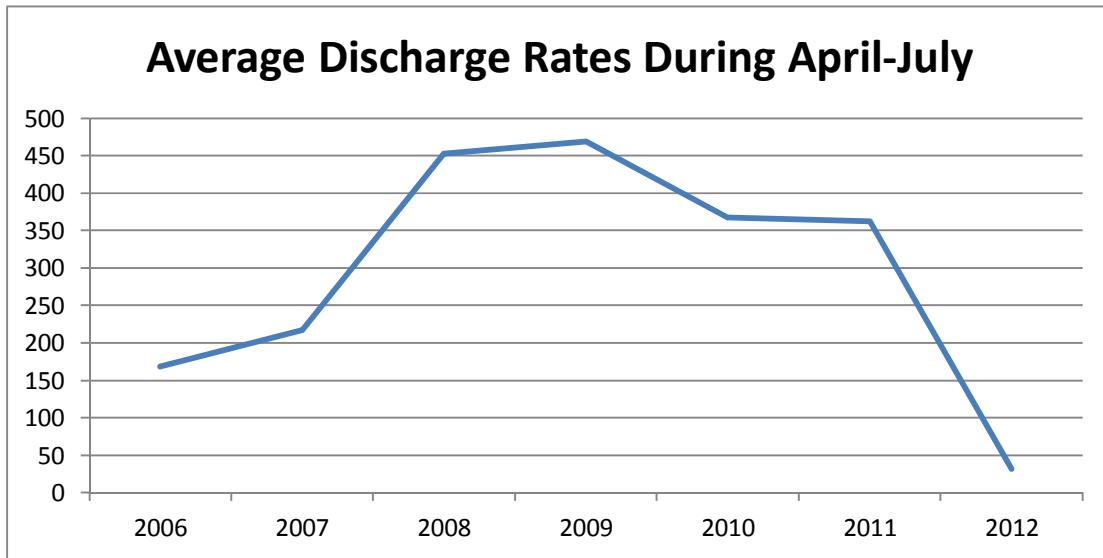
Figure 13. Average discharge from April-July in the years 2006-2012 at USGS Gage 05580000—Kickapoo Creek at Waynesville, IL (nearest stream gauge to the Bellrose project area; the results are an indication of high regional flows in 2008-2011 as compared to other years).

The most plausible explanation for the low smallmouth bass numbers 2008-2010 were unusually high rainfall amounts during the spring spawning months and the summer sampling season (Figure 13). High stream flows affect both the overall stream health (high erosion,

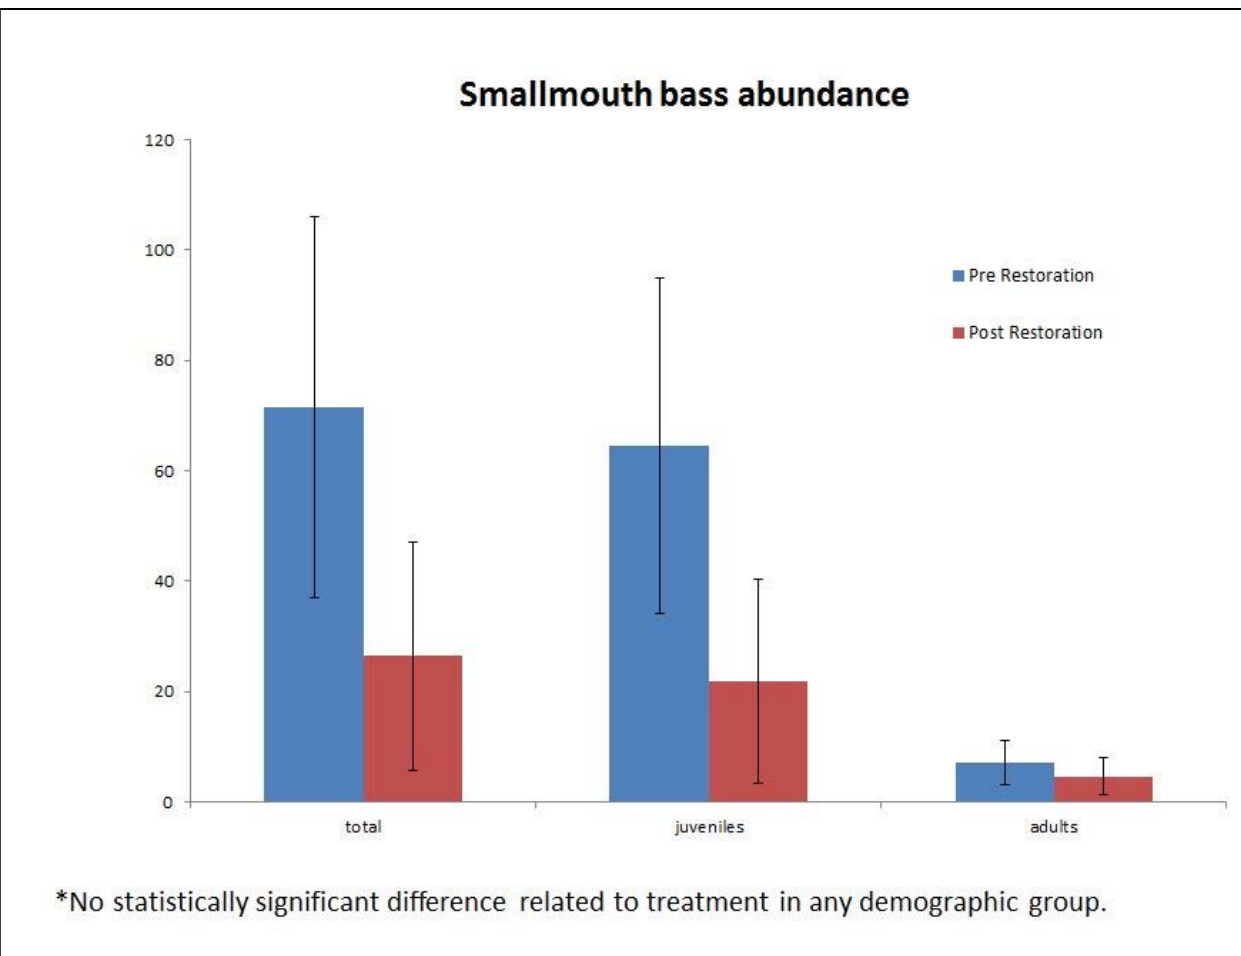
Figure 14. Smallmouth bass abundance in both juveniles and adults pre versus post restoration [graphic provided by Metzke July 2015].

Samples show a declining overall catch rate that went from 22.2 fish per hour in 2006 and 53 fish per hour in 2007 (pre restoration) to 18.8 fish per hour in 2008 and 5.7 fish per hour in 2009 (post restoration)(Carney 2009). Very similar post restoration results were observed in 2010. However, in 2012 there was a rebound in the population similar to the year's pre restoration.

- there was a return of juveniles in the 2012 sample;
- the fishery staff documented that young smallmouth bass continue to be found around the rock structures that were constructed;
- three fish over 300 mm and one fish over 400mm were netted (the fish over 400mm is the largest smallmouth bass fish observed in the stream reach since the monitoring began in 2006).

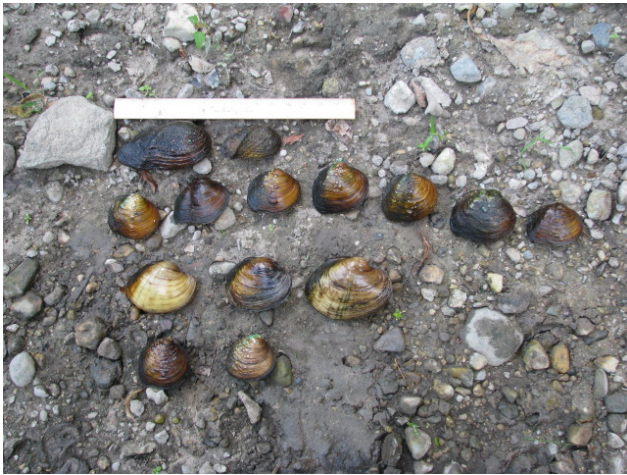
Figure 15. A group of Mussels collected at one of the three transects during the August 2010 Bellrose mussel survey.

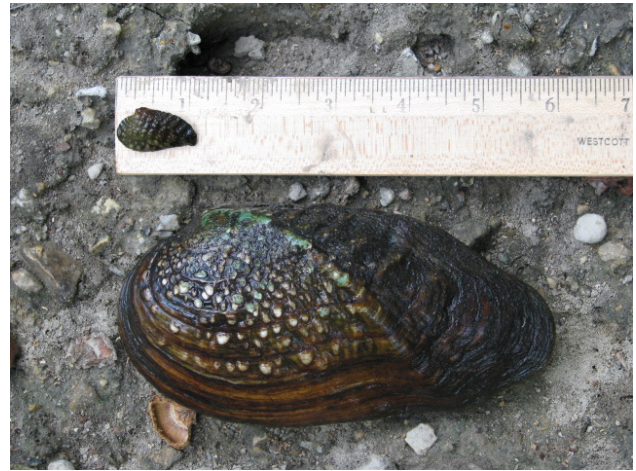
Figure 16. Juvenile (top of picture) and adult (bottom of picture) Pistolgrip mussels; collected during the August 2010 Bellrose mussel survey.

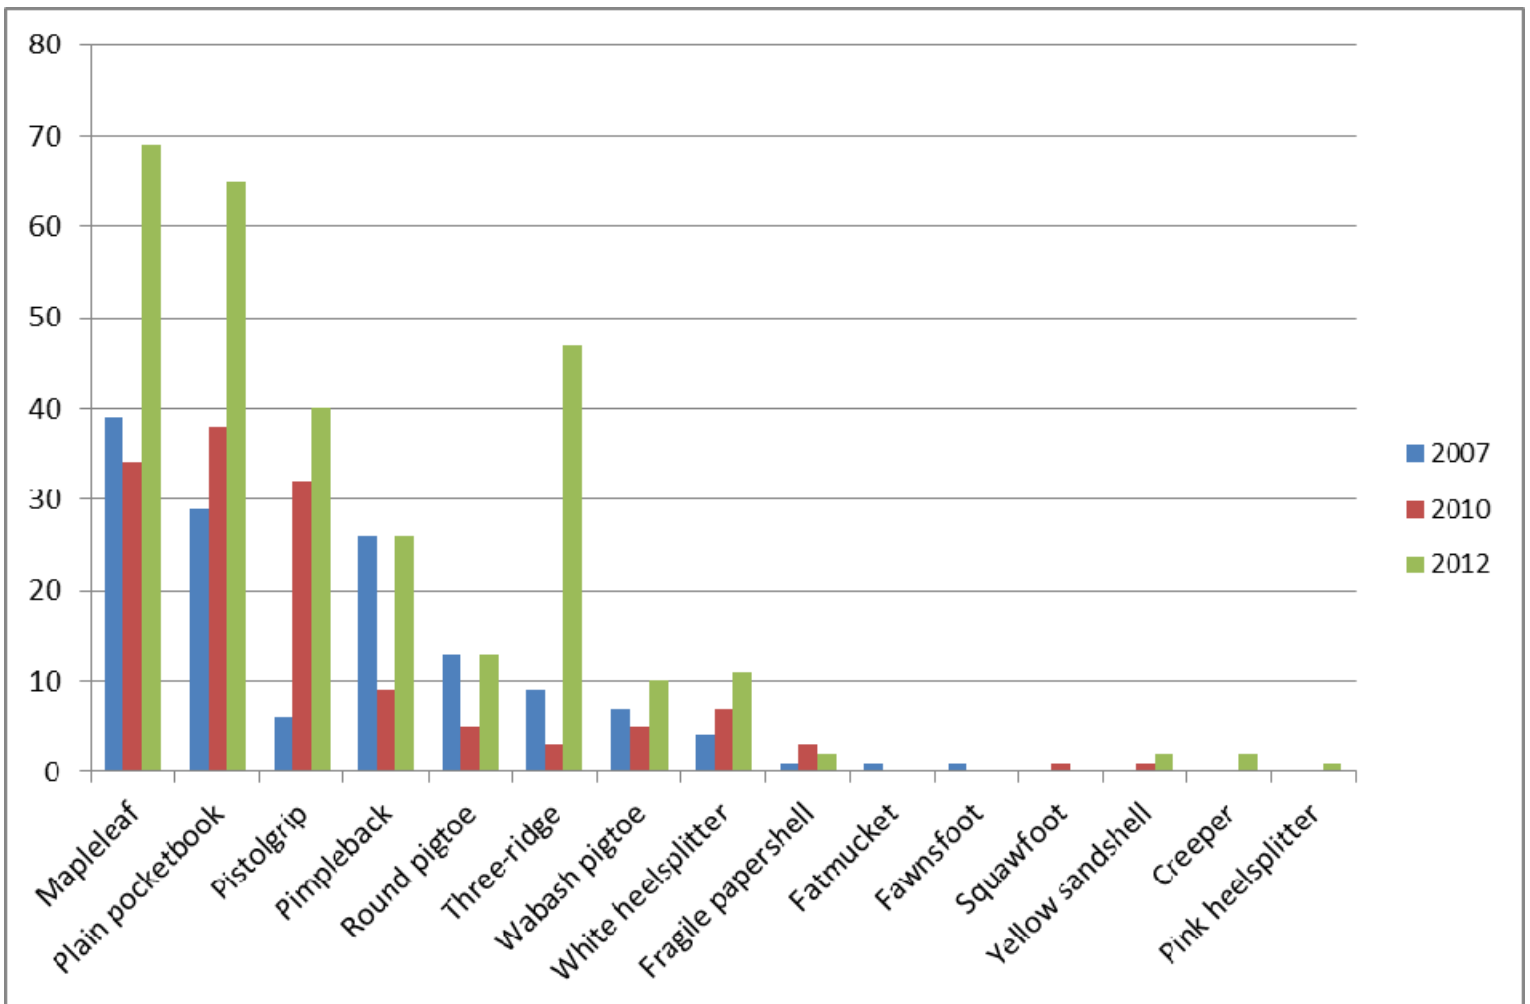
Figure 17. Summary of live mussels collected at the Bellrose Instream restoration reach; pre restoration (2007) and post restoration (2010 and 2012).

A pre restoration mussel survey was conducted in 2007. High water levels (non-wadeable stream conditions) did not allow for mussel surveys to occur in 2008 and 2009. In 2010, the first post restoration survey was conducted, and a second post restoration survey was conducted in 2012. Comparative results were found in the 2007 and 2010 surveys: throughout both methods (transect/quadrat survey and four-hour timed search) 136 individuals of 11 species were collected in 2007 and in 2010, 138 individuals of 11 species were collected (Fig 15 & 17). In 2012, the number of collected mussels doubled, and the species diversity increased by one (2012 survey = 288 individuals of 12 different species; Fig 17). There were only two species differing from 2007 to 2010: in 2007 a Fawnsfoot and Fatmucket were collected, which were not collected in the 2010 sample; however, in 2010 a Squawfoot and a Yellow sandshell were collected, which were not collected in the 2007 survey. In 2012 a Creeper and Pink heelsplitter were collected, which were not collected in previous surveys. Missing from the 2012 survey as compared to the two previous surveys were Fatmucket, Fawnsfoot, and Squawfoot. No juvenile mussels were collected in the 2007 sample, whereas a Pistolgrip juvenile was collected in 2010 (Fig 16), and a Fragile papershell and Creeper or Squawfoot juveniles were collected in 2012.

These results indicate an overall increase in mussel abundance in the restoration reach, including an increase in juvenile mussels, which is a very good sign as to the overall quality of the stream reach. Since mussels rely on host fish to disperse their larvae, an increase in mussel abundance may be an indication that fish abundance and diversity has increased in the restoration reach. Examples of host fish for the mussels listed above include (but are not limited to): largemouth bass, flathead catfish, creek chubs, gars, sunfish, bluegill, crappie, and drums. The mussel community will continue to be sampled and analyzed over a longer period of time to determine changes in stream conditions and overall project success.
