Sangchris Lake Aquatic Vegetation Restoration Project – 2018 Progress Report

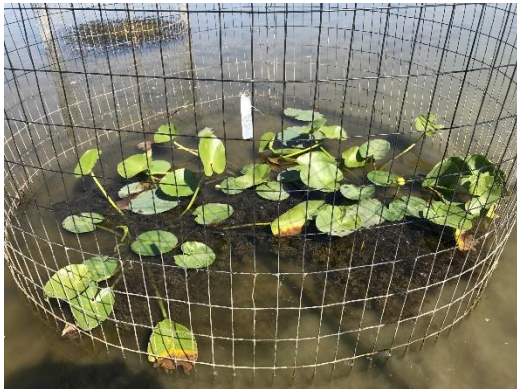
Figure 2. Small Single Species Exclosure

As stated in the restoration plan and recommended by the Army Corp of Engineers (Dick et al., 2013), the second phase in the project included expansion of the first-year planting sites by increasing the size of the protective exclosures. This gives the plants more room to grow and spread, while also keeping them safe from herbivores. The existing exclosure fences, each 20 feet in length, were dismantled and linked together to form larger exclosures (Figures 2 and 3). These large exclosures were placed around the surviving plants in May of 2018. Wherever possible, plots with no visible growth were included within the new larger exclosure in anticipation of regrowth later in the growing season. Exclosure fences were secured with rebar hooks at the base and wooden stakes were attached for structural support.

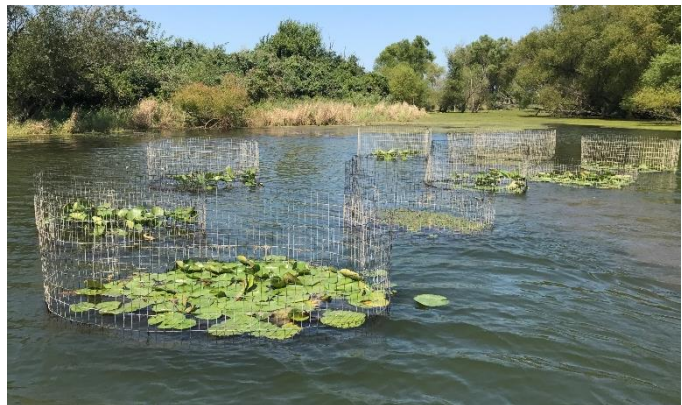
Figure 4. West Cove 2 on 8/28/18

In addition to expanding exclosures at the existing planting locations, two new planting locations were selected for 2018 (Figure 1). The first was in another cove in the west arm of the lake, called West Cove 2 (Figure 4). This cove is large, shallow, and well protected from wind and wave action. A total of nine plots were established at this site, each with a 20-foot circumference exclosure. Approximately four plants of each species were planted at three plots each. All plots exhibited good growth and had surviving plants throughout the growing season. As in West Cove 1, brittle naiad was abundant at this site. Before planting, the brittle naiad was cleared from each exclosure. It grew back in many plots but appeared to be less dense inside the exclosures than in the surrounding area. It did not seem to effect growth and survival of the target plants.

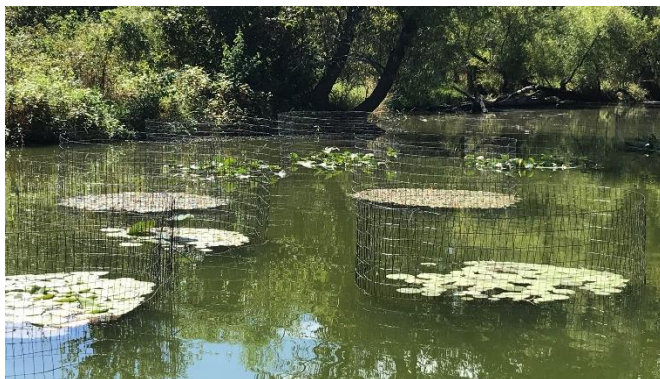
Figure 5. Refuge South on 9/13/18

The second new planting location created in 2018 is in the southern portion of the wildlife refuge area and is called Refuge South (Figure 5). This site is in a well-protected cove with limited fetch and should therefore not have the wind and wave action problems observed at the Refuge North site. A total of 12 plots were established at this location, each with a 20-foot circumference protective exclosure. This allowed for four plots for each species, with approximately four plants placed
