EAGLE CREEK RESORT ASSESSMENT

ILLINOIS DEPARTMENT OF NATURAL RESOURCES

DNR PROJECT 3-15-006

May 9, 2016

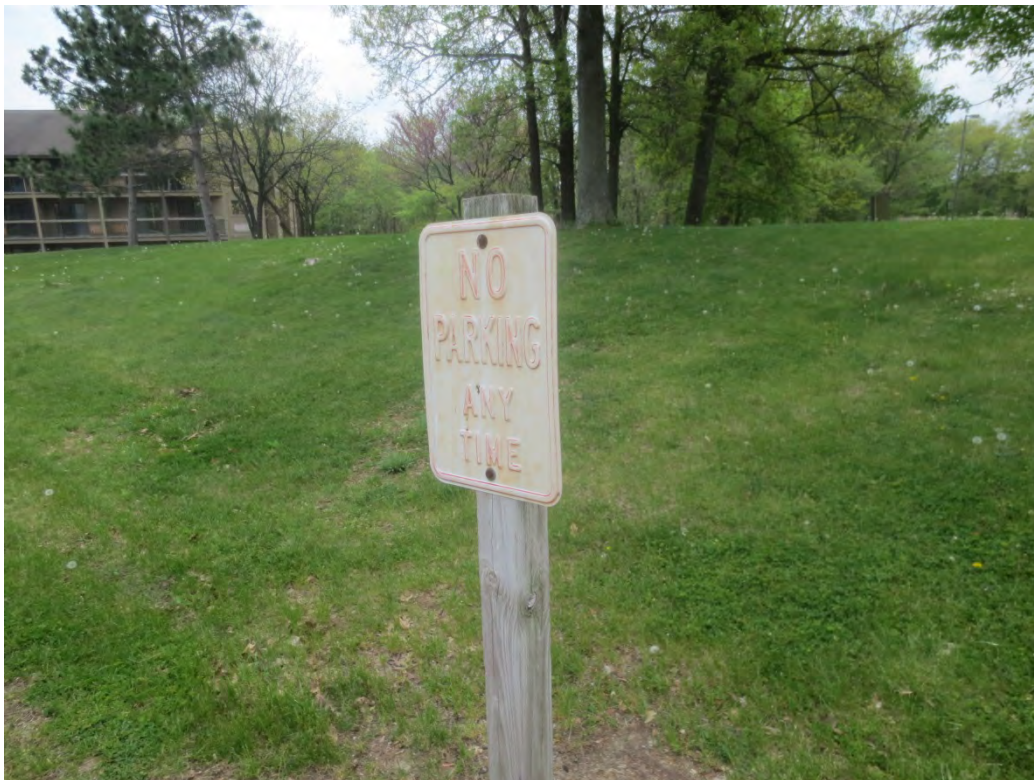
Typical Sign

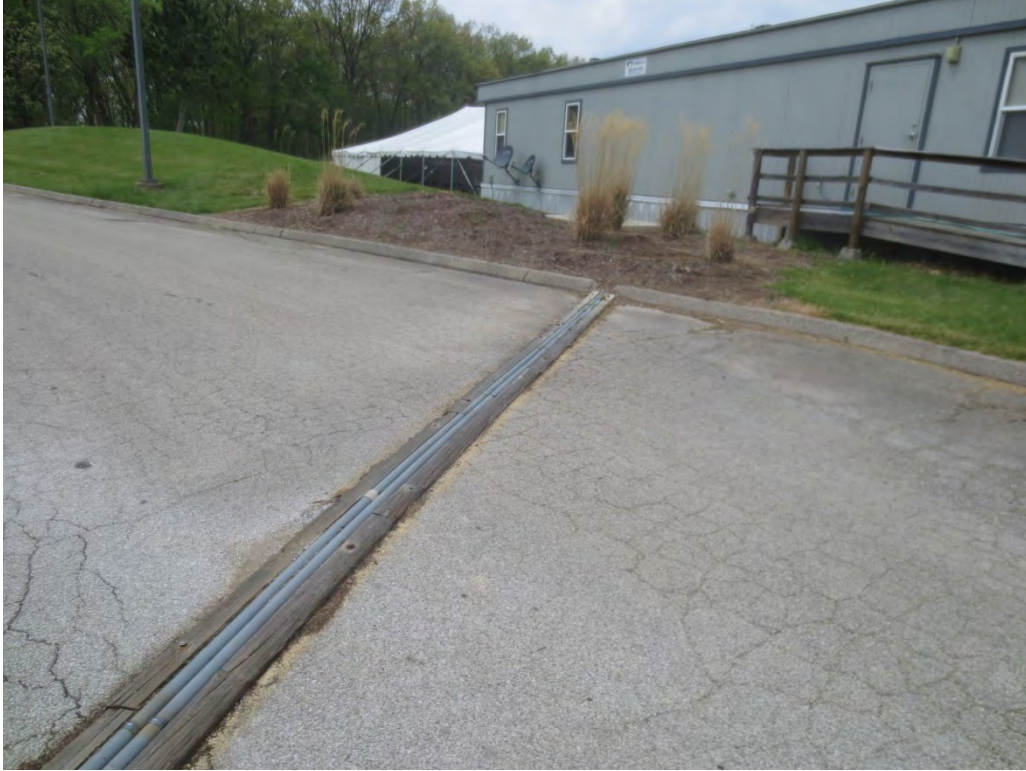
Water line leading to the temporary Pro Shop Trailer

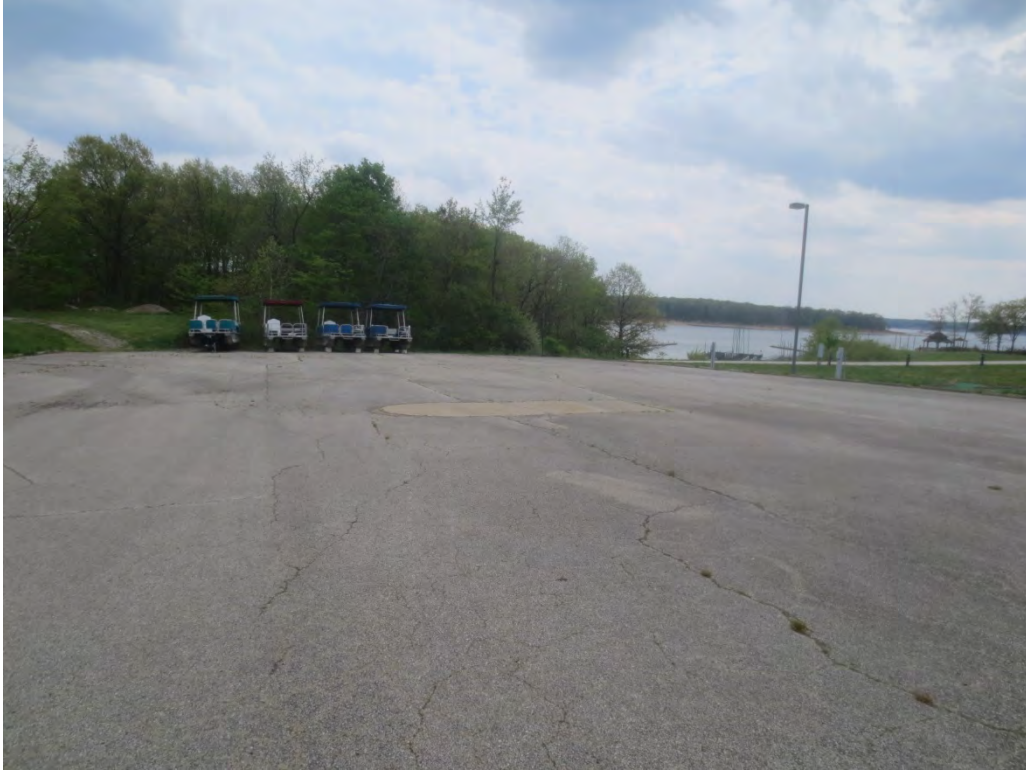
Typical pavement in south parking lot

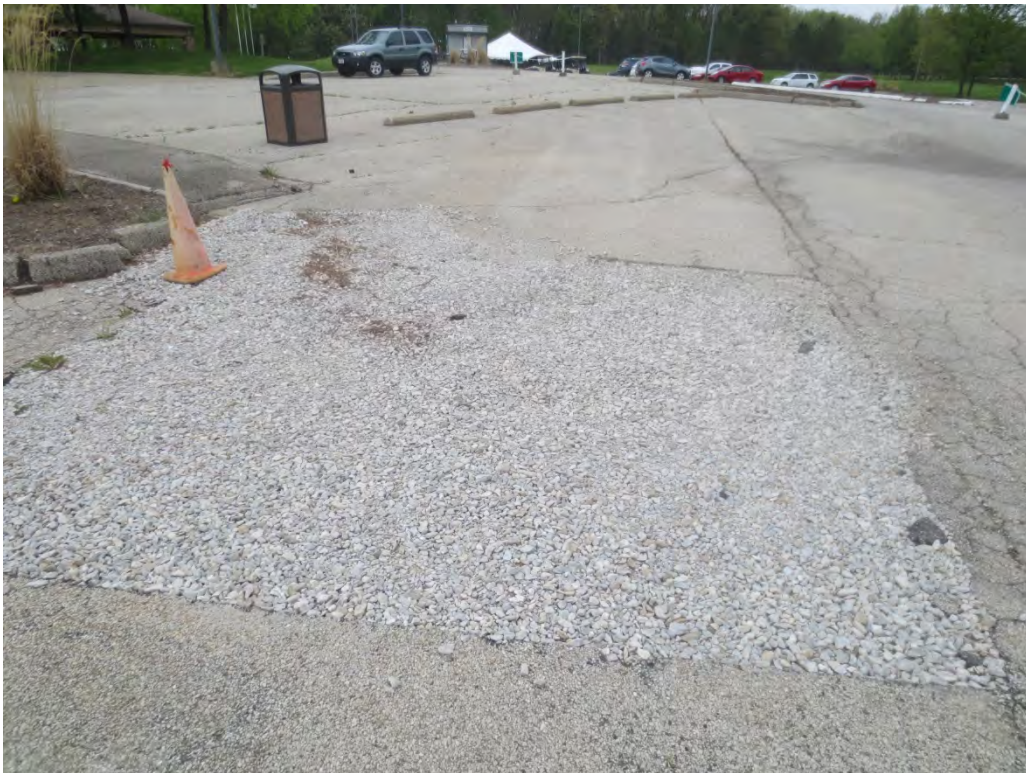
Approximately 15' x 15' area of gravel near loading dock

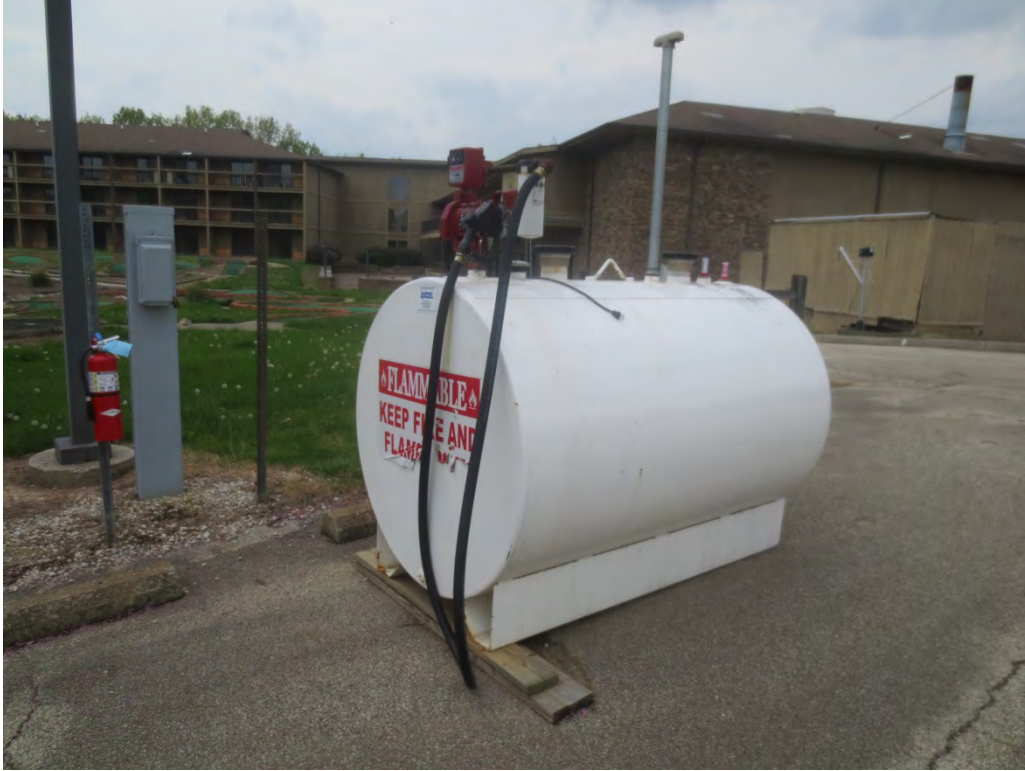
Unprotected fuel tank adjacent to mini-golf

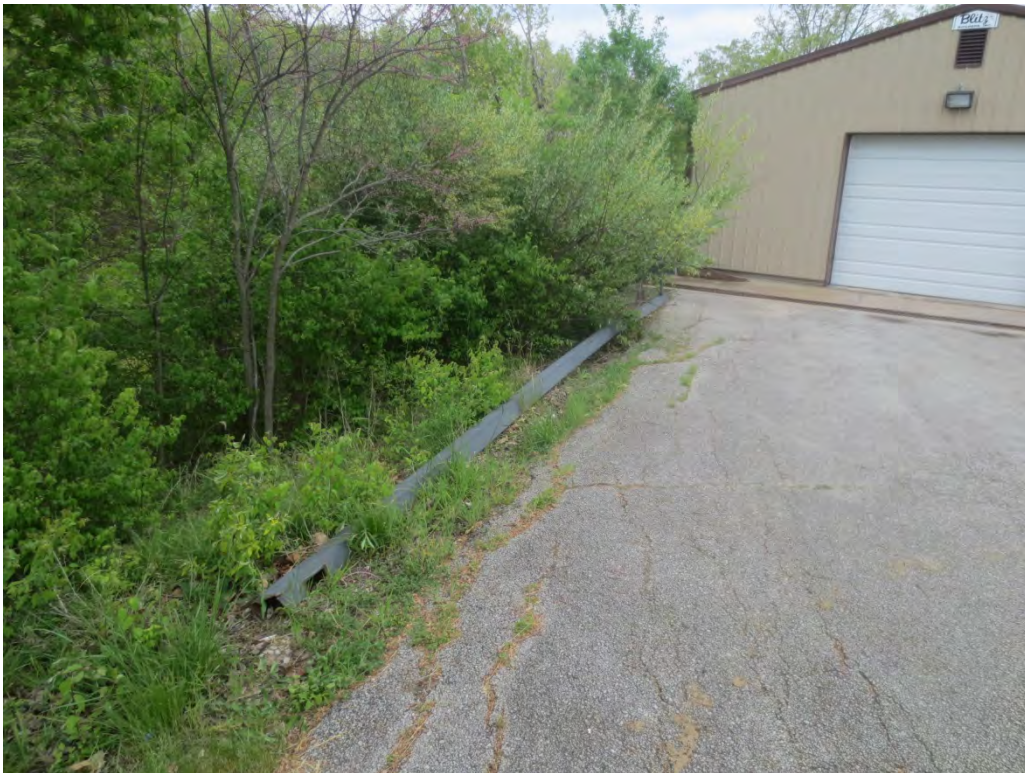
Steep drop off north of cart building

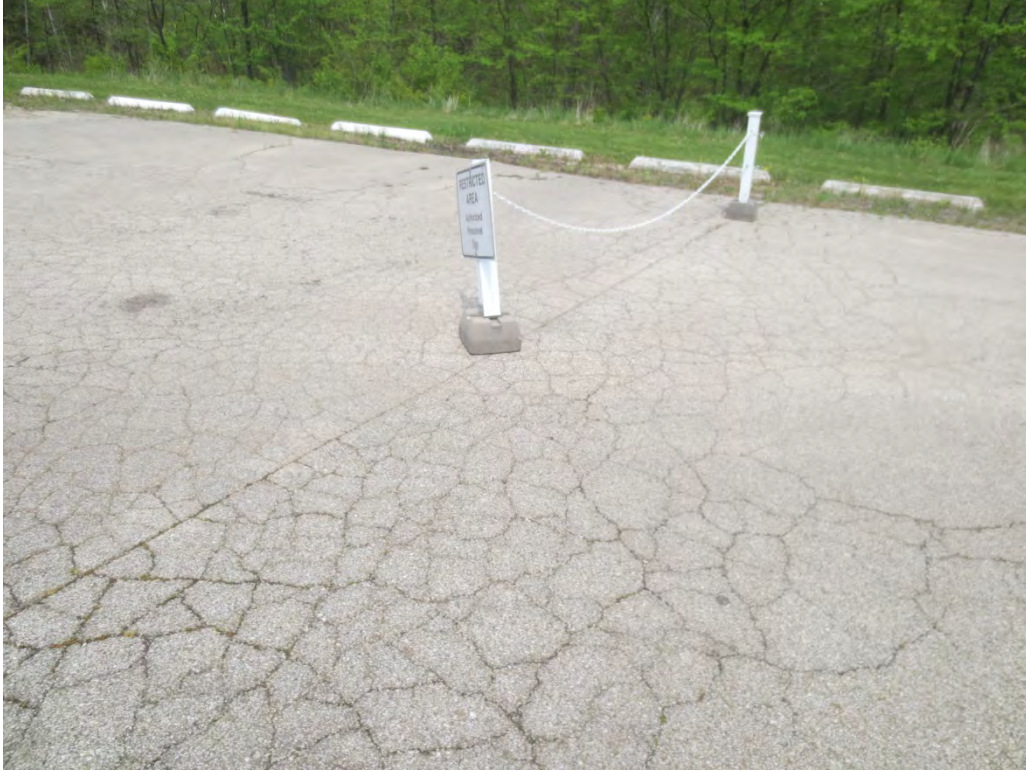
Wheel stops on north east side of lot located in grass

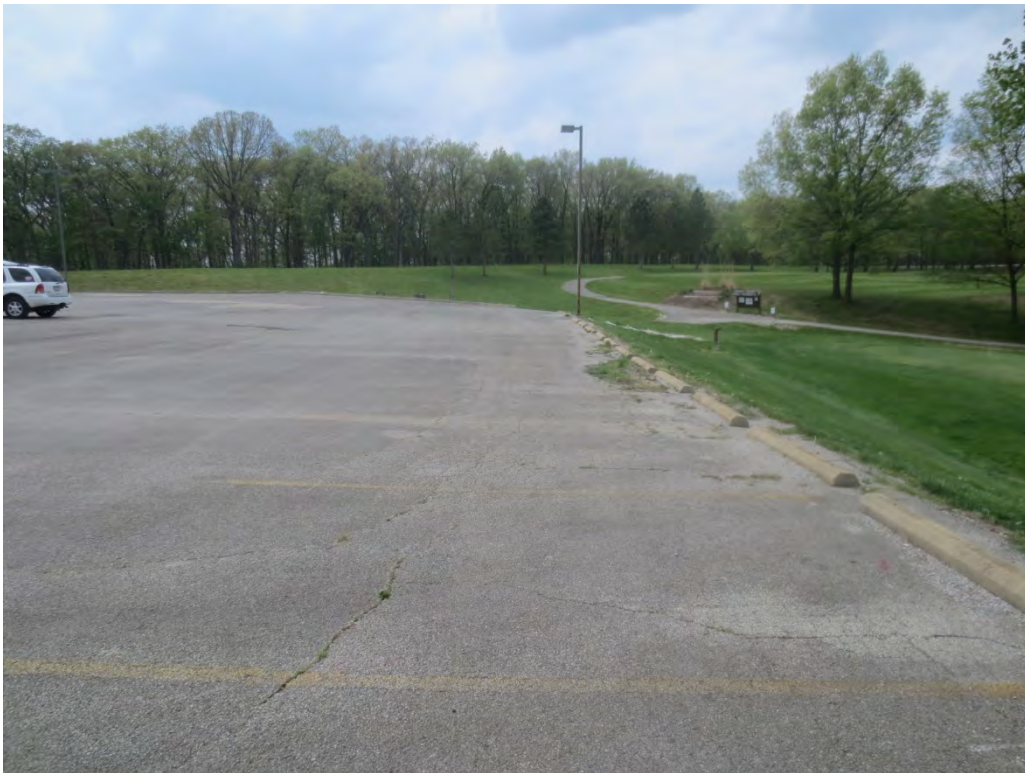
North side of north parking lot

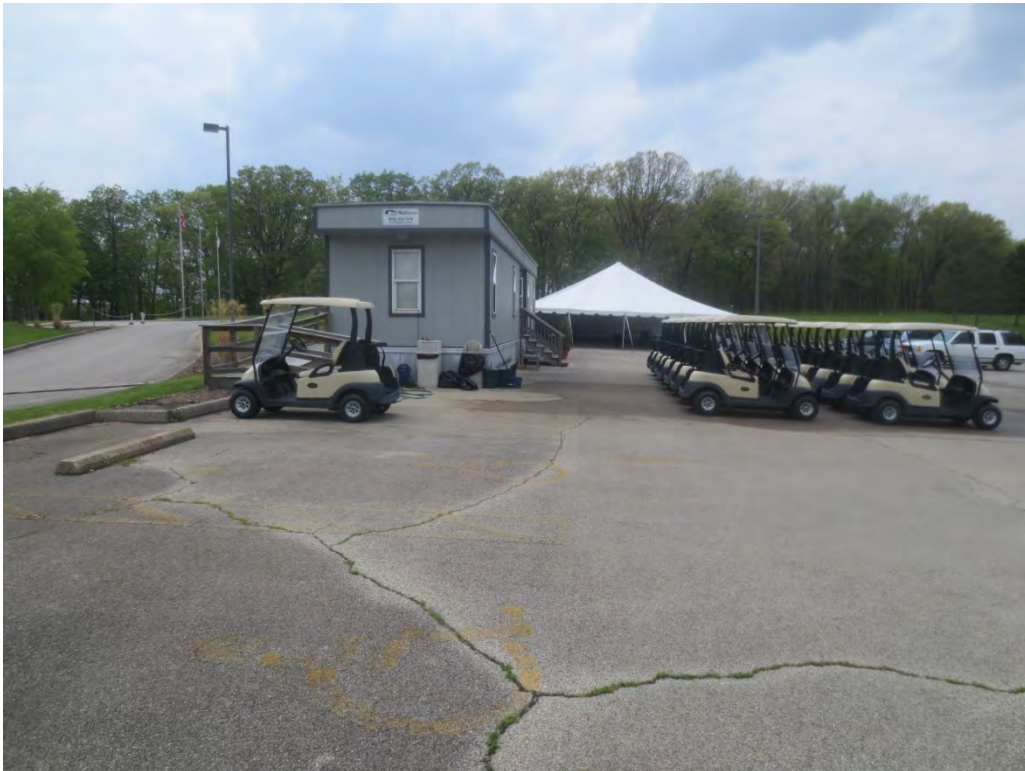
Golf cart parking / temporary Pro Shop trailer and tent

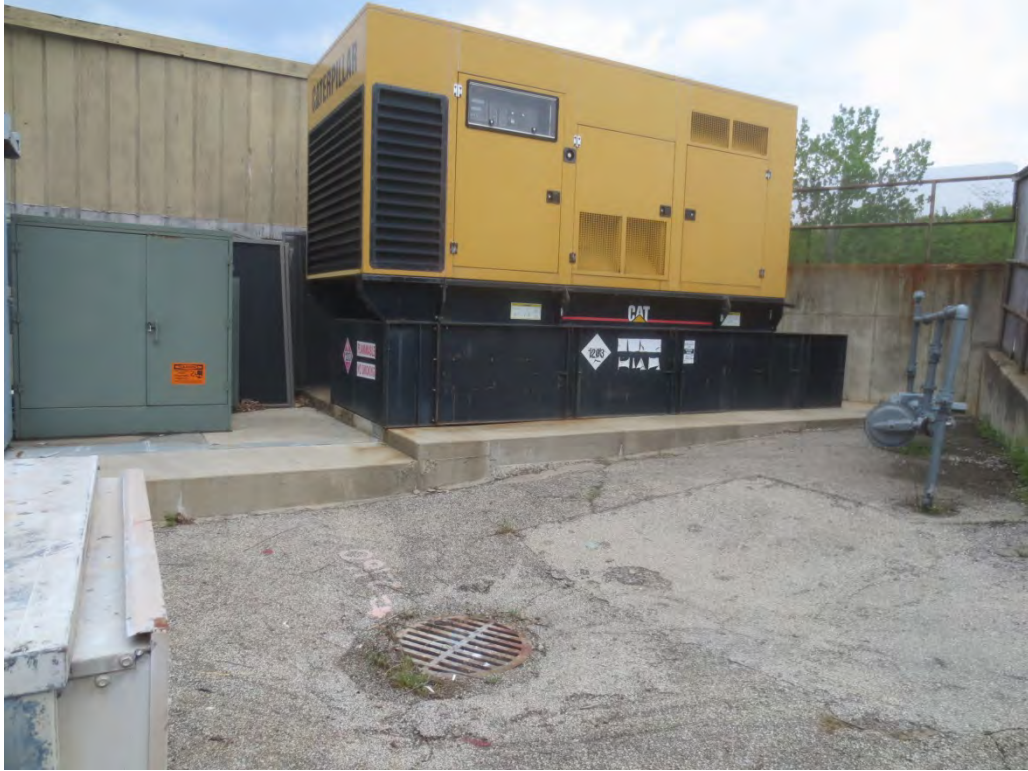
Back-up generator with belly tank. Note catch basin.

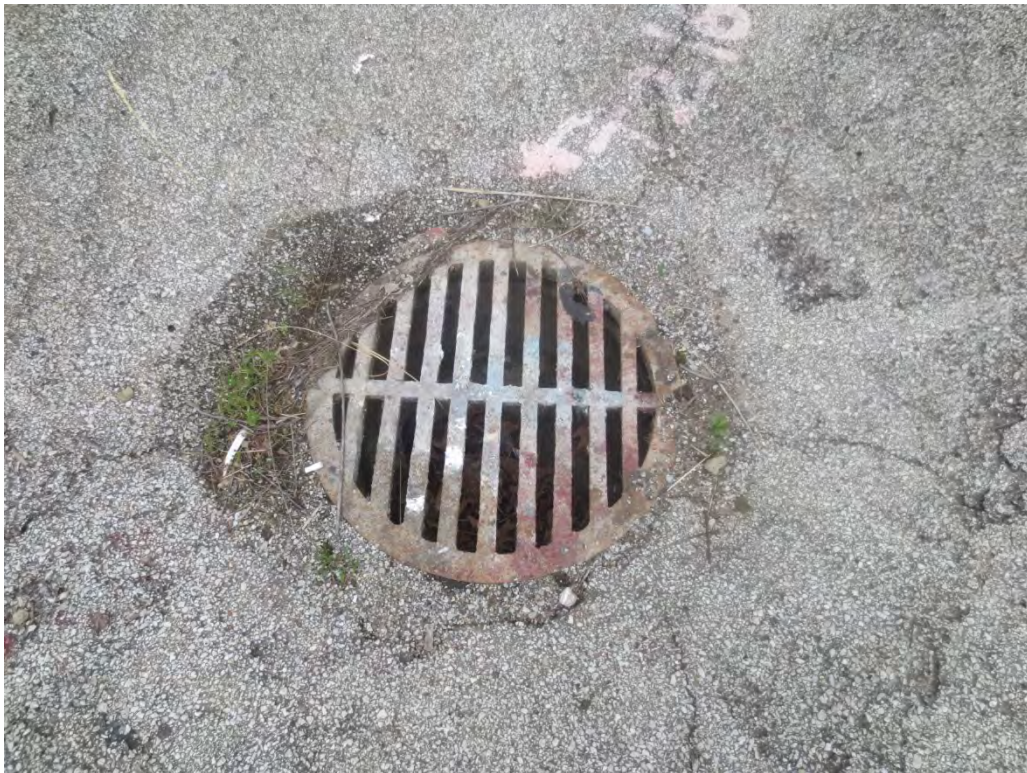
Debris filled catch basin adjacent to backup generator

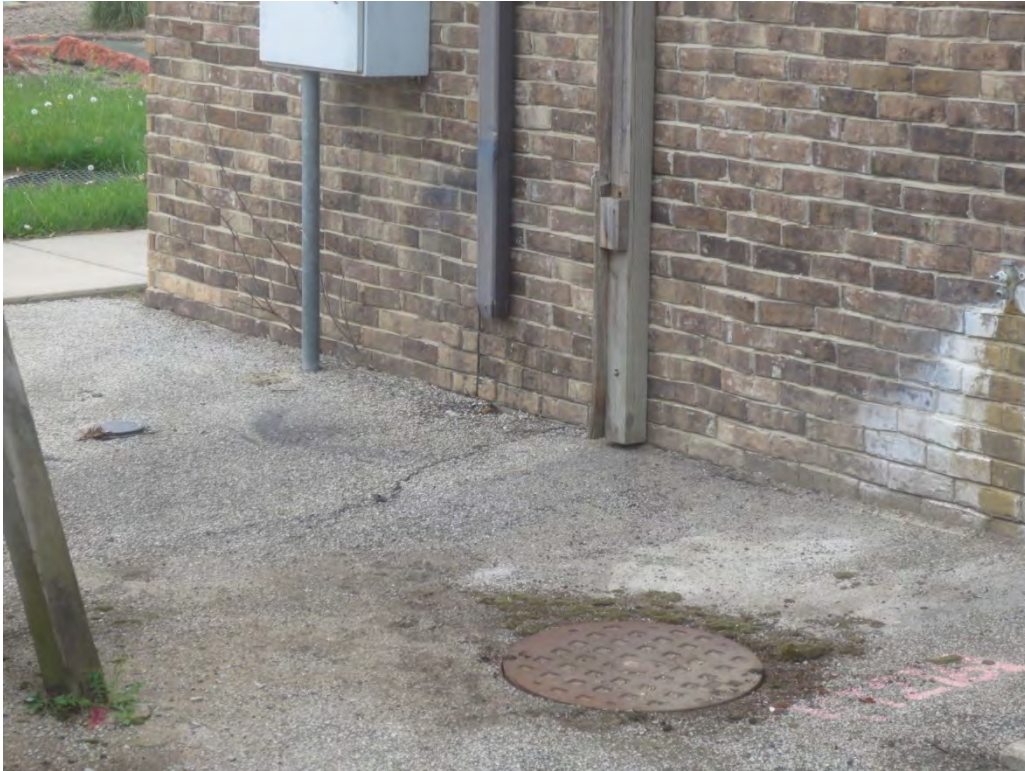
Roof drain discharging to pavement

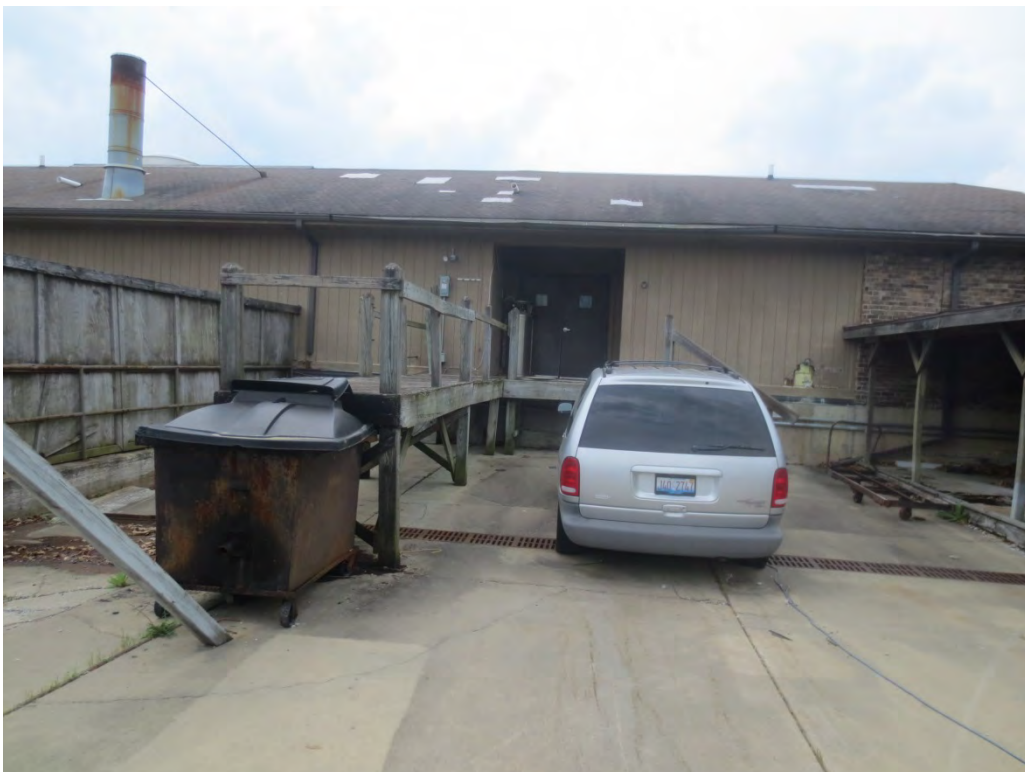
- Concrete pavement in the loading dock area is in fair condition.
- There is a missing grate on the stormwater slot drain.
- The wooden loading dock and wood fencing in this area are in poor condition and should be reconstructed during the renovation phase.

Loading dock area; note wooden dock platform

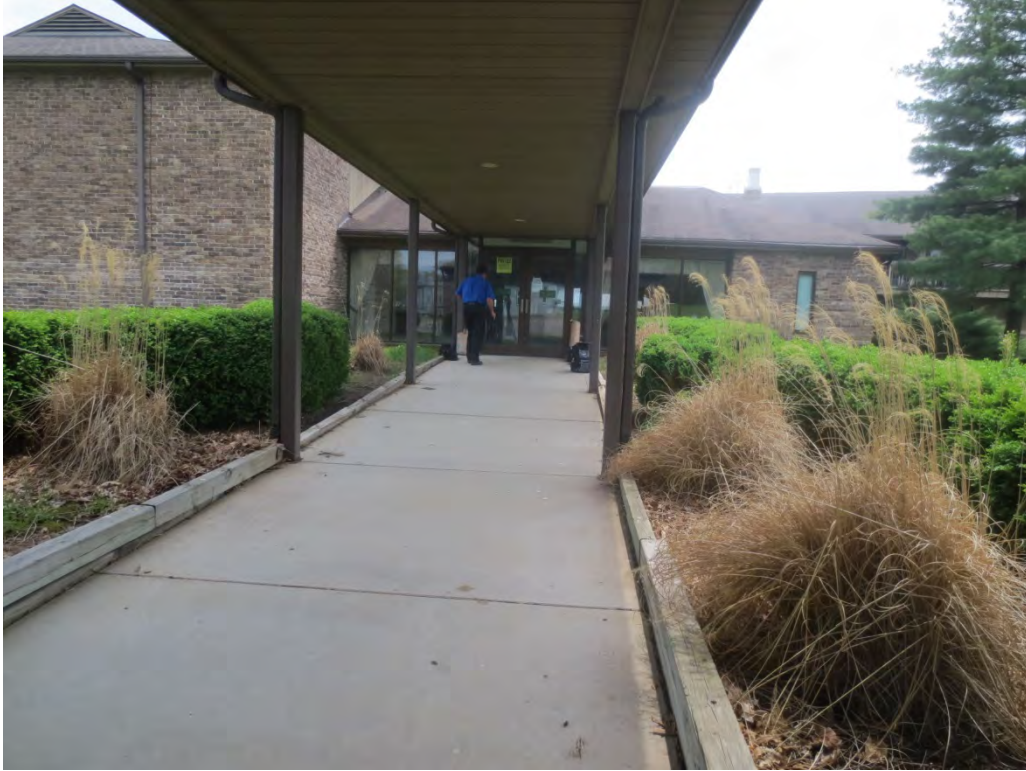
Main entry concrete walk

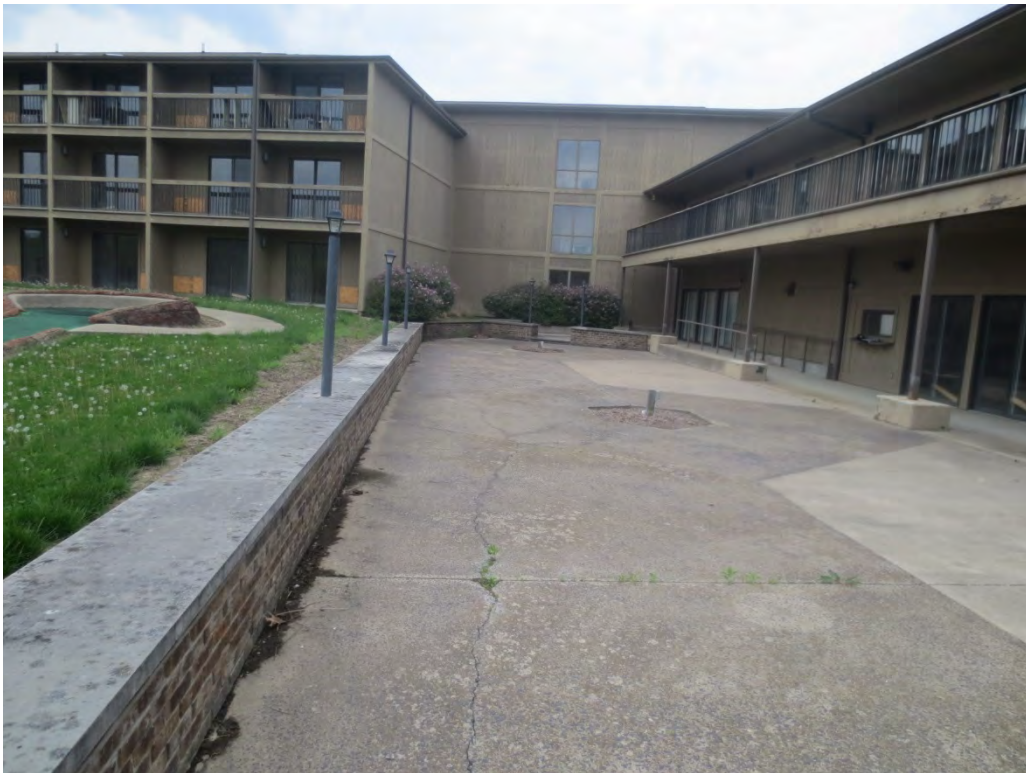
Patio area adjacent to original pro shop

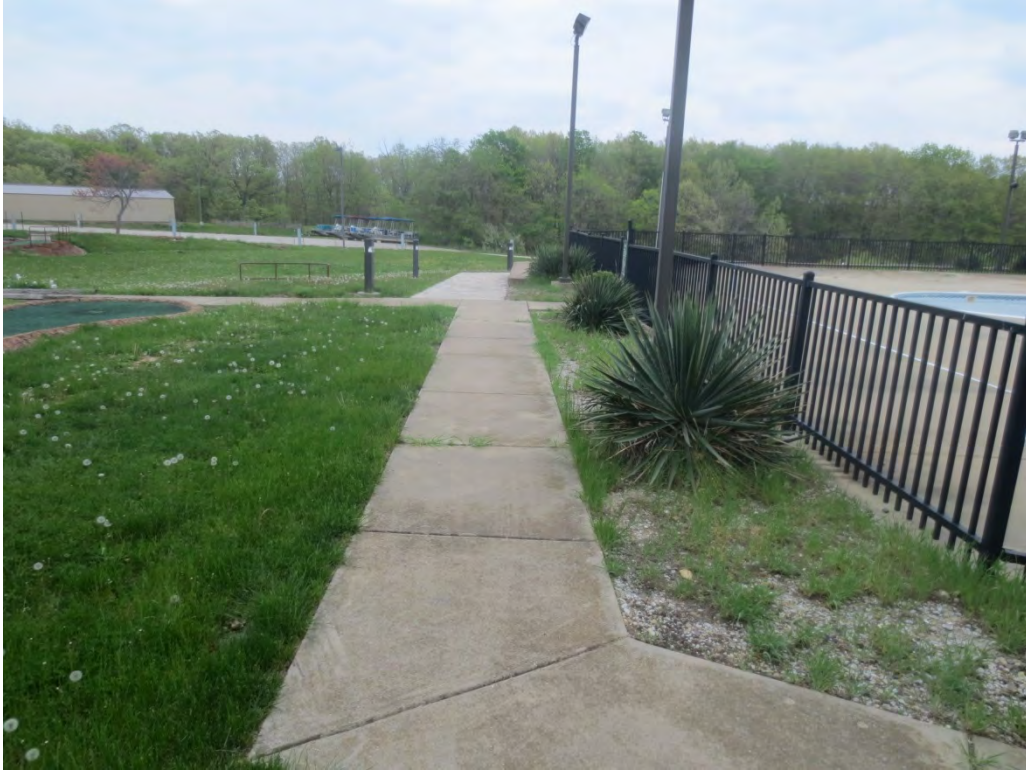
Sidewalk adjacent to pool

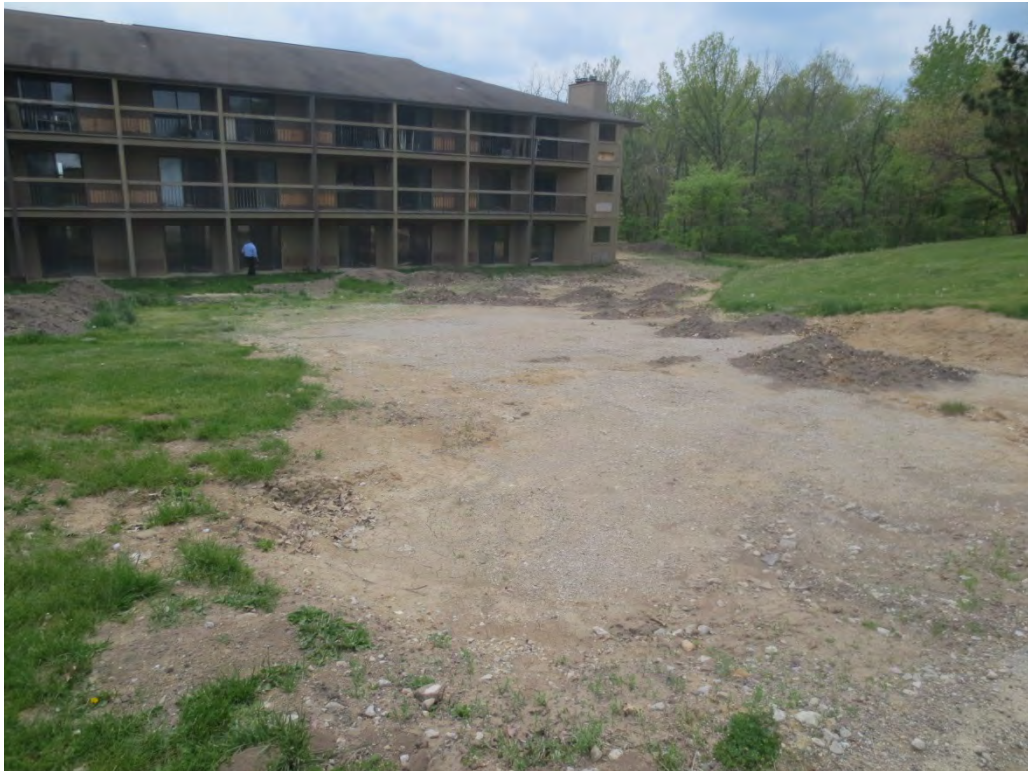
Disturbed landscape area near front of hotel

- Some bare patches of turf area were noticed throughout the site. These can be remedied with minor topsoil placement and seeding.
- There were few trees or shrubbery in the immediate hotel area. Additional site landscaping should be performed to improve the overall aesthetic quality of the site.

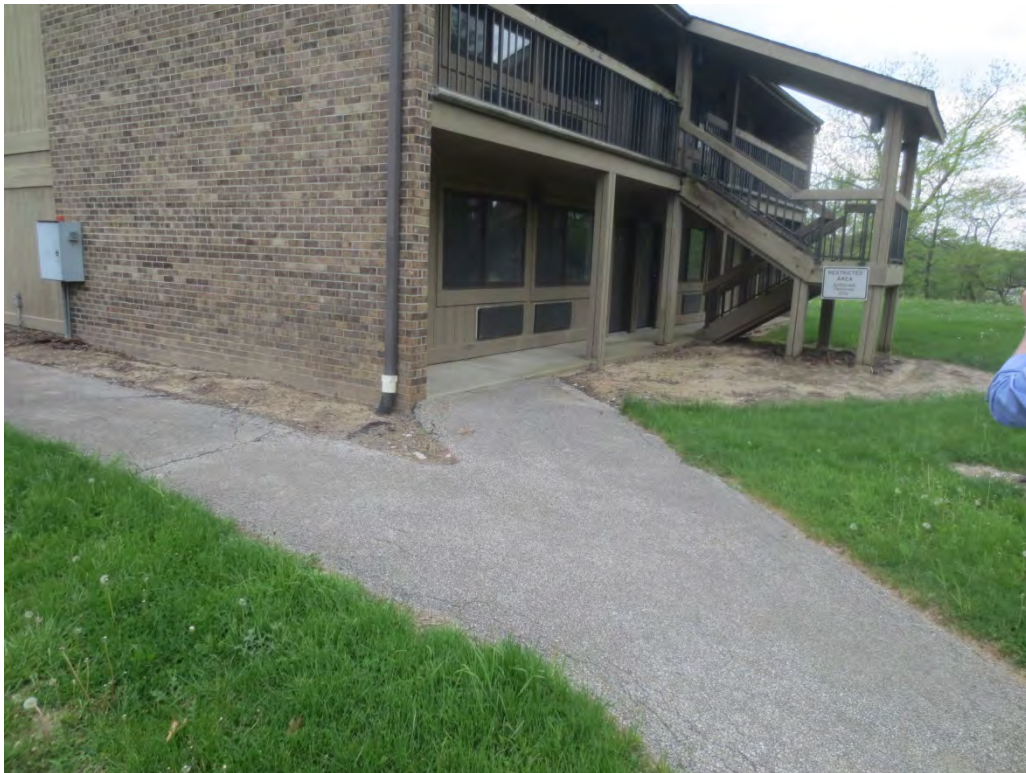
Eagle's Landing building and sidewalk

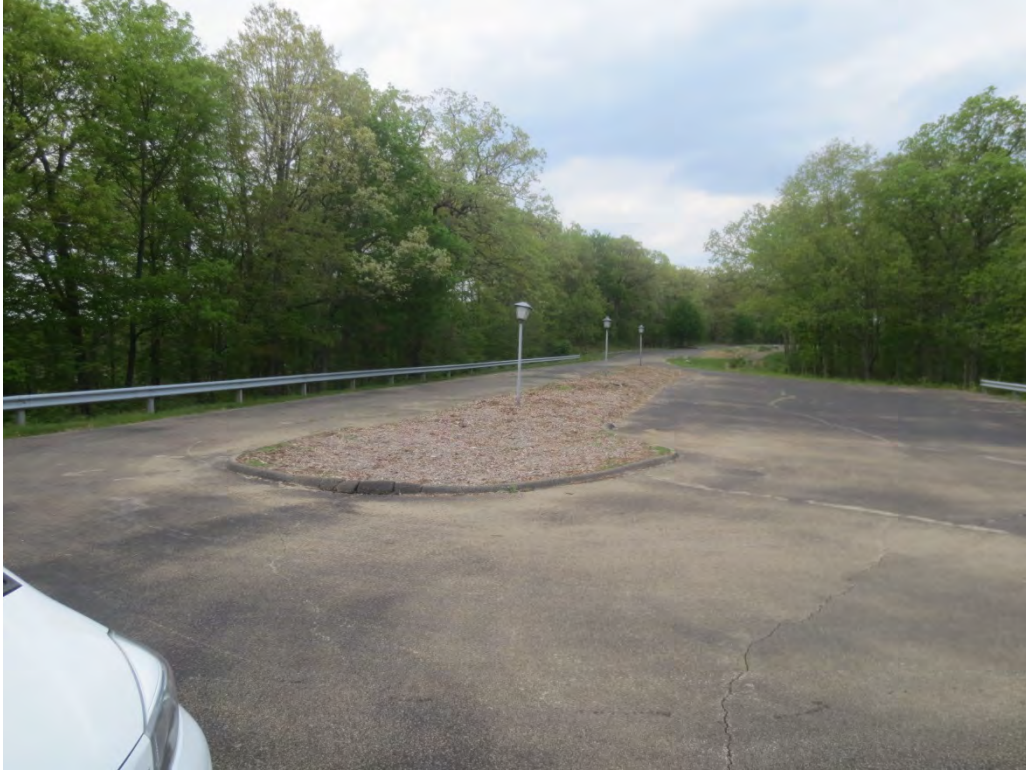
Parking lot north of Eagle's Landing building

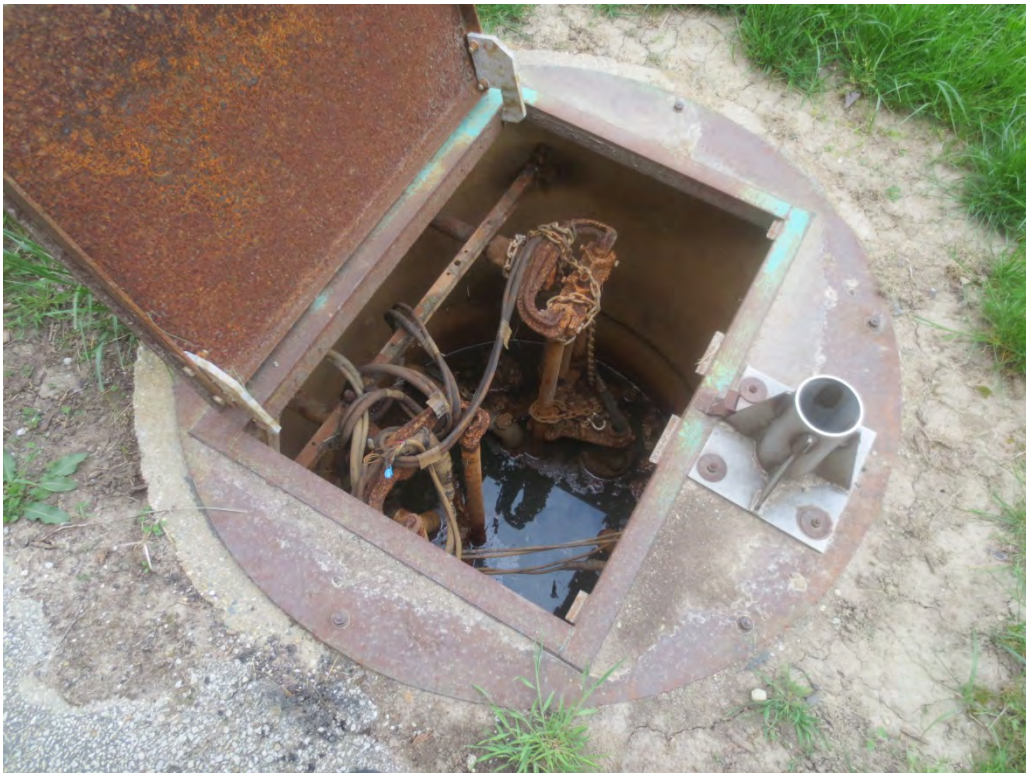
Eagle's Landing Sanitary Sewer Pump Station

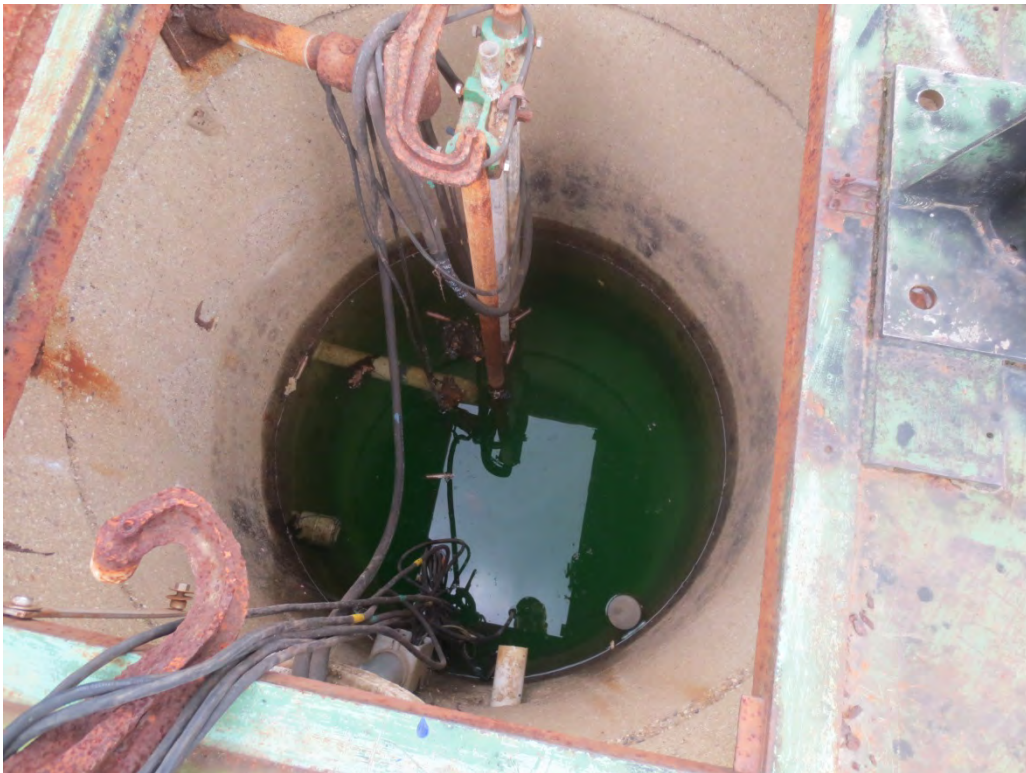
Pump station interior

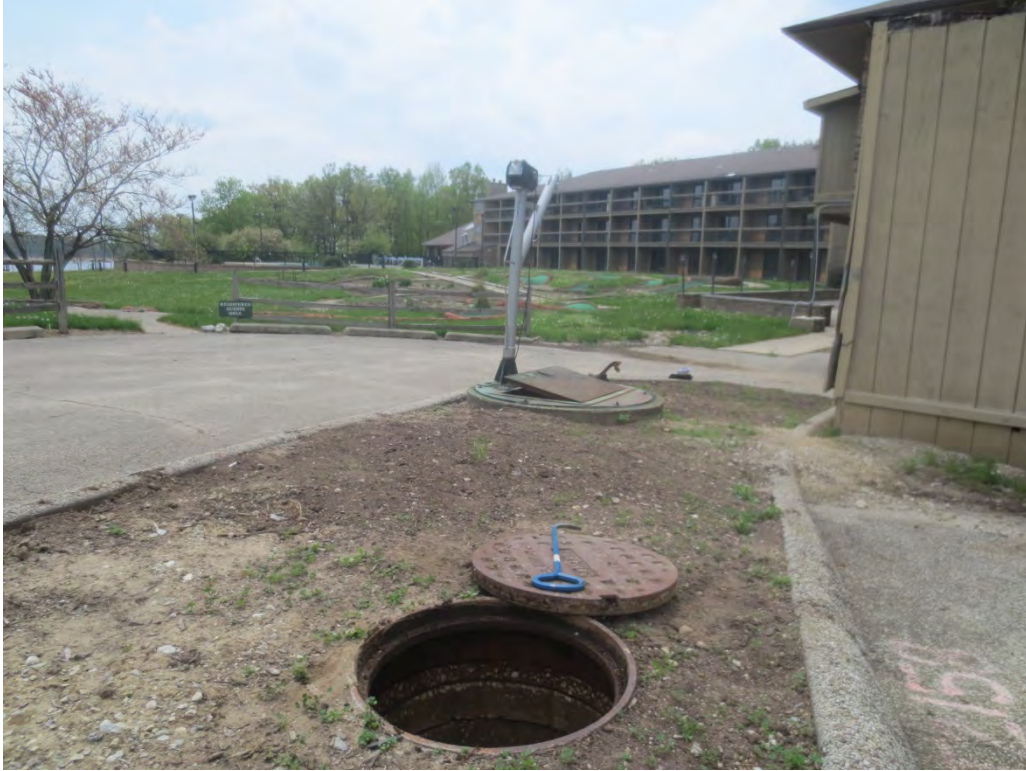
Pump and tank manholes

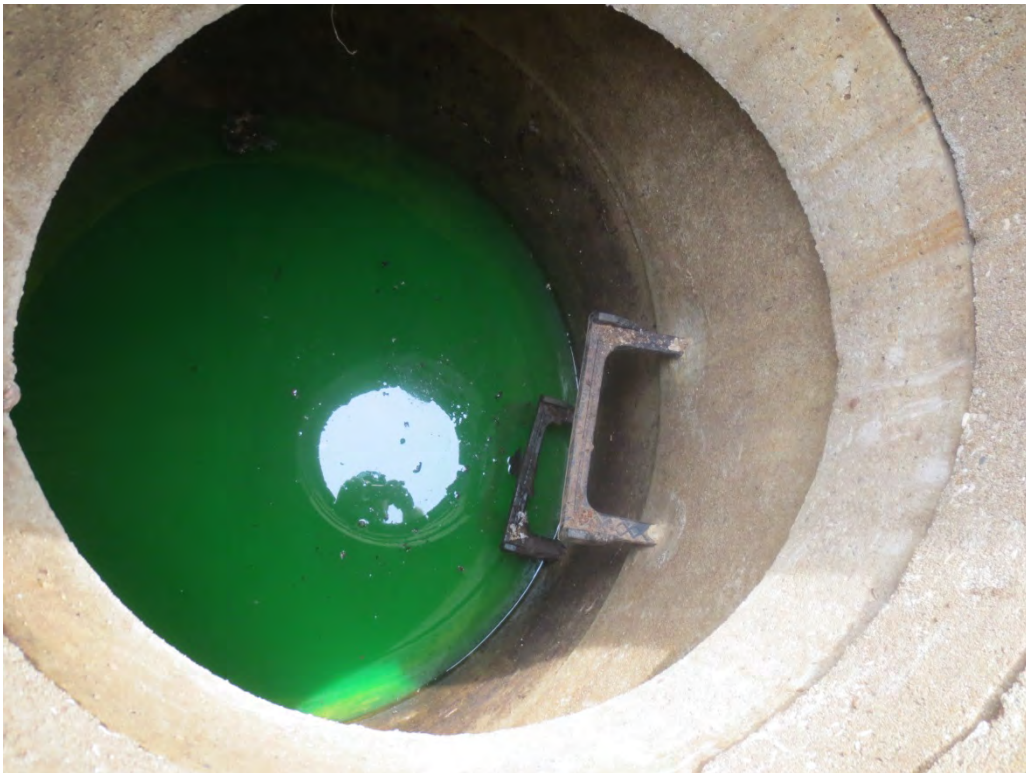
Tank manhole

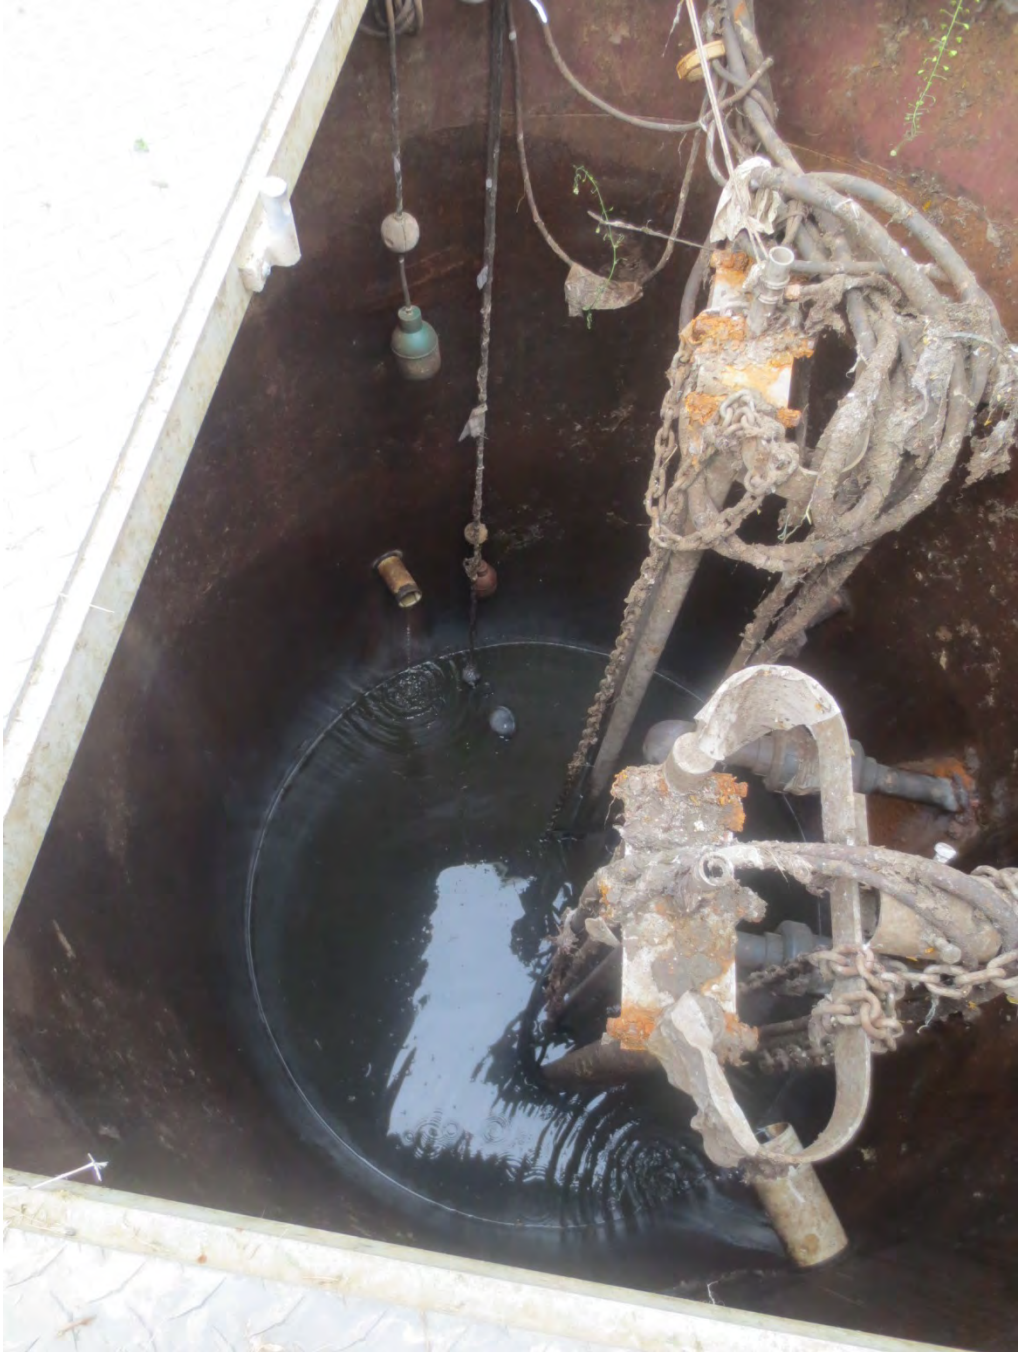
Berry Pond Pump Station

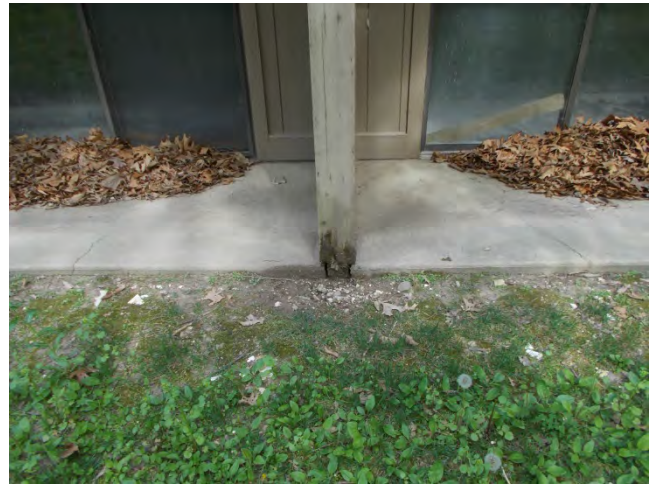
Wood siding and trim is typically in poor condition throughout. Holes, cracks, and missing trim pieces appear in numerous areas (Figure 7). These deteriorated conditions have been typically left uncovered and therefore have made the wall cavities susceptible to water infiltration. There is some evidence of water damage from inside the walls (Figure 8). Additionally, the removal of thru-wall air conditioner units without properly covering the wall opening has often left the inside of wall cavities exposed and susceptible to water and moisture damage (Figure 9). There is water damage on the wood trim in numerous areas. The original paint finish on the siding and trim has faded and begun to peel over time leaving the bare wood susceptible to further deterioration (Figure 10). Wood trim is also separating from the façade at various locations.

Figure 8 – Wood Party Wall at Grade

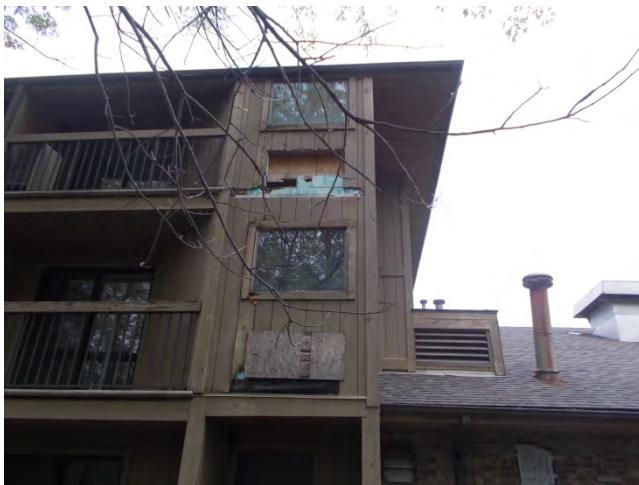
Figure 9 – Exposed A/C Openings in Wall

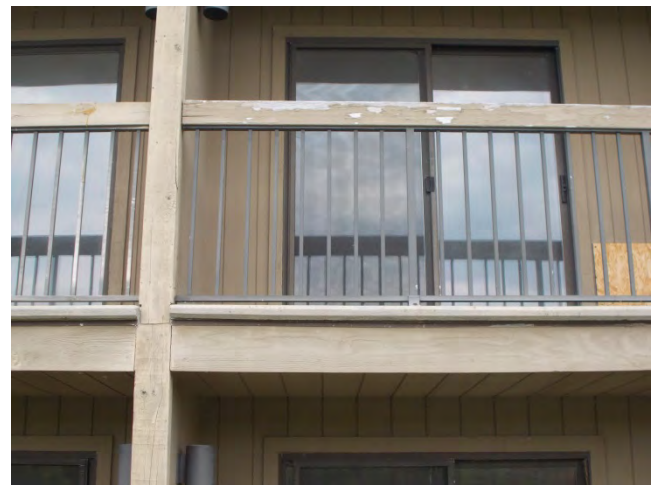
Figure 10 – Balcony

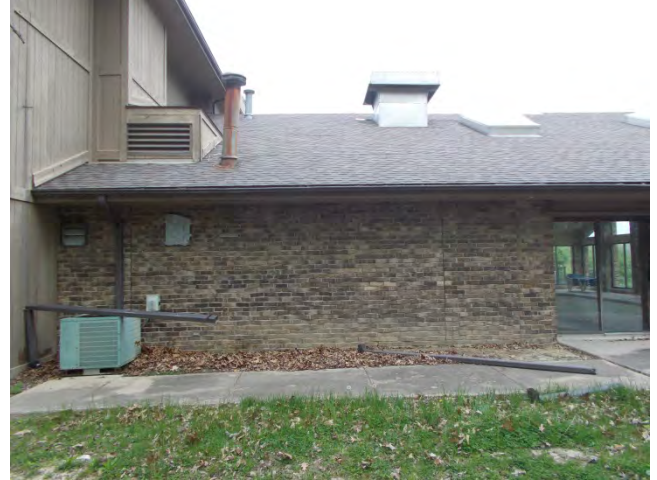
Missing or damaged downspouts and splash blocks have created conditions where water has not been shedding properly away from the building and has likely caused roof/foundation damage due to erosion (Figures 15 and 16).

Figure 16 – Hotel Entrance Wall

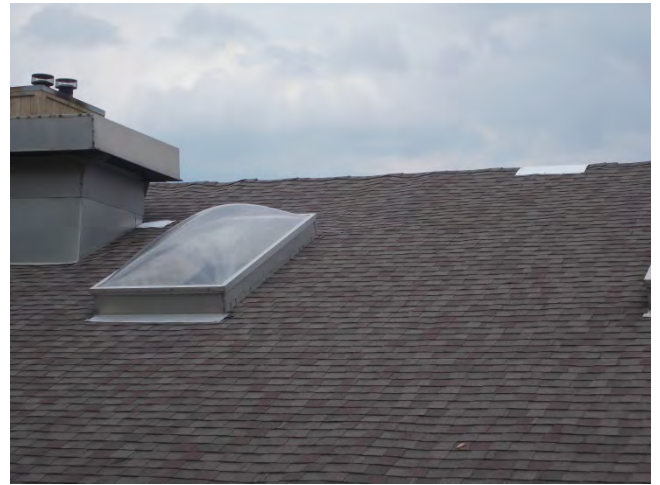
Asphalt shingles are in poor shape and have presumably outlived their useful life, and are likely original to the hotel. Visual imperfections such as discoloration and sagging at ridges suggest the age and wear of the shingles and substrate (Figures 23 and 24). In numerous areas throughout the shingled portions of the roof substantial holes have appeared, most likely created by animals. These holes have been temporarily covered with stainless steel sheets anchored to the roof through the shingles (Figures 25 and 26). However, it is likely that water has infiltrated the inside of the building and may have caused damage to the roof structure. The plywood sheathing is likely to be damaged and require replacement in some areas. There are numerous areas inside where ceiling tile has sustained water damage.

Figure 24 – Roof Detail

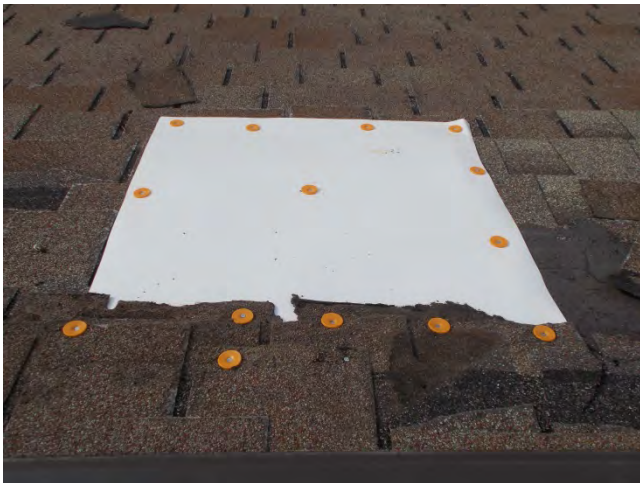
Figure 25 – Roof Patching

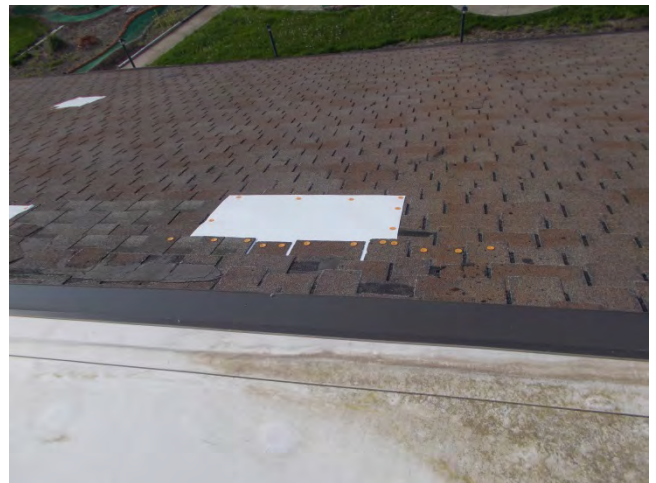
Figure 26 – Roof Patching

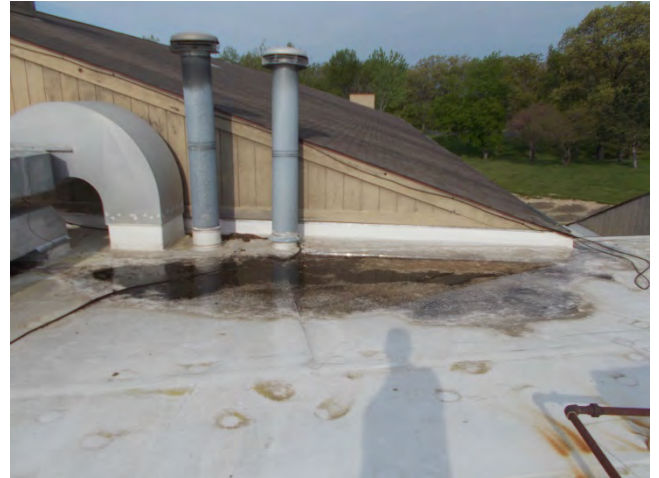
Gutter and downspout system is substantially damaged and is missing pieces throughout. Missing downspouts have caused water to pool and collect in some parts of the flat roof and has caused staining and deterioration to the wood siding, trim, and asphalt shingles (Figures 27 and 28). Some flat roof areas are exhibiting mold.

Figure 28 – Ponding at Flat Roof
