EAGLE CREEK RESORT ASSESSMENT

ILLINOIS DEPARTMENT OF NATURAL RESOURCES

DNR PROJECT 3-15-006

May 9, 2016

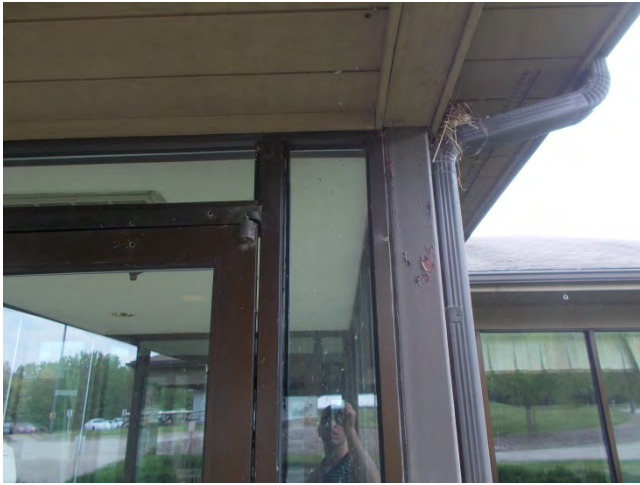
Exterior doors appear to all be original to the building. No significant damage appears to have occurred; however, due to age, general wear, and a long period of disuse most hardware is in fair to poor condition and some hardware is missing completely (Figures 37 and 38). Hollow metal doors and frames have instances of rusting and peeling paint particularly at the base and are in fair to poor condition due to age and wear (Figure 39). Wood framed sliding glass doors are in poor condition due to frame cracking and peeling along the frames (Figure 40). General deterioration of weather-seals and gaskets has occurred over time as well. Exterior hollow metal doors within the kitchen area are in very poor condition likely due to heavy usage and missing weather seal hardware.

Figure 37 – Exterior Door Detail

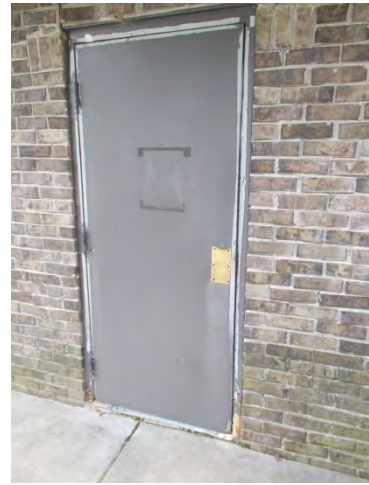
Figure 38 – Hollow-Metal Door without Hardware

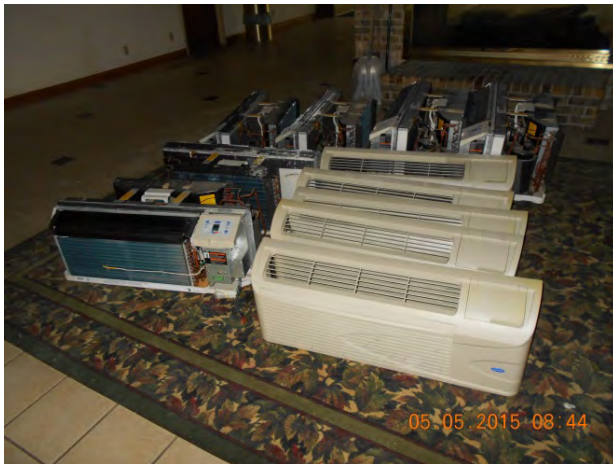
Hotel wing guest rooms are served by individual wall mounted PTAC units with 1 ton cooling capacity and 3.7 kw electric heating capacity. Numerous PTAC units have been removed and are being stored in various locations inside the building, as well as on exterior balconies (Figures 1 and 2). For each wing toilet exhaust risers are provided for each back to back guest room tier and tied into a common exhaust header in the attic and discharged to the outside by a 2200 cfm inline ceiling hung exhaust fan. In addition, each attic space is provided with a 2200 cfm inline ceiling hung exhaust fan.

Figure 1 – PTAC units stored in open space

Recommendation is to replace all PTAC units.

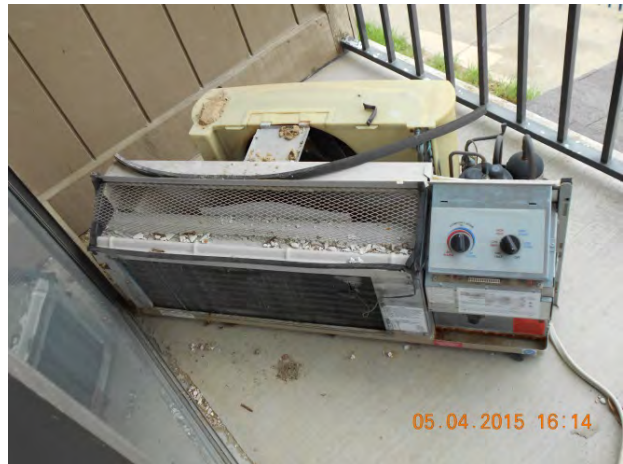
Figure 2 – Guestroom PTAC unit stored on balcony

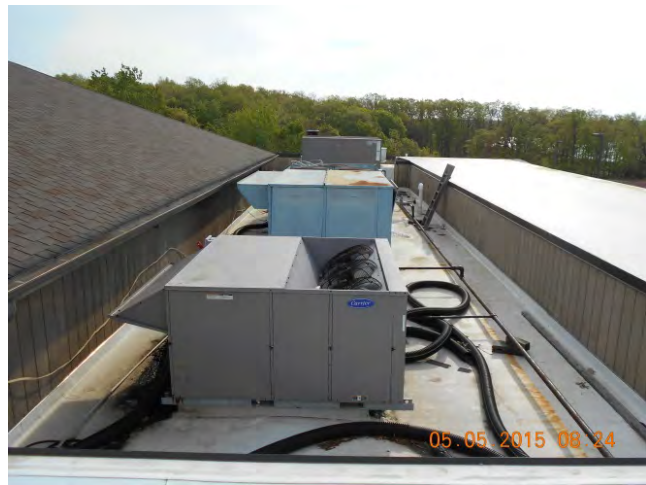
All air handling and rooftop units have not operated or been maintained for the past 7 years. All components requiring lubrication have most likely dried out. All cooling units utilize the refrigerant R-22 which has been phased out. It is not known if refrigerant has been disposed of (Figure 3).

Figure 3 – Makeup air handling units in rooftop mechanical courtyard

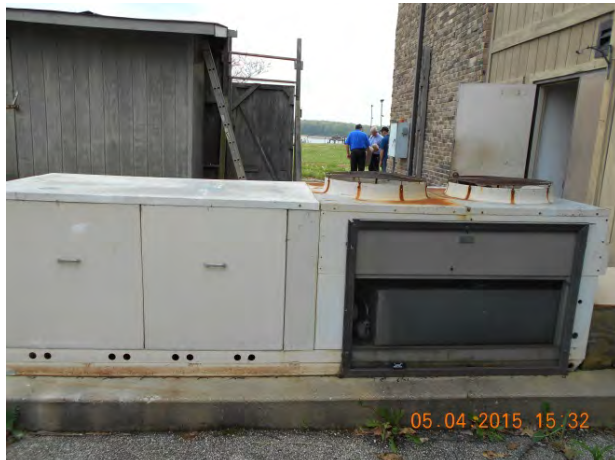
The walk in coolers cooling system appears to be original. The in cooler evaporators are in fair condition and are class 2 items. The condensing unit is in poor condition. The unit has exceeded its useful service life and is a Class 1 item (Figure 7).

Figure 7 – Walk-in cooler condensing unit

Recommendation is to replace the condensing unit and test the evaporators for operation and replace as needed.

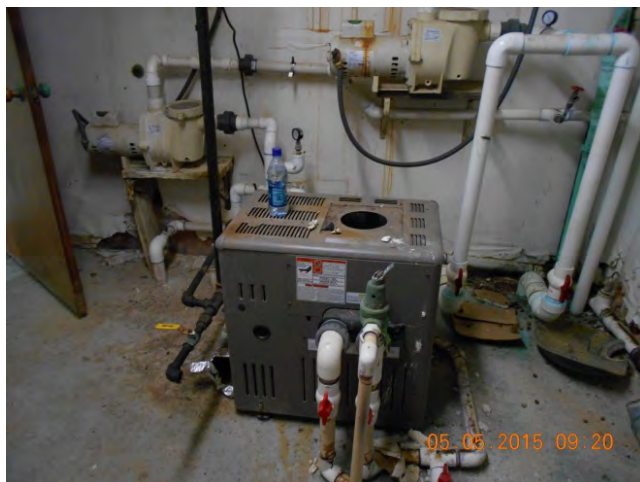
Observed indoor pool plumbing system components including gas fired water heater, pumps, expansion tank and PVC distribution piping appear to be original and in fair to poor condition. These are Class 1 and Class 2 items. Pool water heater has exceeded its useful service life (Figure 12).

Figure 12 – Indoor pool gas fired water heater

Recommendation is to test all equipment for proper operation and repair or replace as needed. Replace pool water heater and all broken PVC piping.

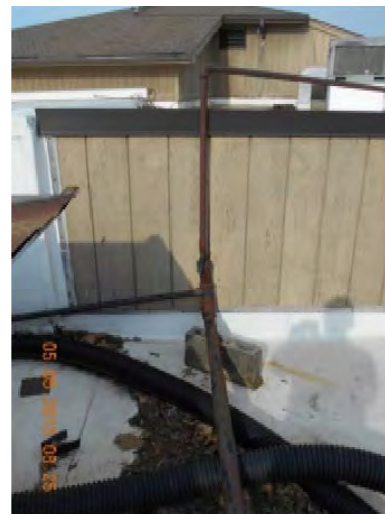
Observed black iron gas distribution piping appears to be original and is in poor to good condition with some piping having varying degrees of rust. These are class 1 and 3 items. Recommendation is to provide a pressure leak test. Brush off surface rust and replace piping sections that are heavily corroded with rust (Figure 13).

Figure 13 – Gas pipe routing to rooftop mechanical units

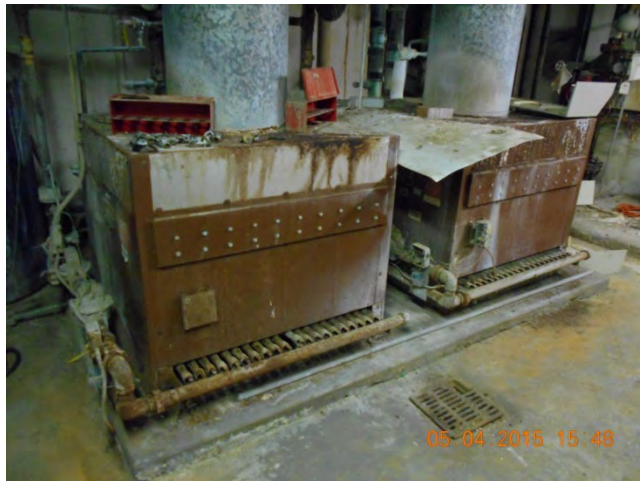
The main hotel and conference center domestic hot water boilers appear to be original and in poor condition (Figure 2). The burners and gas train assembly are heavily rusted. The Eagle's Landing electric domestic water boiler appears to be in good condition. The main resort domestic hot water boilers have exceeded their useful service life and are class 1 items. The Eagle's Landing electric boiler is a Class 3 item.

Figure 2 – Hot water boilers

The recommendation is to replace the main resort building domestic water boilers with Department of Energy efficiency compliant condensing boilers sized to meet new building demand loads. Provide an operation and performance test on the Eagle's Landing boiler.

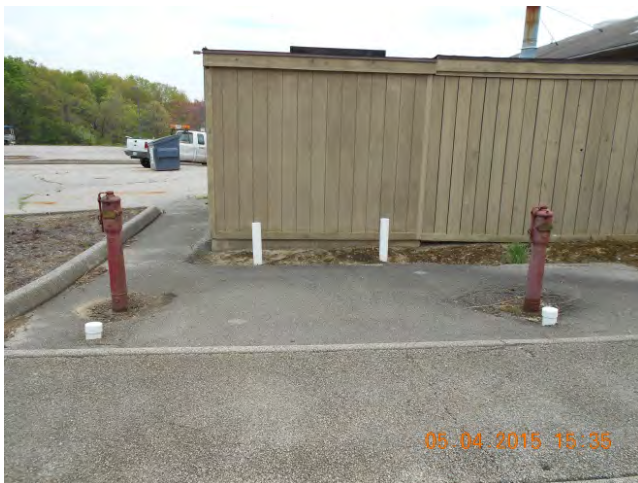
Fire protection water is provided by two 15,000 gallon underground tanks located adjacent to the fire pump house. Post indicator valves are located above each tank (Figure 1). As-built drawings indicate that the two underground tanks are tied together with a common pipe header which rises vertically through a manhole inside the fire pump house and into a vertical in-line fire pump driven by a 75 HP motor (Figure 2). There is no name plate on the fire pump. In addition there is a jockey pump located in the house. The fire pump controller is located in the mechanical room of the main building. Additional backup fire protection is provided by a 4" underground main which tees off of the incoming 4" domestic building water service and ties into the fire main inside the fire pump house via a reduced pressure backflow assembly. From the fire pump house the 8" fire main drops underground where it is routed to the main building.

Figure 1 – Post indicator valves located above underground water tanks

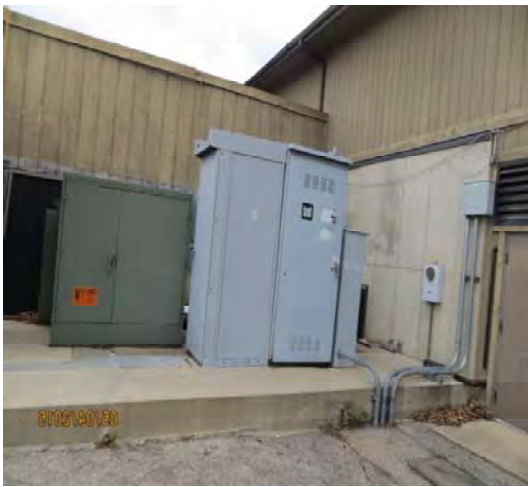
The facility is fed by two electrical services. The first source is the existing utility transformer (Figure 1) and the second is a 750KW, 277/480 volt, 3 phase 4 wire emergency generator (Figure 2). Both services are connected to an existing 2500 Amps, 277/480 volts, 3 phase, 4 wires Automatic Transfer Switch (ATS) (Figure 1). The service feeder cables from the utility transformer and the generator are run via a cable trench and connected to the normal and emergency sides of the ATS respectively. The cable trench is filled with water and the services cables are submerged.

Figure 1 – Utility transformer and automatic transfer switch

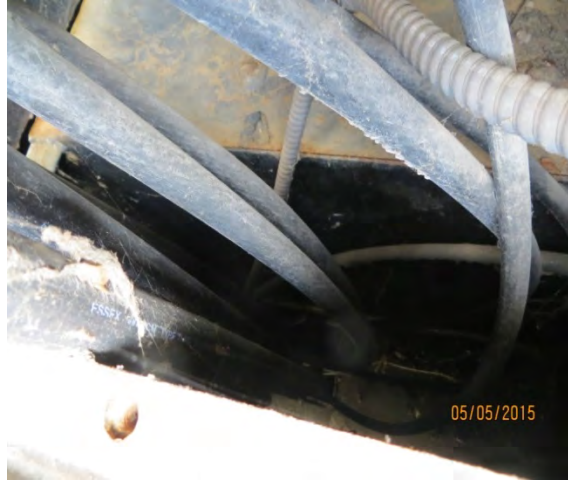
The service cables from the generator and the utility transformer run through a metal trench with a cover (Figure 3). The gasket/caulking has failed and the feeder cables are submerged in water. Water can also be seen in the conduit space of the ATS (Figure 4).

Figure 4 – Service feeders submerged in water

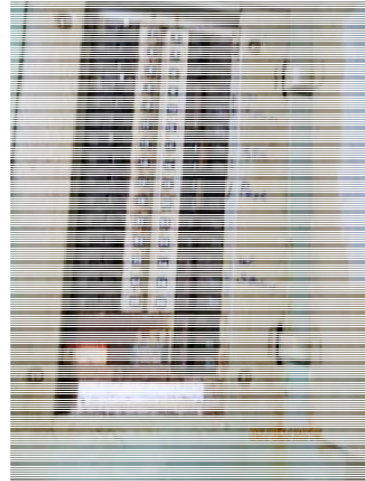
The electrical panels serving the inside swimming pool are corroded. All electrical equipment including conduit and wires in this area should be replaced. Electrical equipment subject to this environment should be rated NEMA 4X. Refer to the Pool Section of this report for additional details (Figures 9 and 10).

Figure 10 – Indoor swimming pool panelboard interior

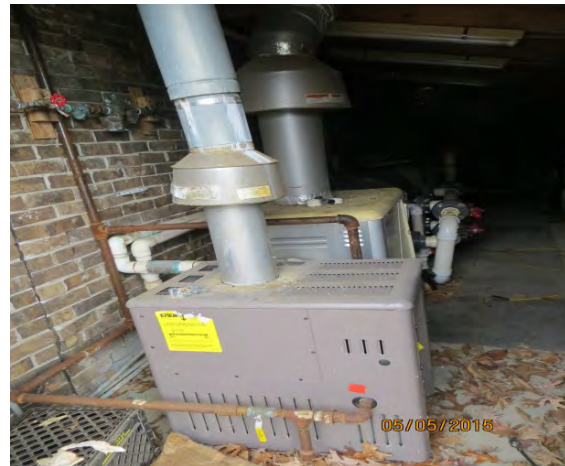
The electrical panel serving the outdoor swimming pool is corroded and its cover is missing. All electrical equipment including conduit and wires in this area should be replaced. Electrical equipment subject to this environment should be rated NEMA 4X. Refer to the Pool Section of this report for additional details. (Figures 11 through 14)

Figure 12 – Swimming pool water heater

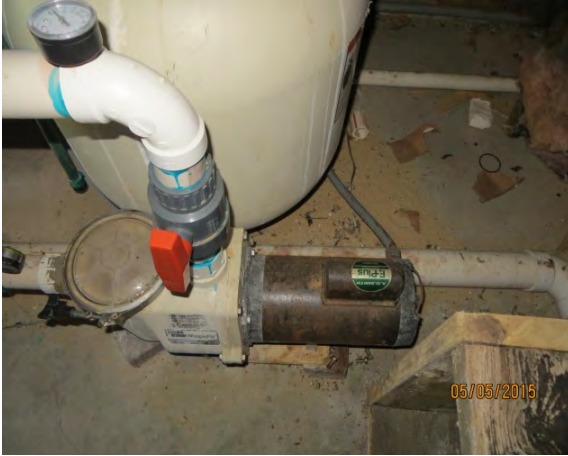
Figure 13 – Water pump purifier

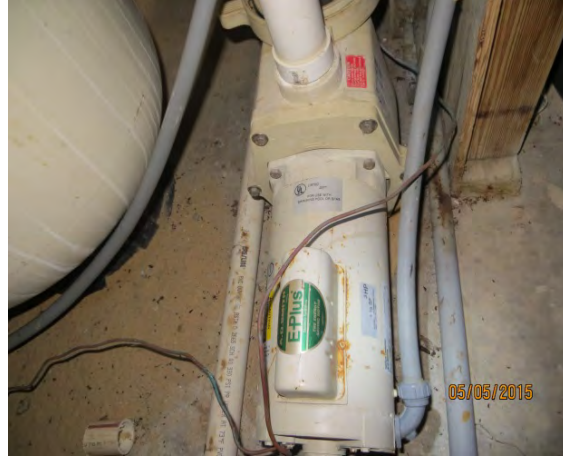
Figure 14 – Water pump for spa

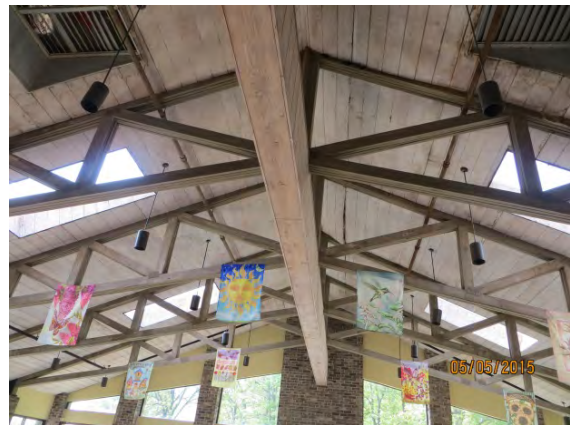
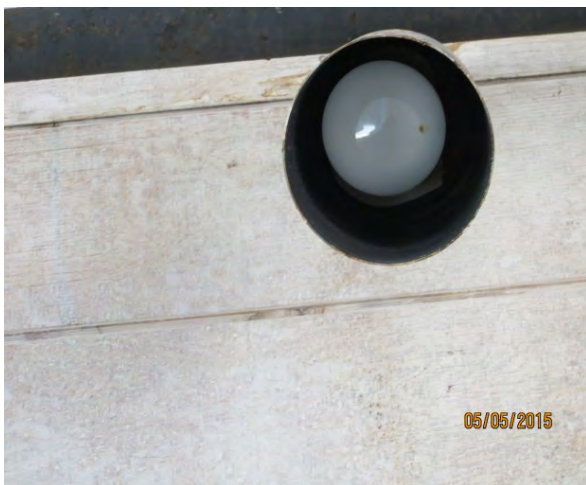
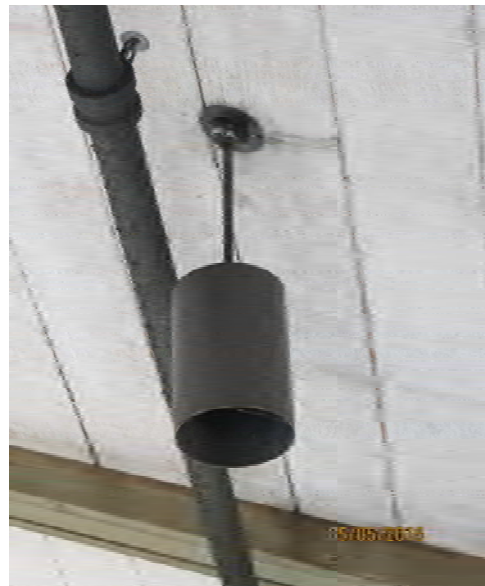
Figure 35 – Indoor swimming pool – pendant incandescent fixtures

Figure 36 – Indoor swimming pool – pendant incandescent fixtures

Figure 37 – Indoor swimming pool – pendant incandescent lighting fixtures

Figure 38 – Indoor swimming pool – pendant incandescent lighting fixtures

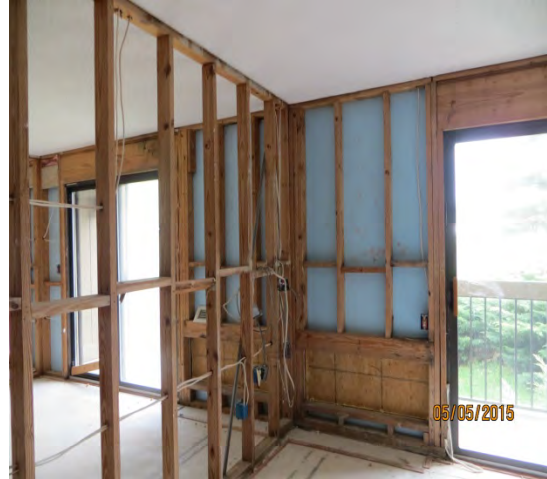
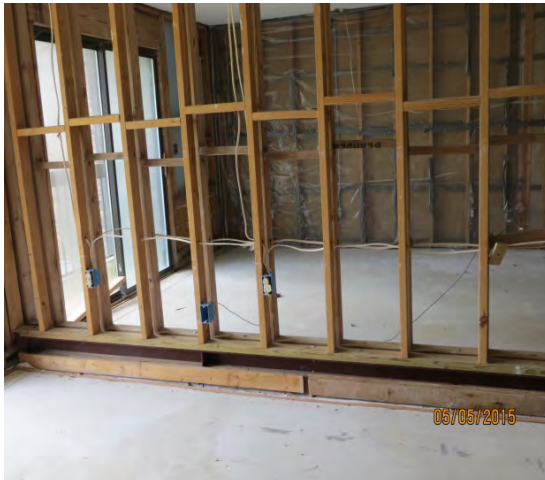
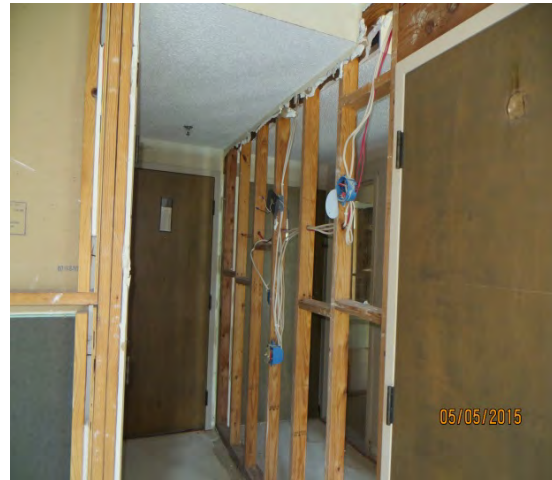
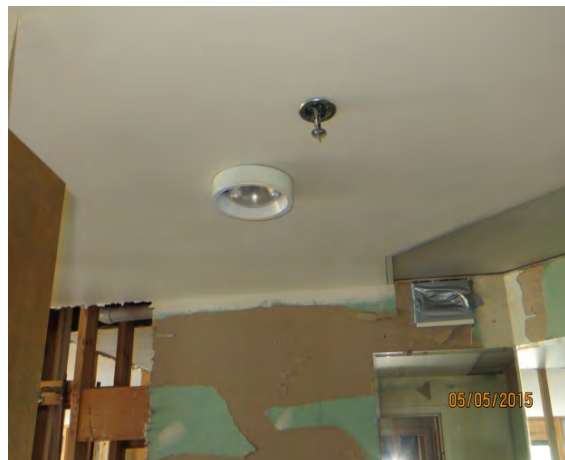
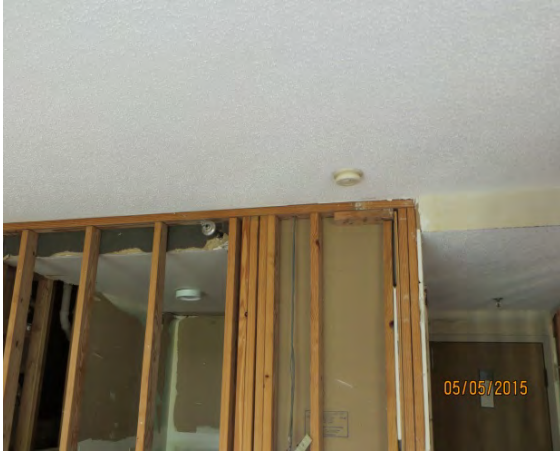
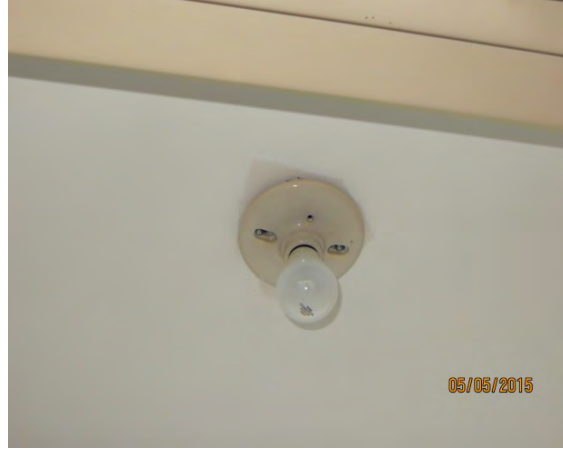
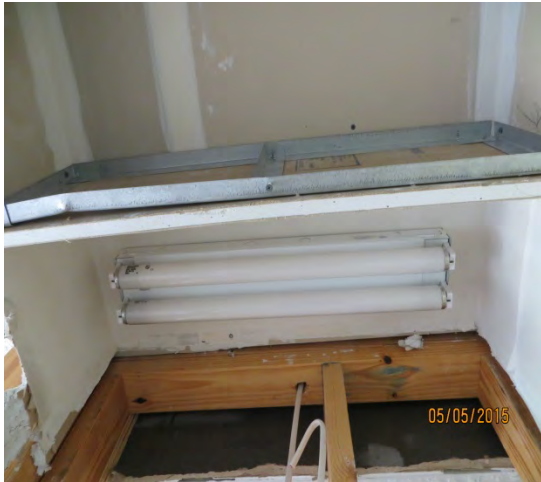
Existing outlets and wall switches in the guestrooms have been left installed in their outlet boxes. If the drywall has been removed then the individual device cover plate has also been removed. The existing non-metallic sheathed cables run from outlet box to outlet box through the wall studs and back to a local panelboard. Continuity and high-pot testing of the cable would be required to determine condition of the cables and if circuits have been maintained. New code requirements for outlets will necessitate their replacement (Figures 41 through 49)

Figure 41 - Typical open wall for every hotel room – electrical outlets with non-metallic sheathed cable installation

Figure 42 - Typical open wall for every hotel room – electrical outlets with non-metallic sheathed cable installation

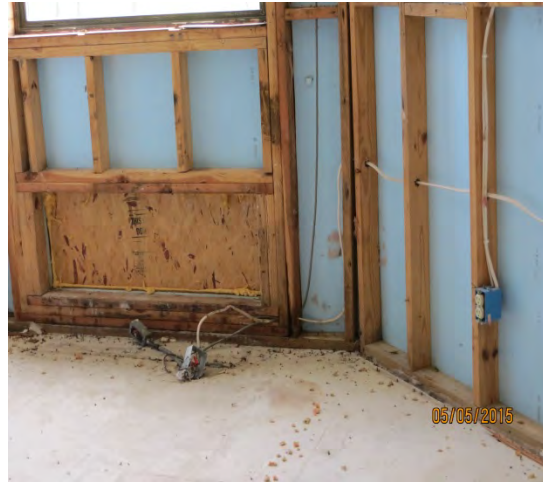
The guestroom mechanical units have been removed from the majority rooms (Figure 50). New electrical wiring and devices will be required. Refer to Mechanical Assessment Section of this report for additional details regarding mechanical units.

Figure 50 - Typical power outlet for Mechanical Unit

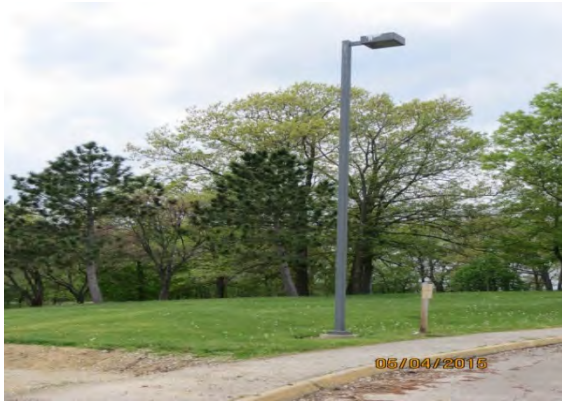
Parking Lots: The North, East and West parking lot lights consist of 30' high poles with rectangular type light fixtures and HID lamps. There is some evidence of rusting along the base of some of the poles (Figure 51).

Figure 51 - Typical 30'-0" Pole Lighting

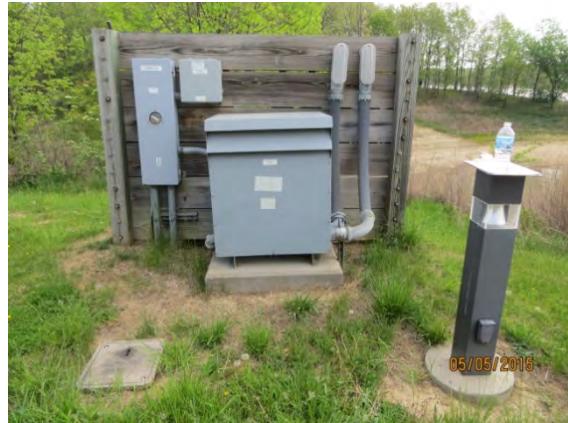
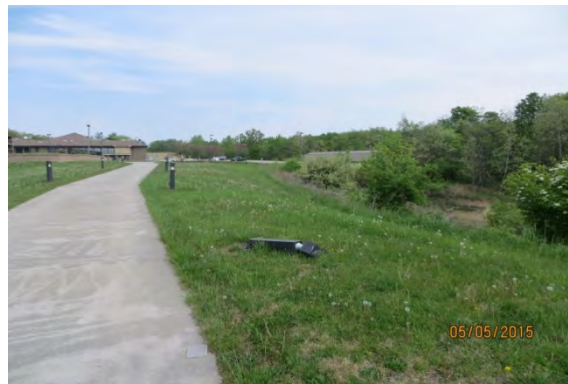
The pathway leading to the boat dock area consists of square bollards and 10' high light poles with rectangular type fixtures and HID lamps. Three existing bollards have been pulled out of the ground (Figures 52, 53 and 54).

Figure 52 - Typical Square Bollard Fixture

Figure 54 - Bollard Fixture Rooted-up

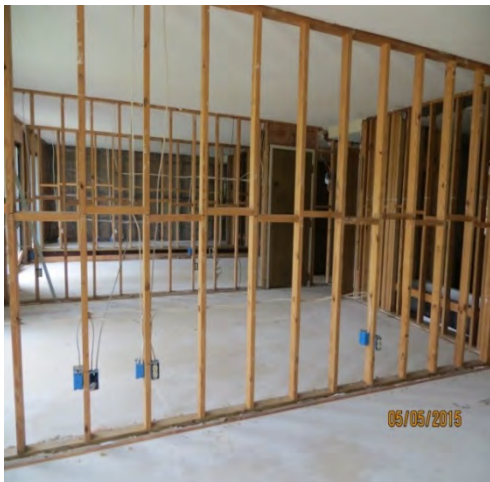
- Nextel SX 200 digital telephone switch (Figure 60),
- Hub enclosure (Figure 61),
- A rack mounted patch panel,
- Branch wiring is distributed above the drop ceiling to the individual guestrooms in Building Wings "A" & "B" and to the rest are for miscellaneous rooms requiring telephone service.
- The existing telephone jacks and cover plates have been removed from all the guestrooms. The individual telephone wires are coiled in their respective outlet boxes (Figures 63 and 64).

Figure 63 - Typical Guestroom with Back-to-Back Telephone Outlets with Coiled Telephone Wires

Figure 64 - Typical Guestroom with Back-to-Back Telephone Outlets with Coiled Telephone Wires

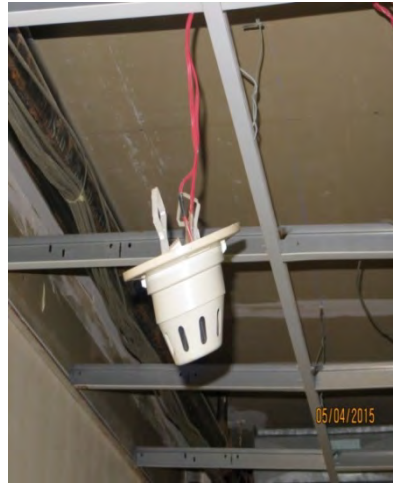
Smoke detectors in public corridors and lobbies are hanging by their wires and laid on ceiling grid (Figure 66).

Figure 66 - Existing Smoke Detector In Public Corridor

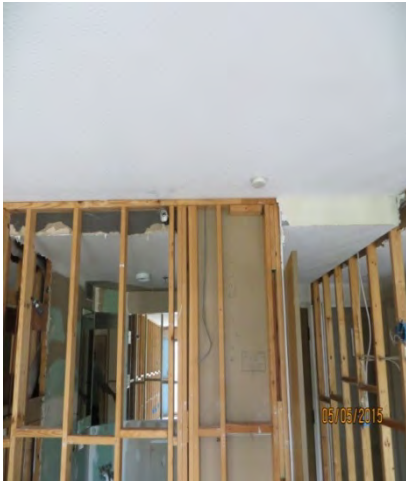
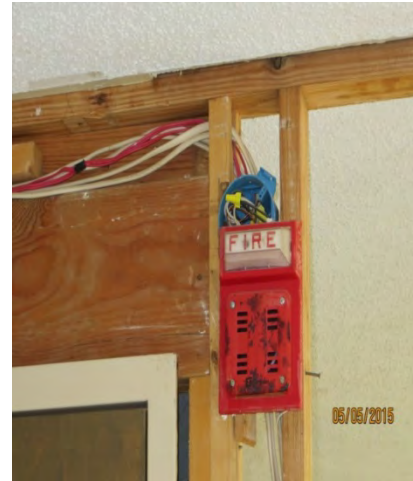
In the guestrooms the smoke detectors are mounted in ceiling and visual enunciators are mounted on the walls (Figures 69 and 70).

Based on the fact that the system has been abandoned and demolition work has been completed without properly protecting devices, there is a high likelihood that devices will not perform to manufacturers specifications. In addition, a new code compliant system will be required.

Figure 69 - Typical Smoke Detector in Guestroom

Figure 70 - Typical Audio Visual Alarm

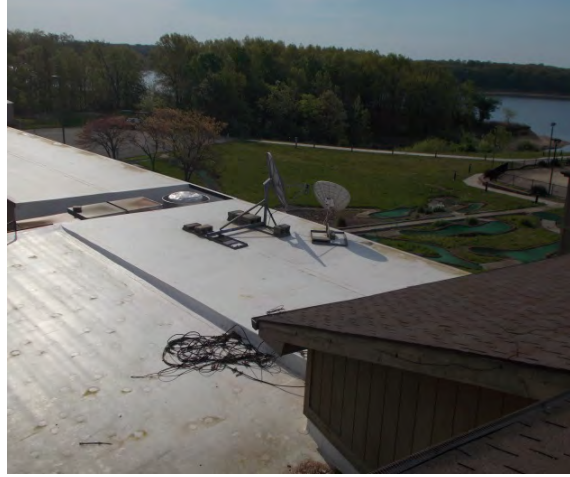
The existing TV System consists of two existing satellite dishes mounted in the roof on Building Wing "A" and Building Wing "B" (Figures 71 and 72). Coax cables are pulled from the top floors down to the ground floors creating a riser system. Typically, a maximum of 6 guestrooms are connected to a single riser cable via a series of splitters. The satellite system electronics could not be located and it is assumed they have been sent back to the satellite service provider.

Figure 71 - Existing Cable TV Dish Antennae

Figure 72- Existing Cable TV Dish Antennae

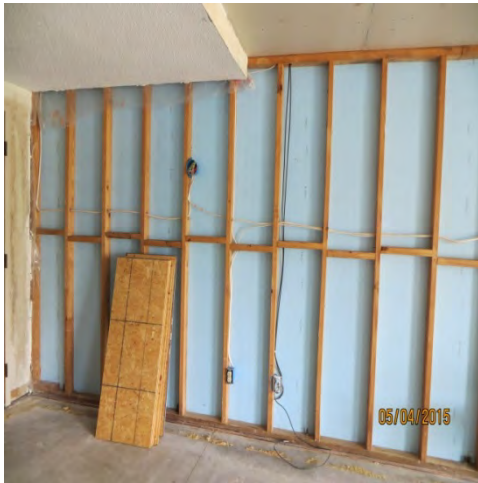
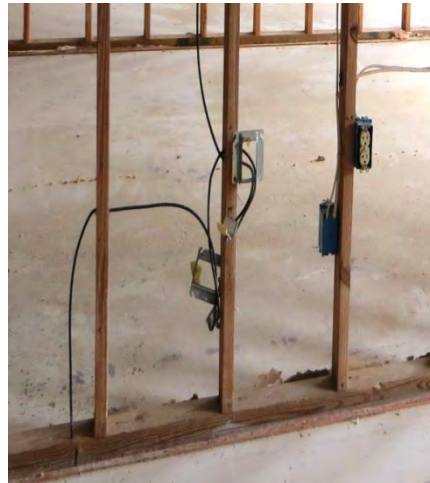
The individual coax cables are pulled to drywall mud rings located in the guestrooms where the cables are connected to a splitter and a coax cable connector. The individual device covers have been removed from the mud ring and the cables and splitters have been left dangling (Figures 73 and 74).

Figure 73 - Typical Existing Cable and TV Outlets Location in Guestrooms

Figure 74 - Typical Existing Cable and TV Outlets Location in Guestrooms

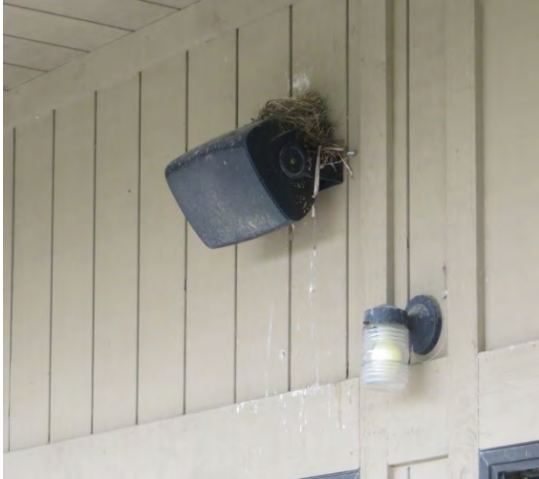
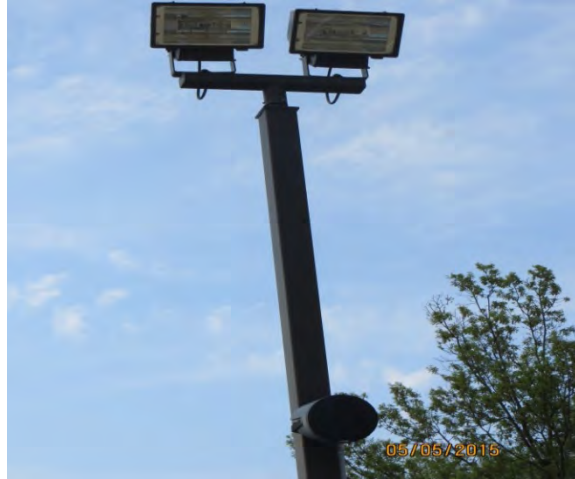
- The existing head-end equipment is located in the Equipment Room (Room P1-23) adjacent to the Main Lobby (Figure 75).
- Interior sound system speaker are located in the corridor lobby elevator, game room, meeting rooms, and banquet room (Figures 76 through 79).
- Exterior sound system speakers are located in the swimming pool area (in perimeter wall and light pole mounted in the middle – Figures 80 through 82).

Figure 80 - Existing PA Speaker – Perimeter

Figure 81 - Existing PA Speaker –
Outdoor Swimming Pool Area

Figure 82 - Existing PA Speaker –
Outdoor Swimming Pool Area

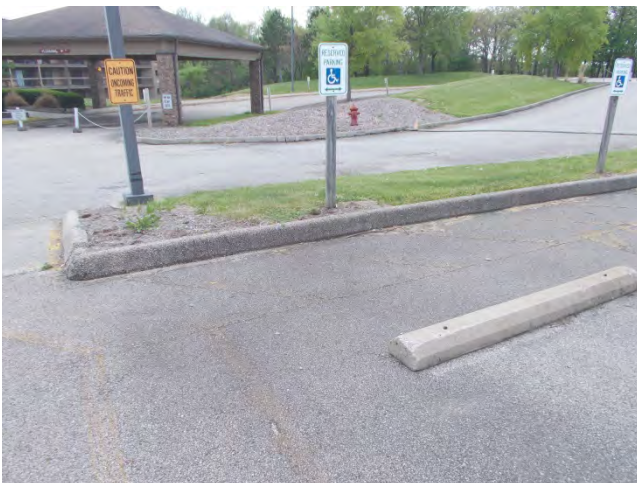
Typical ADA Parking Space

The parking area (approximately 310 spaces total) has the required number of accessible spaces; however, parking striping and signage is faded and/or must be upgraded. There are no “van accessible” spaces. Accessible spaces are distributed in three (3) separate areas; however, none provide a proper accessible path to the building. Paths are either not direct or do not have required proper curb ramps and markings at sidewalks and roadways. There are no detectable warnings at roadways or other vehicle traffic areas.

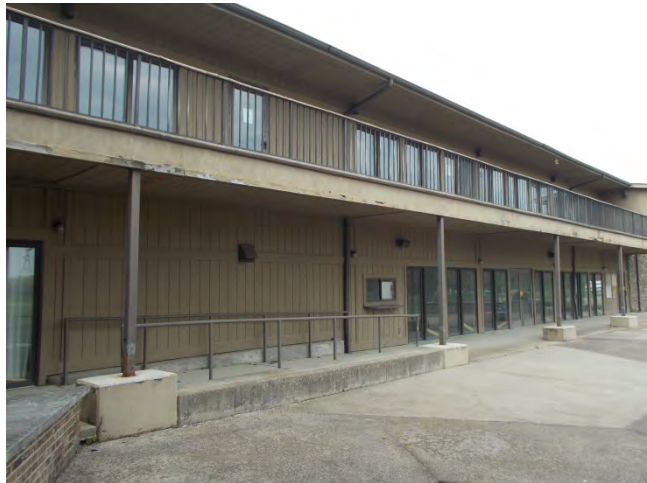
Note Exterior Ramp

The accessible route leading from the hotel site to the pool and mini-golf areas and various off-site amenities appear to have proper slopes and widths per code. There are no observed detectable warnings along any part of the accessible route where pedestrian walks intersect with vehicular traffic. Where accessible routes exceed maximum slope requirements a handrail has been installed. However, handrails must be upgraded per current code requirements (handrails must have straight 12 inch extensions at top and bottom of ramp).

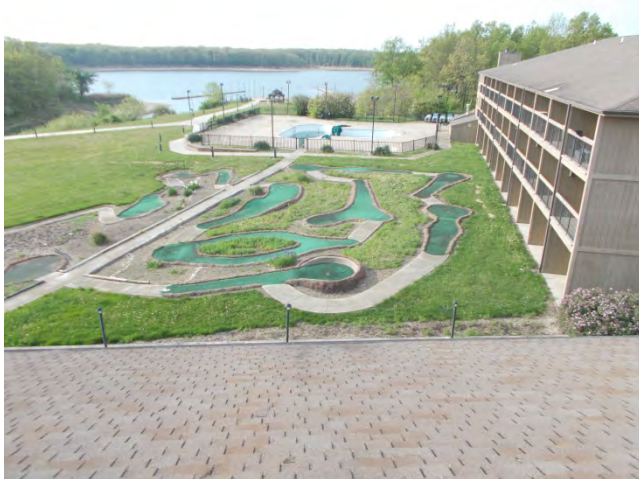
Mini-Golf

Comprehensive investigation of the miniature golf facility will be required to determine compliance with accessibility codes however casual observance suggests that the required accessible path along the courses does not have proper widths, slopes, "start of play" space, etc., for the required 50% of holes provided.

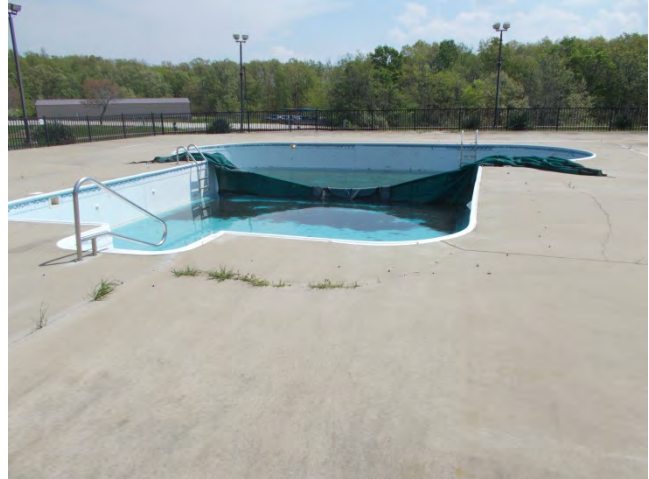
Outdoor Pool

Exterior swimming pool does not have two (2) required accessible means of entry. Existing means of entry (stairs/ladders) cannot be classified as a "primary" means of entry as they are neither a sloped entry nor a swimming pool lift. Existing pool stairs also do not meet current requirements as the secondary means of entry as they do not meet all requirements for pool stairs with regards to tread size and handrail requirements.

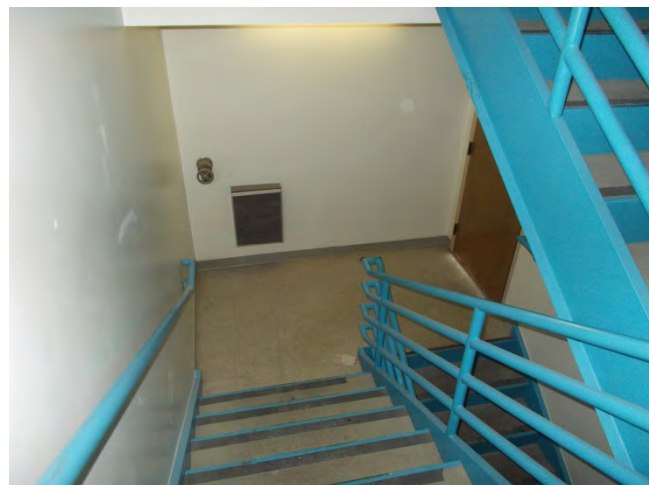
Typical Interior Stair

The stairwells typically meet riser and tread size requirements and have proper handrail configurations on each side of stair stringers. However, areas of rescue assistance are not provided at floors that do not exit to grade.

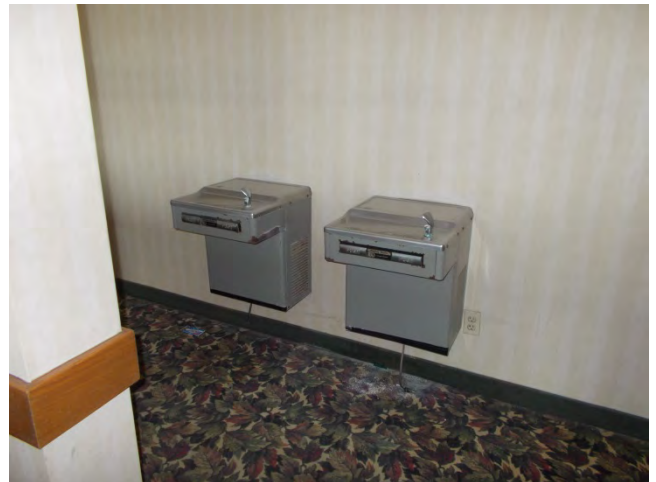
Drinking Fountains

Drinking fountains are provided only at the lower floor adjacent to the restroom entrance. Drinking fountains formerly located outside the first floor restrooms have been removed. Where drinking fountains are present they are both installed at the same height (ADA height), no drinking fountain is installed at the proper height for a standing person.

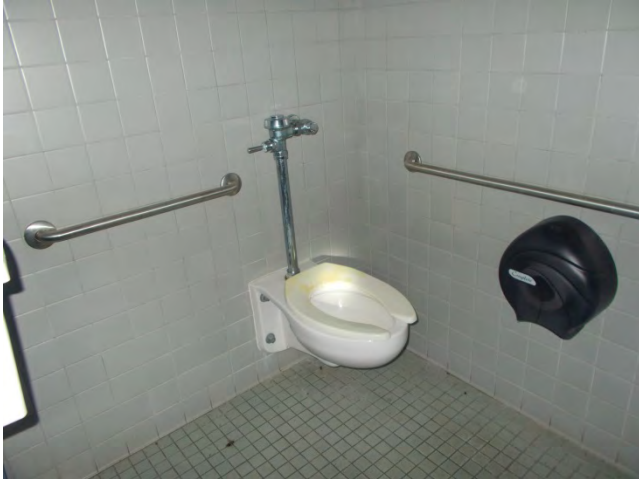
Typical Public Toilet

Clearances at restroom entries and within restrooms meet accessibility requirements typically. One toilet stall in each public restroom is designated as accessible. Clearances around and within accessible toilet stalls appear adequate; however, grab bar configuration must be updated per current codes. Lavatory heights and clearances are compliant. Additionally in each men's restroom one urinal is mounted at accessible height.

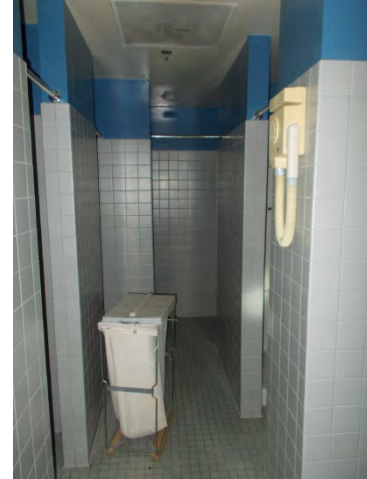
Shower Area

Connected to each of the lower level men's and women's restrooms are locker and shower rooms. These areas do not have adequate wheelchair maneuvering clearances nor are accessible showers provided.
