Two new fish passages reconnect 70 miles of Big Rock Creek and break down barriers to migration.

# No Fish Left Behind

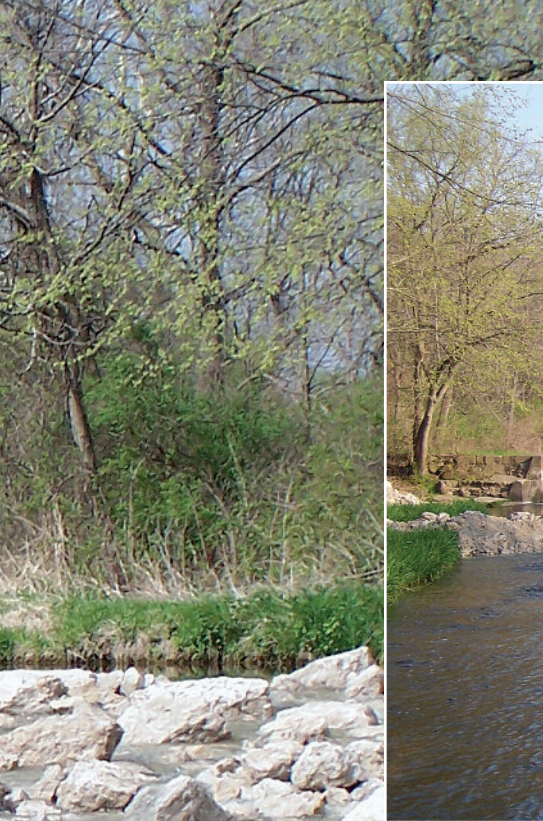
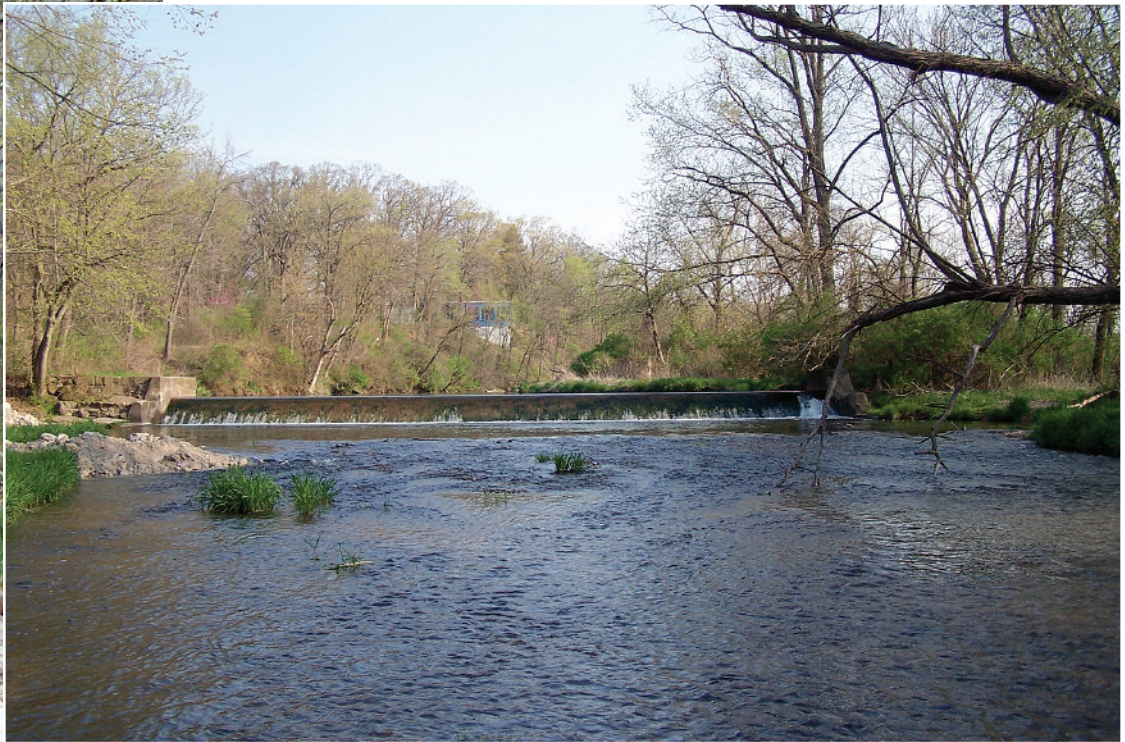
**The completed fish ramp on Big Rock Creek allows fish to move easily upstream (left). Prior to placement of the ramp, the dam was unpassable (right).**

Located in Plano, the first dam was known locally as Drakes Dam and was originally built to power the water pumps for the city. It appeared to be located on city property but actually was owned by an overseas development company—who was in the process of selling it to a local developer who was eventually going to turn it over to the city as a park site. Since it was valued as a historic structure, with the mill house and raceway to be part of the new city park, removal of Drakes Dam was not an option. After several phone calls, letters and a presentation to the Plano City Council, consensus was reached to build a ramp, just like a big riffle, down-

stream of the dam to allow the fish to easily swim past the barrier.

ted, the ramp project started in the spring of 2005. It took three days, 73 truckloads and 1,300 tons of rock—some stones up to 3 feet in diameter were necessary to make sure the structure held during floods—to build the ramp. Even before the ramp was finished, fish were trying to swim past the barrier.

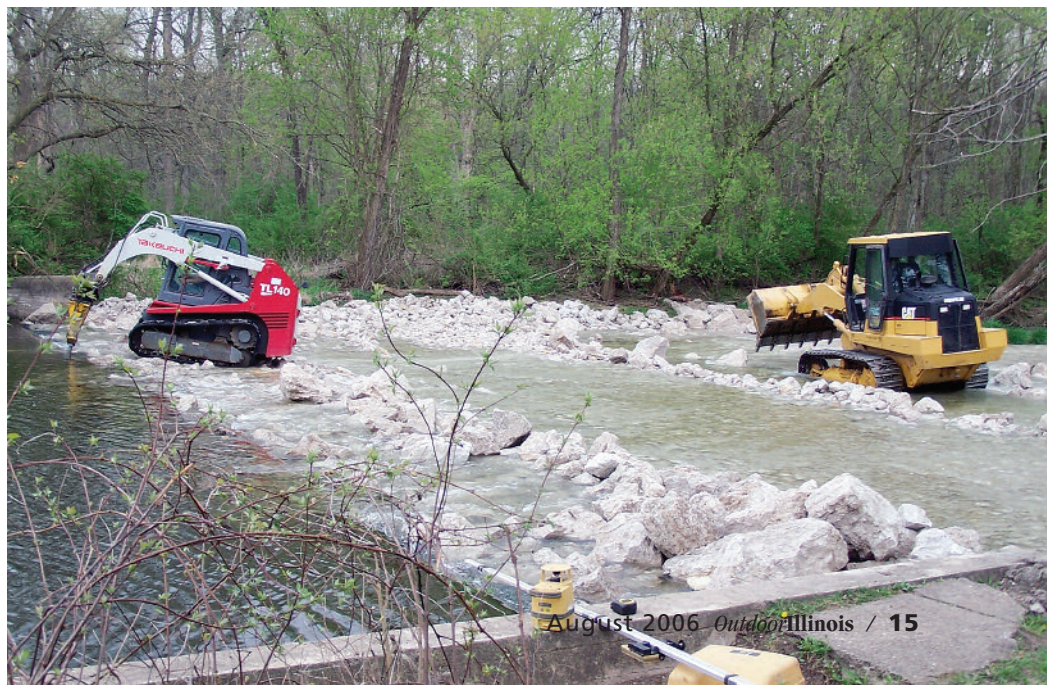
**Ramp construction at Drakes Dam required use of skilled operators and laser-based surveying equipment to ensure proper rock placement.**

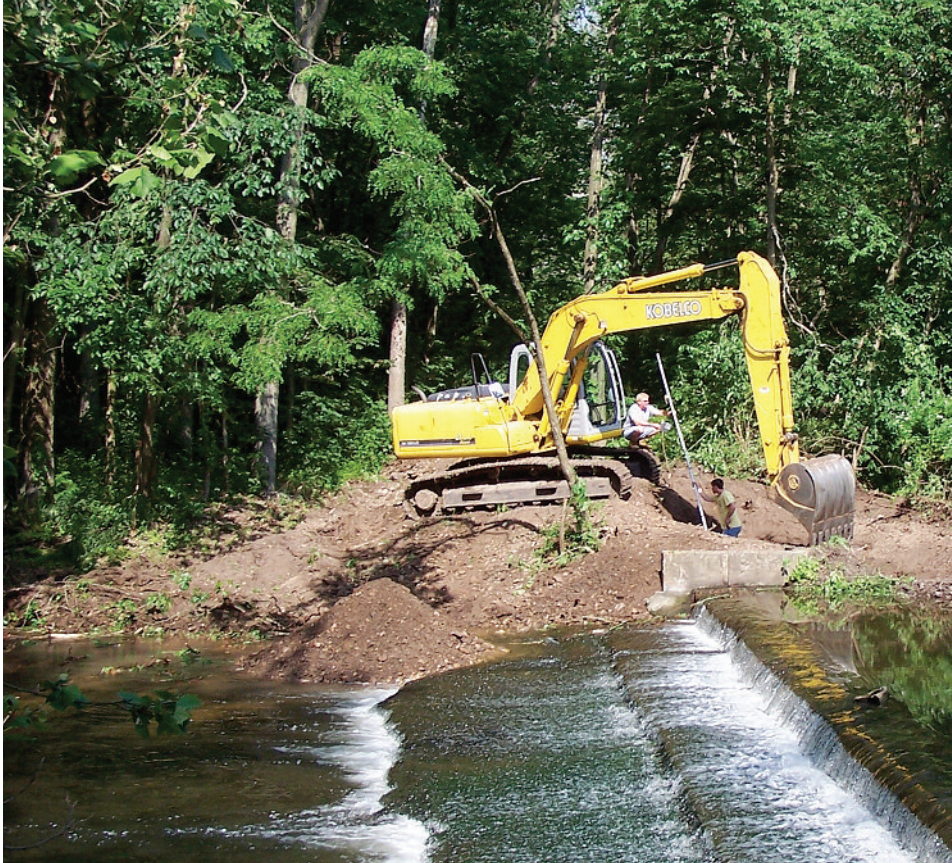
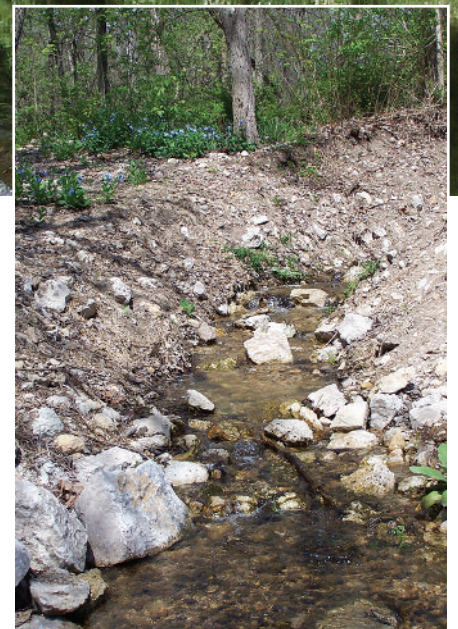
**The bypass ramp was dug out to specified elevations (top), and then lined with rock (right).**

The second dam, located on private property, is used to feed water to off-stream recreation ponds. Obviously, removal was not an option and the design challenge was to get fish around the dam without disrupting the water delivery system. With input from the landowner—an engineer—and many other experts, a small bypass channel was designed.

The bypass channel on the second dam took less rock and only a day and a half to complete, but the placement was trickier. With an entrance elevation the same height as the dam, the channel was designed to work primarily at higher flow levels during the spring when fish are actively migrating. This configuration

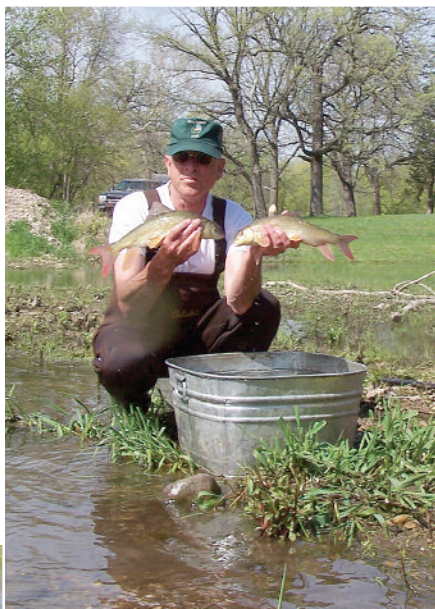
also will have minimal impact on the landowner's water system.

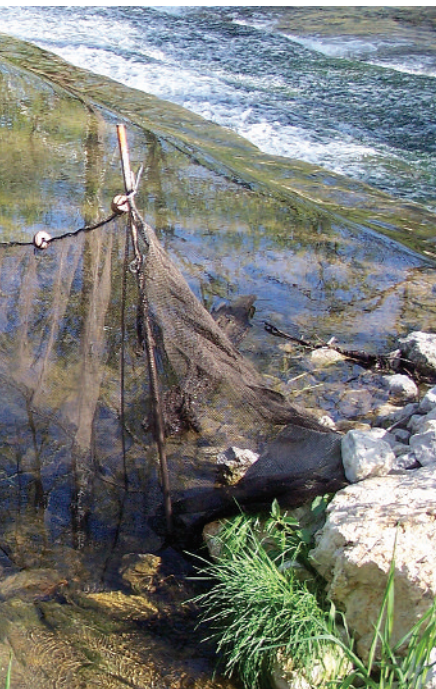
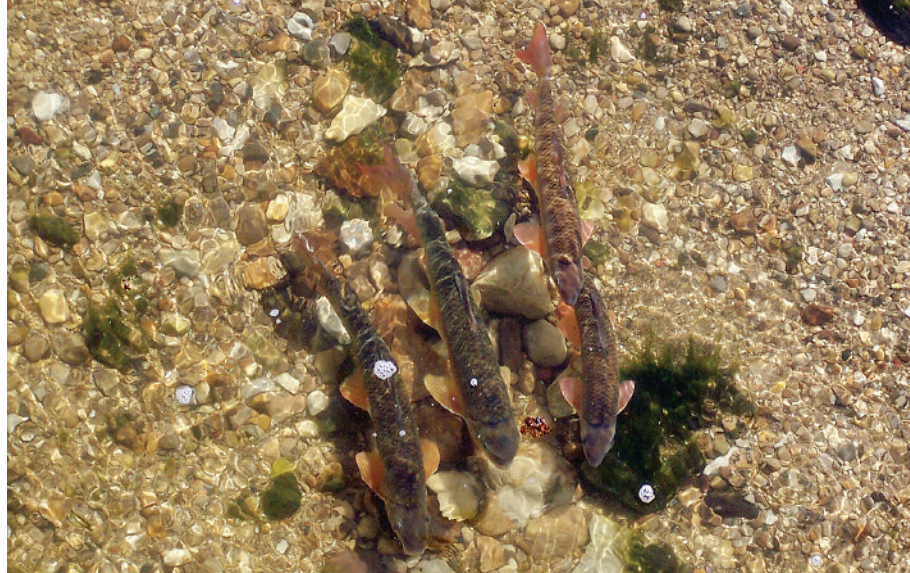
**Shorthead redhorse were collected upstream of the ramp one year after construction (left). To date, 12 fish species have swam up the bypass channel and into the sampling net (below).**

With construction complete, the next phase of the project began: evaluation of the structures. Low water levels during the summer of 2005 made evaluation difficult, but pellet-sized tags with unique numbers were placed on about 150 of the larger, more mobile species to permit identification of individual fish. During the spring of 2006, an additional 500 fish were marked with fin clips, primarily shorthead redhorse, a member of the sucker family known to make spawning runs into Big Rock Creek.
