**Flathead Catfish Nesting Structure and Fry Habitat Project
Along the Rock River
Completion Report
Natural Resources Injury Assessment Restoration Project (2nd of 3)
December 2015**

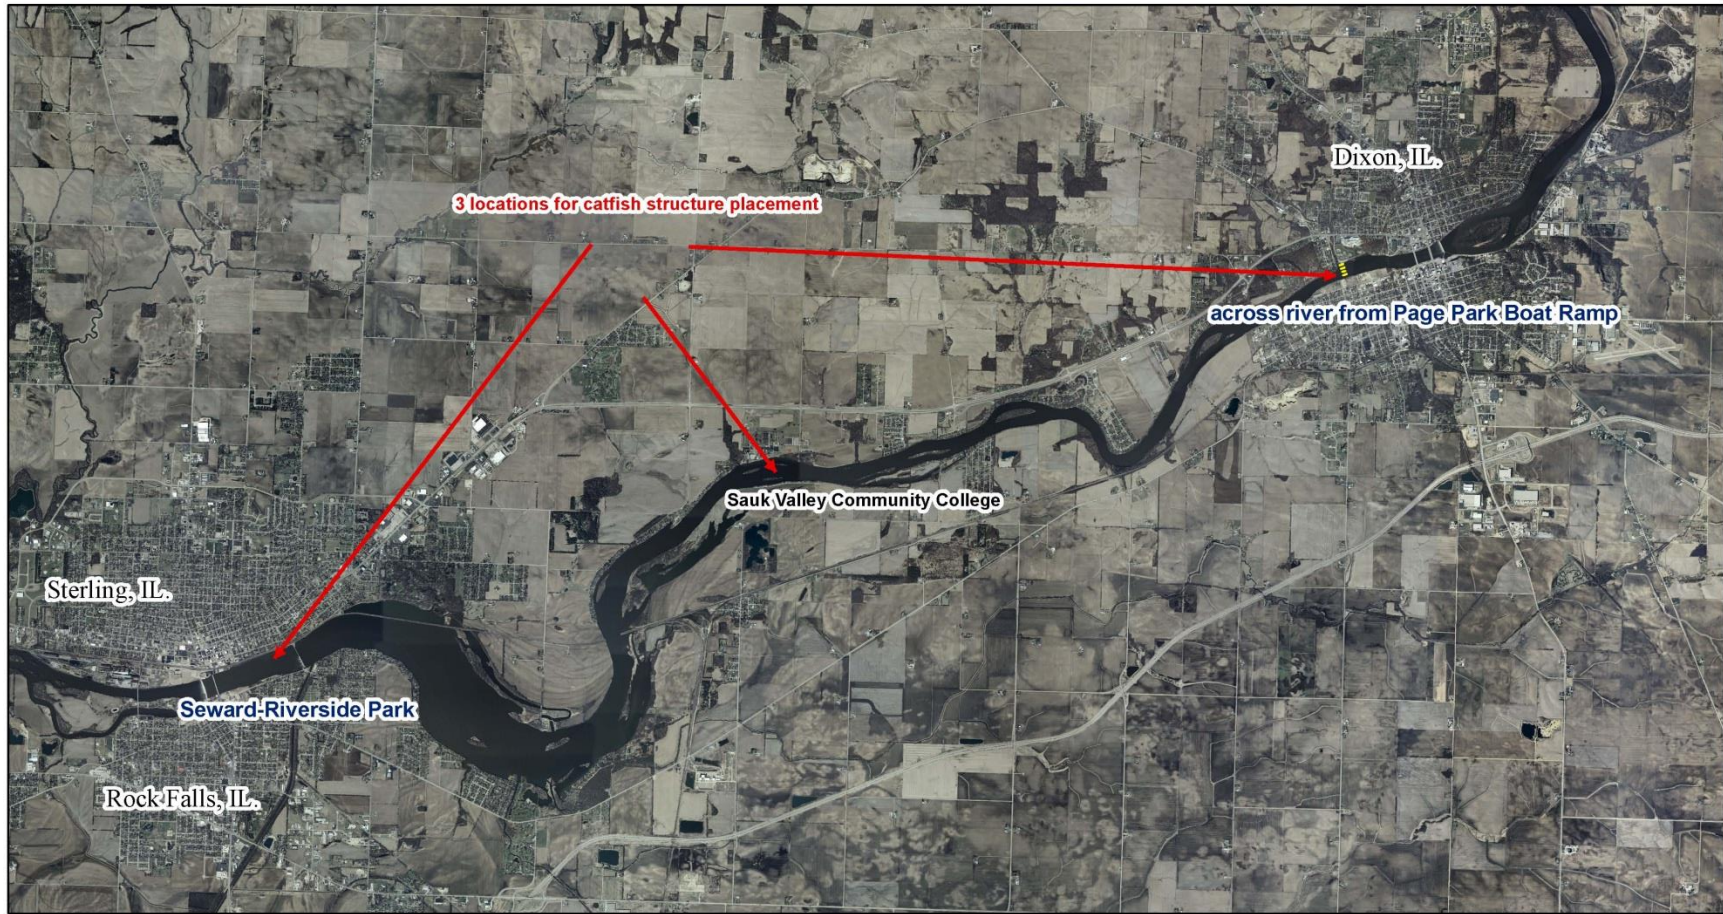
Figure 1. Three locations for catfish nesting structure installation along the Rock River

Beginning on December 7, 2015, and finishing on December 11, 2015, 20 structures were installed at three locations on the Rock River (Photo collage, Figure 1). No mussels were detected throughout the project areas during the searches completed prior to placing the artificial habitat structures. Ten structures were installed at the Sauk Valley Community College site and five structures were installed at the Dixon and Rock Falls sites.
