Mine Subsidence in Illinois: Facts for Homeowners

Circular 569 2013 2nd edition

ILLINOIS STATE GEOLOGICAL SURVEY
Prairie Research Institute
University of Illinois at Urbana-Champaign

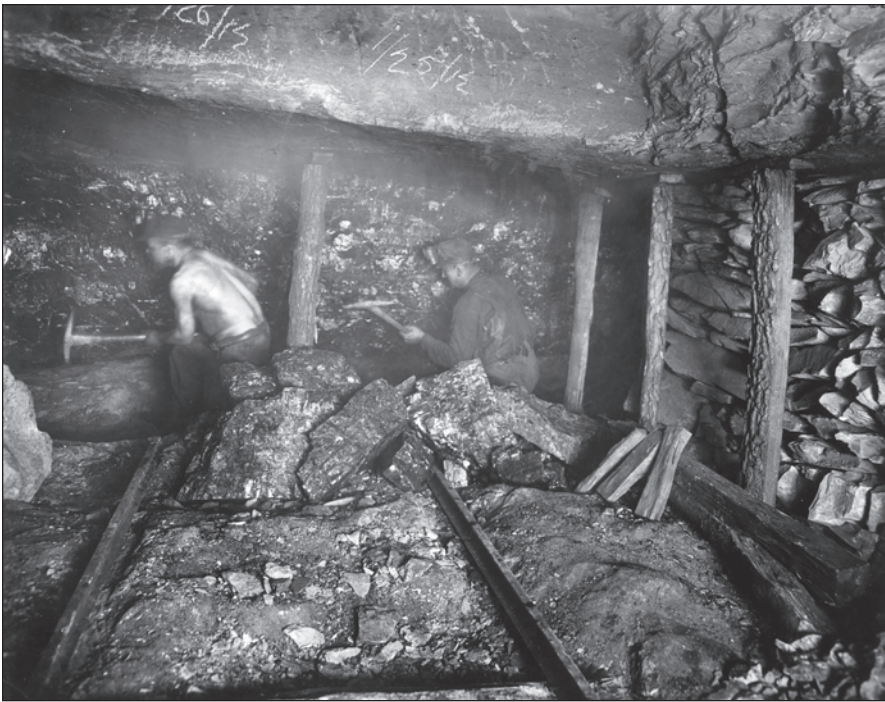
Figure 5 Photograph of mining at the face in an early longwall mine. Note the stacked rock support on the right side. More than 145 of these mines operated from 1856 to 1954 in 18 counties. Most were located in the northern counties from Bureau, LaSalle, Grundy, and Will (fig. 2).

In the late 1800s and early 1900s, longwall mines (figs. 5 and 6a) were excavated by hand, and workers maintained the haulageways (entryways) by placing stacked rock, wooden props, and rock-filled wooden structures to replace the support lost by the removal of coal. The mine roof and the rest of the overburden’s weight settled onto the stacks of rock and compressed them. When this occurred, a few feet of subsidence resulted at the ground surface over the entire mined area.

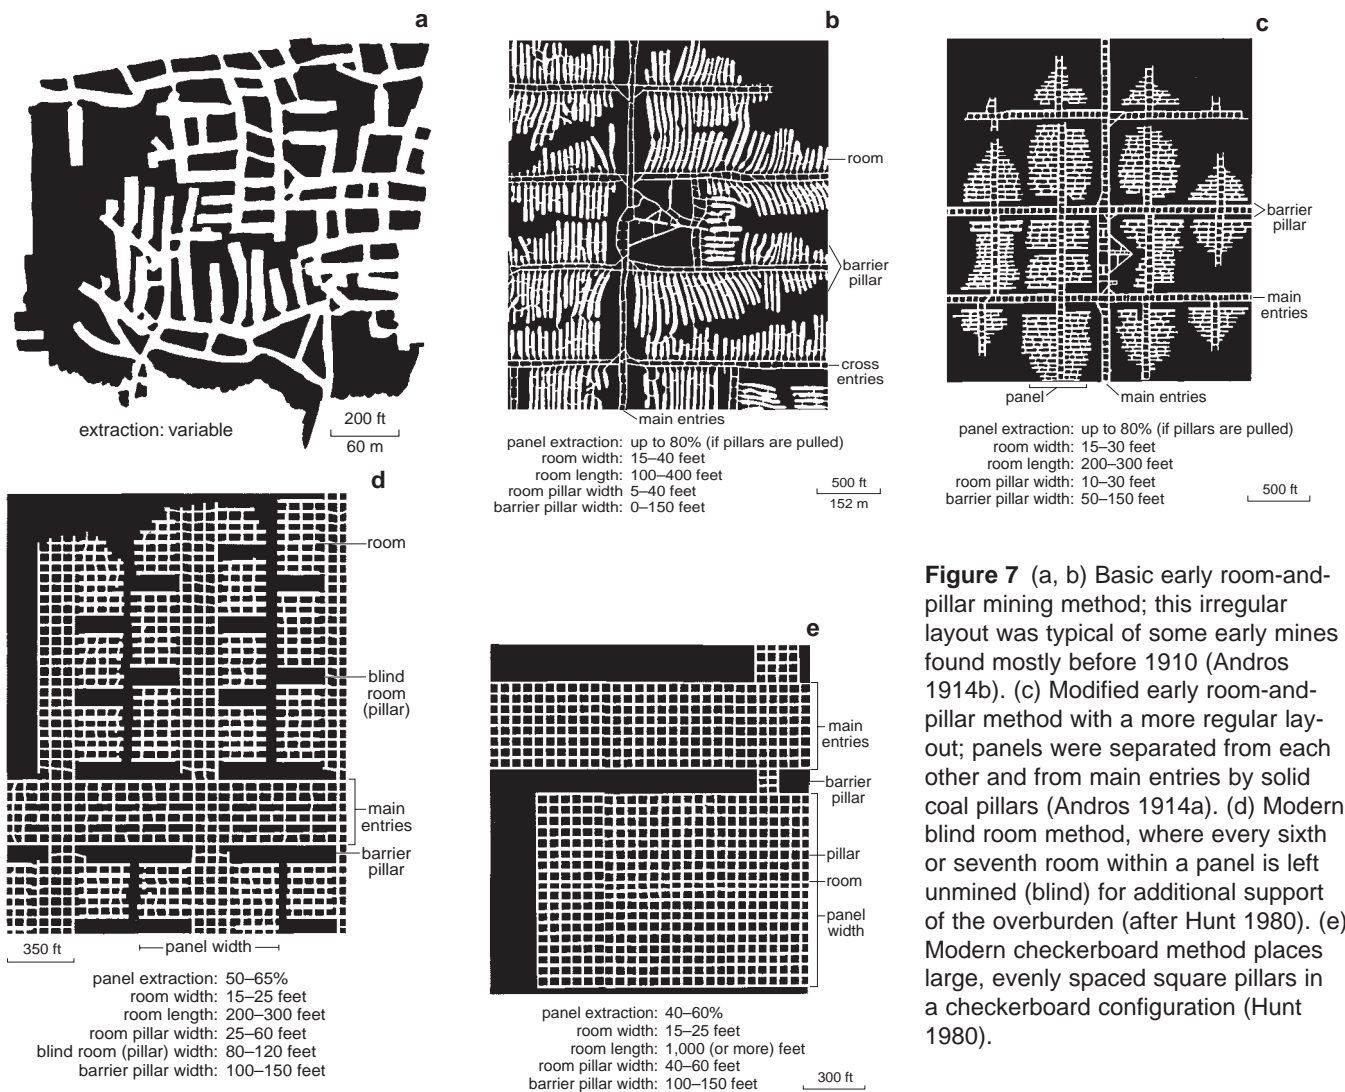
Figure 7 (a, b) Basic early room-and-pillar mining method; this irregular layout was typical of some early mines found mostly before 1910 (Andros 1914b). (c) Modified early room-and-pillar method with a more regular layout; panels were separated from each other and from main entries by solid coal pillars (Andros 1914a). (d) Modern blind room method, where every sixth or seventh room within a panel is left unmined (blind) for additional support of the overburden (after Hunt 1980). (e) Modern checkerboard method places large, evenly spaced square pillars in a checkerboard configuration (Hunt 1980).

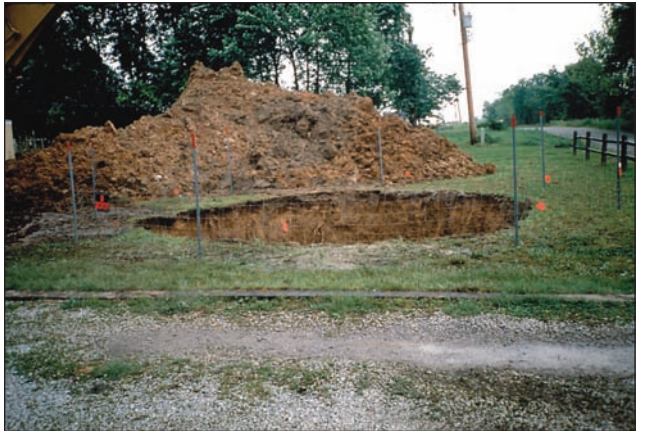
Figure 8 Diagram (Wildanger et al. 1980) and photographs of typical pit subsidence events.

Pit subsidence mostly occurs over shallow mines that are less than 100 feet deep and where the bedrock over the mine is less than 50 feet thick and composed of weak rock materials such as shale. The pit is produced when the mine roof collapses and the roof fall void works its way up through overlying thin, weak bedrock and surficial layers to the ground surface. Pit subsidence forms very quickly. If the bedrock is only a few feet thick and the surficial deposits are loose, these materi-

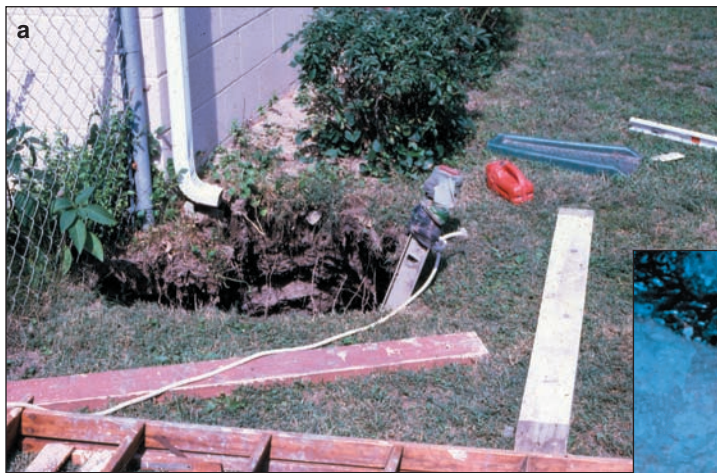
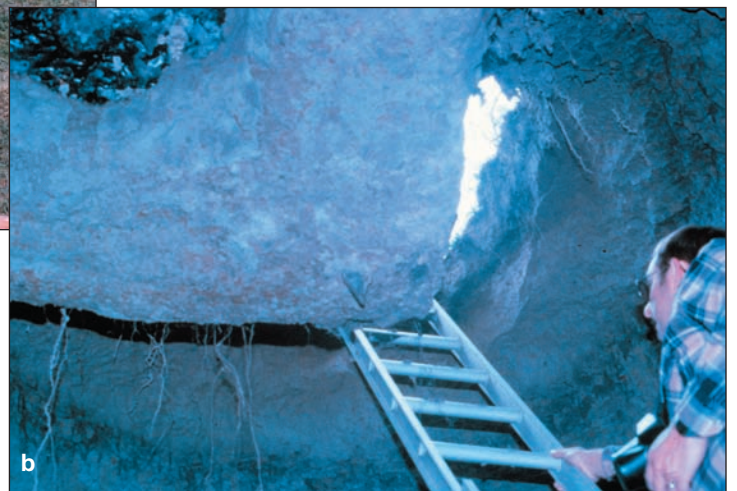
Figure 9 Pit subsidence under the corner of a house from (a) above and (b) below ground.

develops under the corner of a building, the support posts of a foundation, or another critical spot. Otherwise, the probability of a structure being damaged by pit subsidence is low because most pits are relatively small—only a few feet across. If pit subsidence develops under foundation walls, the house may not be affected immediately because the foundation may temporarily bridge the pit (figs. 8 and 9). Left unfilled, the structure (bridge) may become damaged from lack of support.

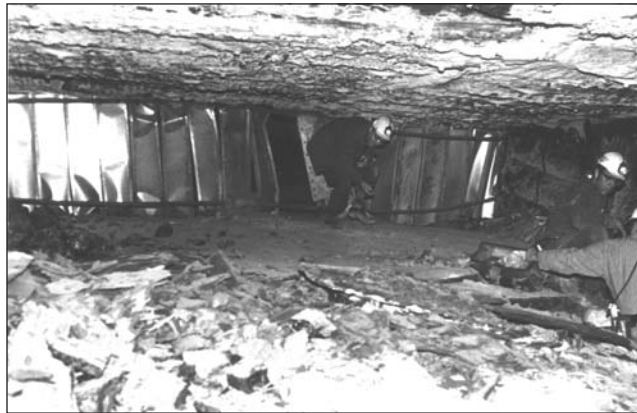
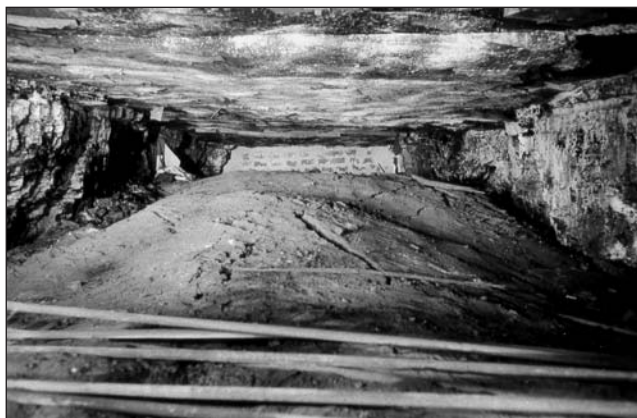
Figure 12 Diagram and photographs of coal pillars being pushed into a soft floor. The claystone material is being squeezed out from under the pillar up into the entryway.

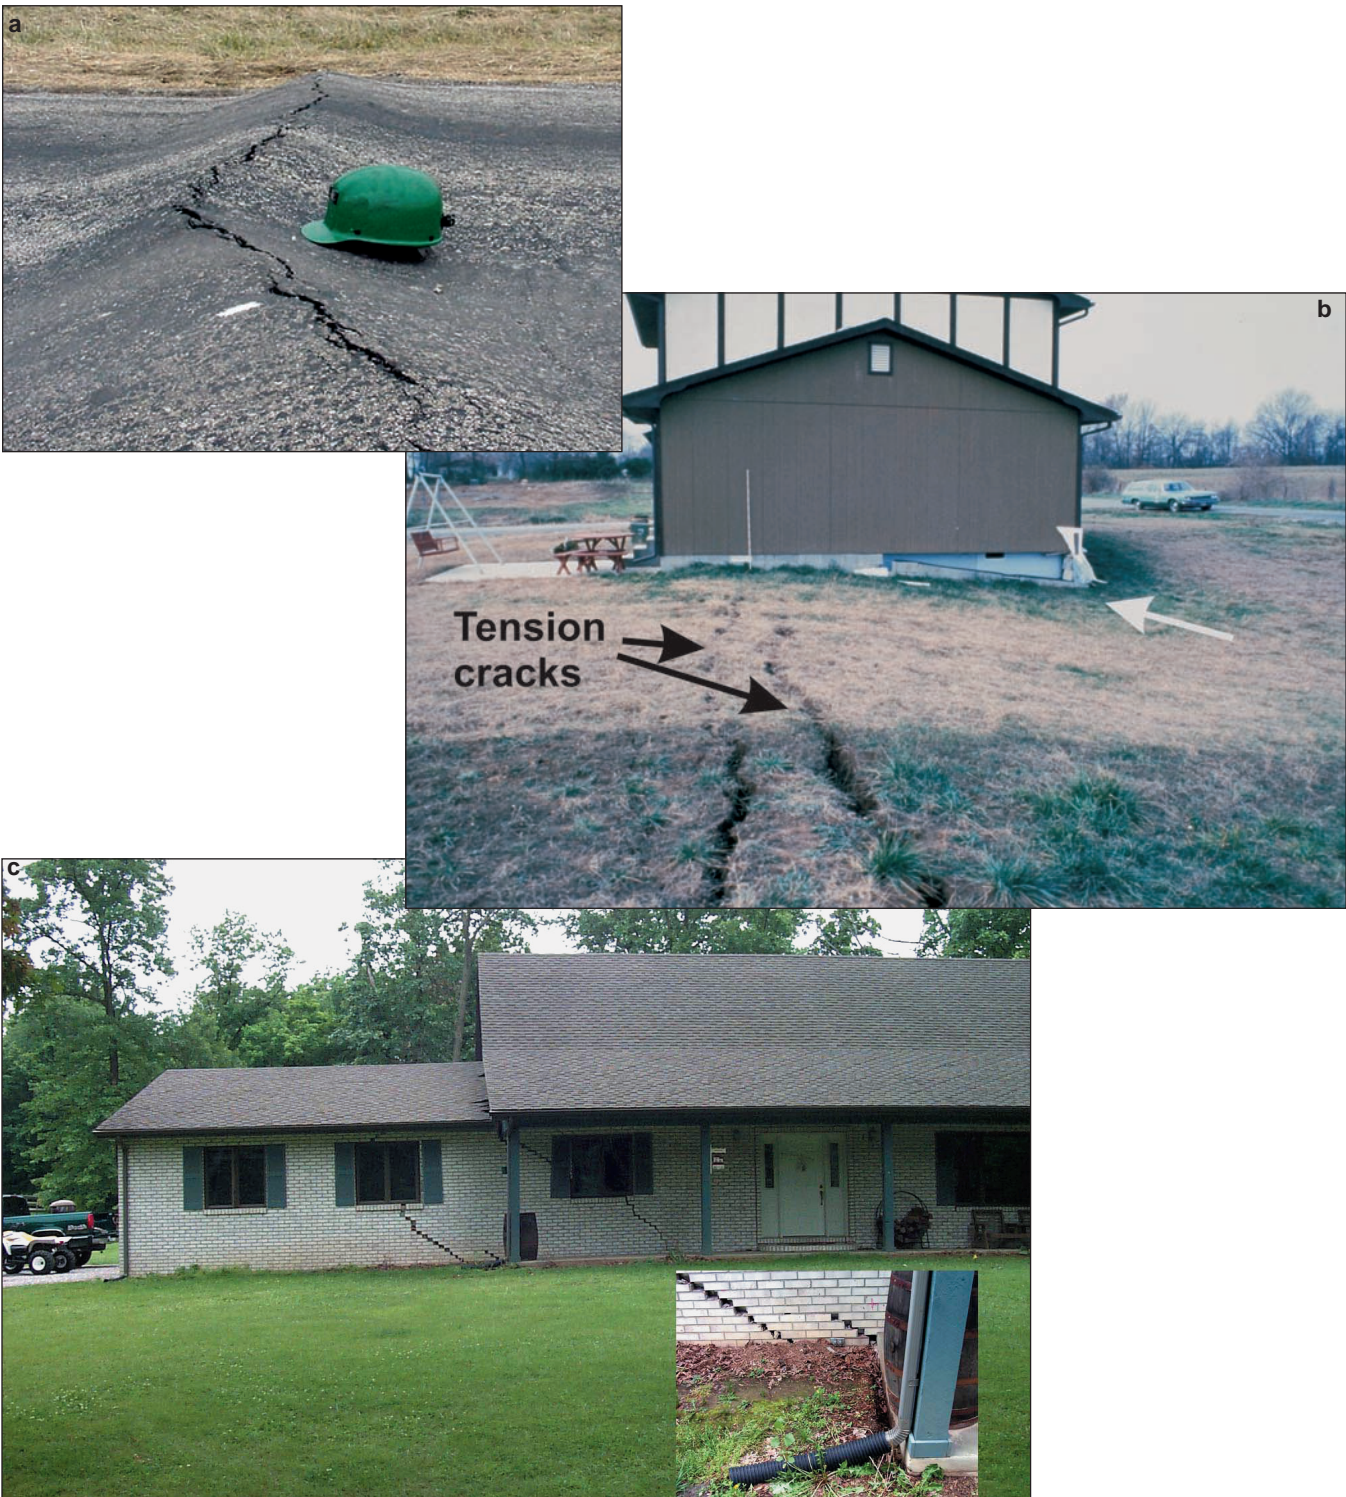
Figure 14 Photographs illustrating the sag subsidence event and features shown in figure 13. (a) Compression ridges formed in the road (feature R) as the result of ground movement (compression) associated with coal mine subsidence. (b) Tension cracks form in the ground surface extending through a home (feature H1); the foundation has settled at the house corner close to the center of the sag. (c) The brick-sided house (feature H2) in the tension zone shows downward bending (compare roof lines). The left side of the home is closest to the sag center and has dropped down. Inset: Ground has pulled away from the porch toward the sag center (left).

The ground moves in two directions during sag subsidence (figs. 13 and 14). The ground drops vertically and moves horizontally toward the center of the sag. At the surface, the sag may be much broader than the collapsed part of the mine. For example, a failure in a mine 160 feet deep could cause minor surface subsidence more than 70 feet beyond the edge of the collapsed area underground (edge of panel). The deeper the mine, the larger the area affected out over the unmined area. Collapsed areas in abandoned underground mines may occur in only part of a panel or mined-out area (fig. 15).

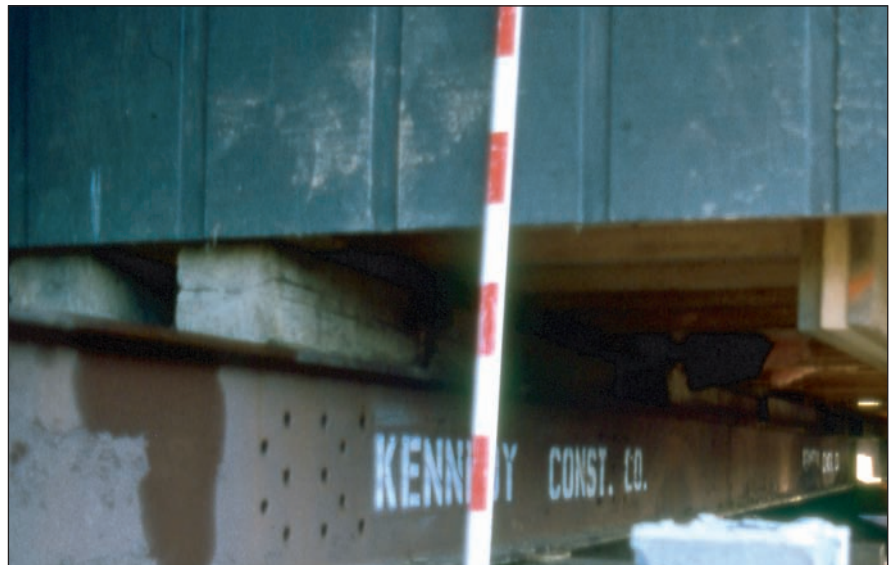
Figure 17 Concrete blocks of a crawl space have been removed to make room to jack the house to a level position. I-beams support the re-leveled house.

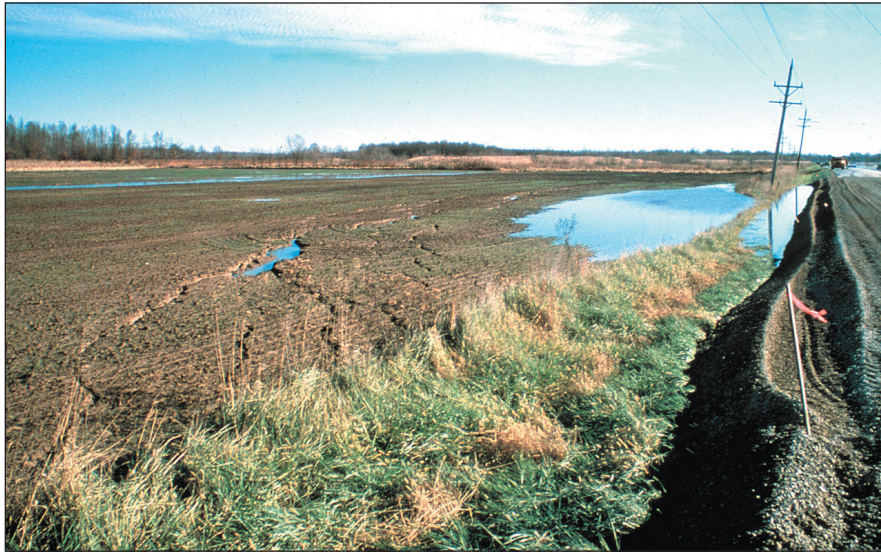
Figure 18 Ponding created by sag subsidence. Note the tension cracks around the edge of the depression.

Water can also pond in a sag subsidence event (fig. 18). If any part of a house is in a sag, an attempt should be made to keep water from accumulating around and under it. The ground surrounding the foundation must be kept well drained

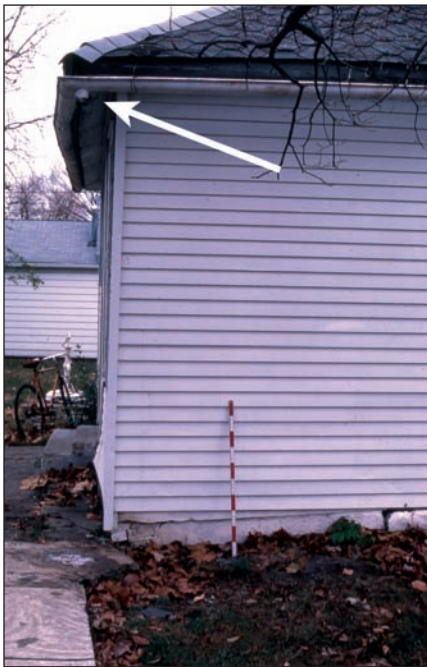
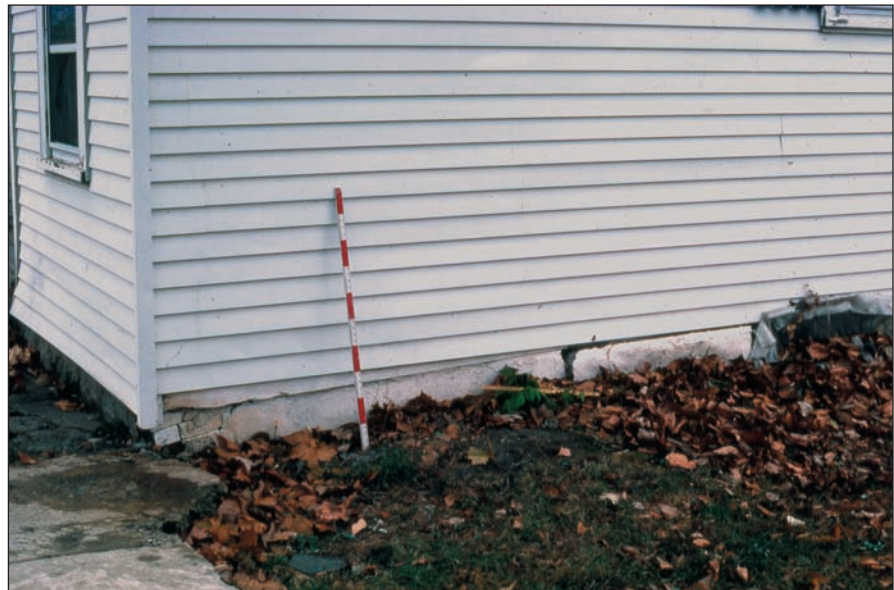
Figure 20 Foundation sinking at the corner of a building due to reduced support caused by excessive, repeated moisture changes. Note gutter drainage (arrow) and lack of downspout to channel drainage away from the foundation.

Reduced load-bearing support of the soil can cause foundations to tilt or sink at the corners (fig. 20). To avoid problems, homeowners should take measures to keep excessive amounts of water away from foundation walls. Downspouts should discharge water several feet from the house. The soil should be built up around the house and graded to slope away from the foundations so that water will then drain away from the house. The cracks produced in foundations by this rotating downward movement of the corner are wide at the top of the foundation and decrease to a nearly hairline crack near the base (footing) of the foundation. This pattern is in contrast to that

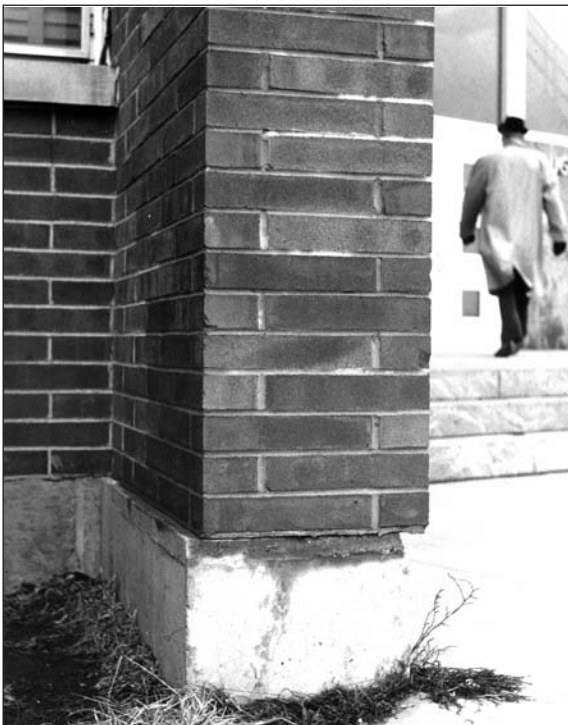
Figure 28 The largest movements are at the edges of the long, continuous wall. At this point, the short brick wall is being pushed off the foundation by the long, continuous brick wall to the left.

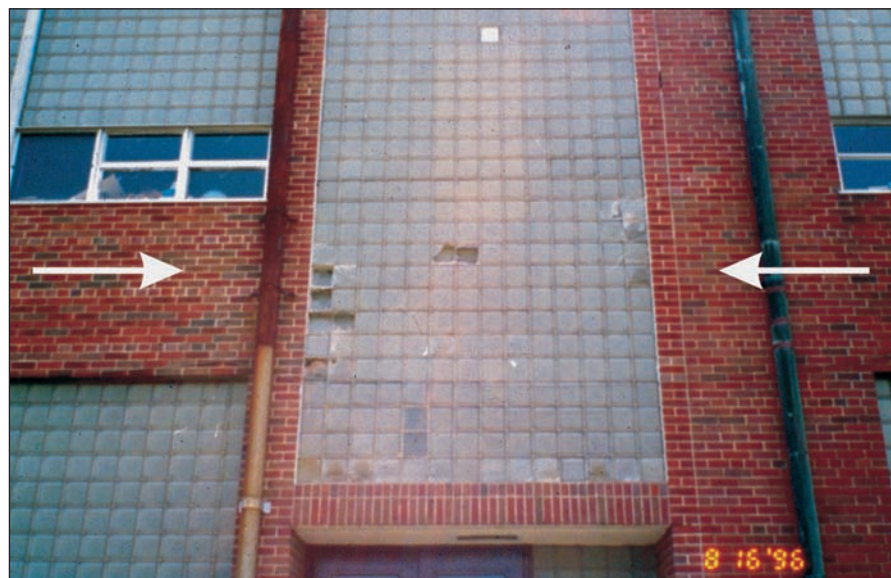
Figure 29 The long, continuous brickwork intersects the vertical glass block wall. Pressures have broken the glass blocks in line with the long, continuous expanse of brickwork.

blocks, may be crushed (fig. 29), and the sliding wall may become separated from the interior floor slab. To minimize this type of problem, functioning expansion joints should be incorporated into the construction. Expansion joints should be clear of any hard materials that may have fallen in during construction, and pliable caulk should be used to seal the gap.
