ILLINOIS DEPARTMENT OF NATURAL RESOURCES
NATURAL RESOURCE TRUSTEE PROGRAM

**RESTORATION PLAN
FOR
MILLHURST FEN, KENDALL COUNTY, ILLINOIS**

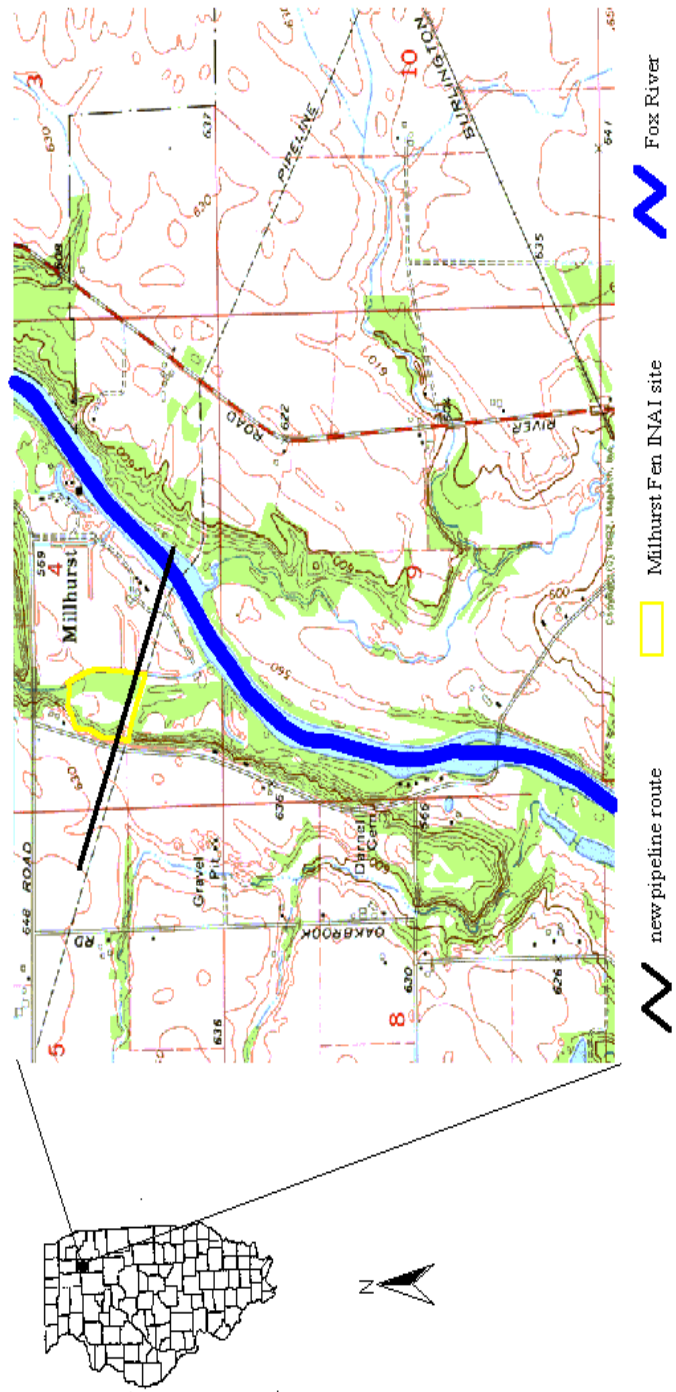
Figure 1. Topographic map depicting location of pipeline route and the Millhurst Fen Illinois Natural Area Inventories site in Kendall County, Illinois.

Lakehead Pipe Line Company (Lakehead) installed a 24-inch diameter crude oil pipeline under the Fox River and Millhurst Fen using a horizontal directional drill (HDD) method. The drilling site is located approximately 6 miles west of Yorkville, Illinois in Kendall County. The locations of the Fox River, Millhurst Fen, and drilling site are shown on Figure 1.

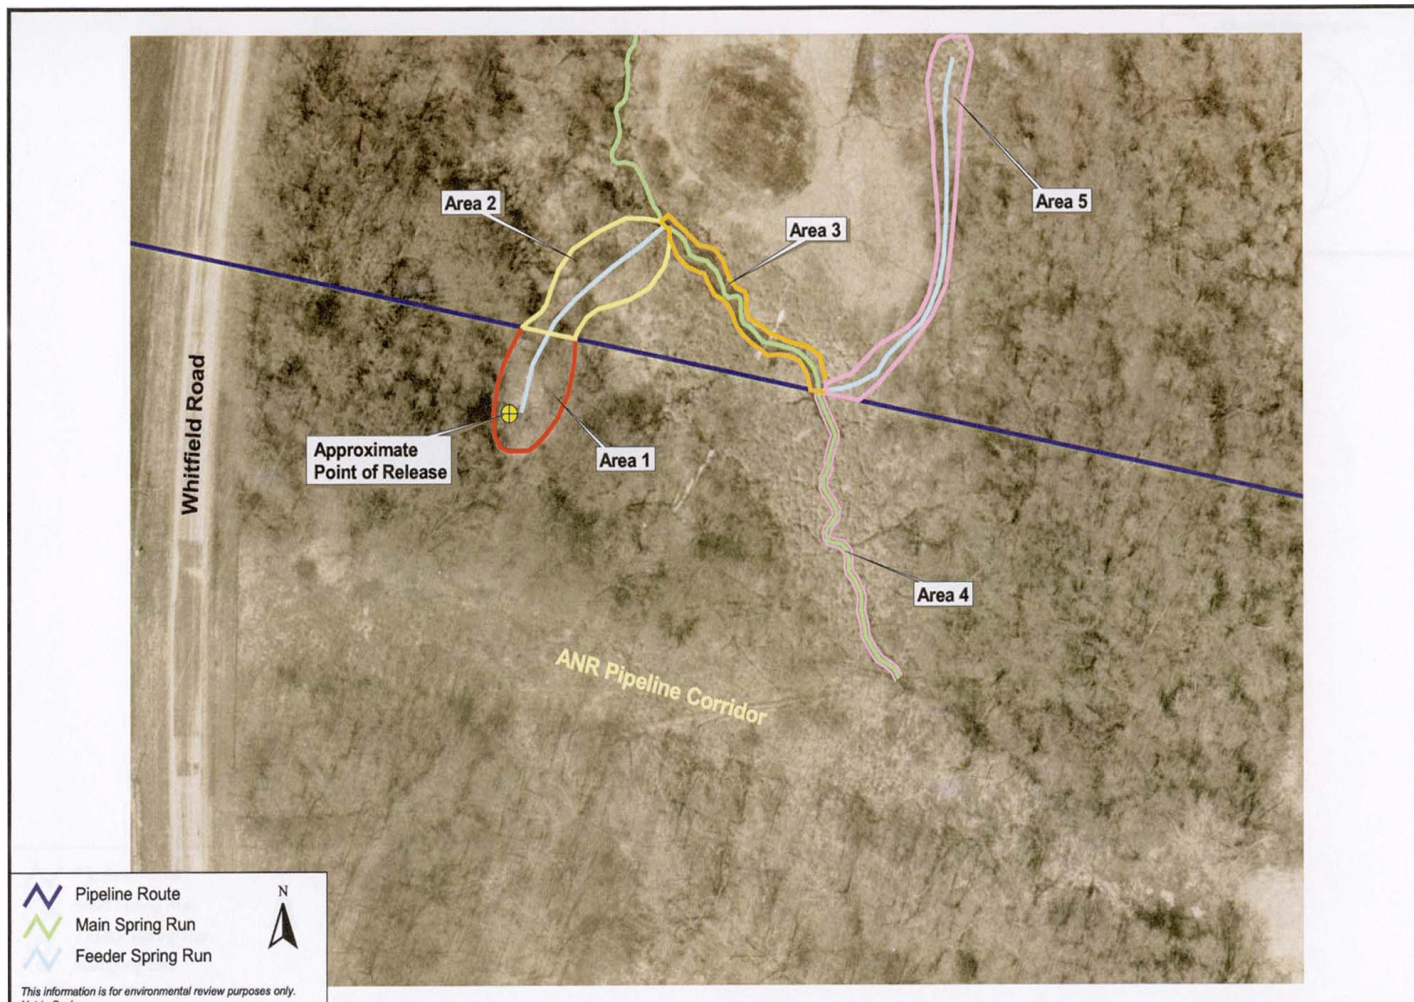
Figure 2. Aerial photo depicting areas of release of the drilling mud into Millhurst Fen (Kendall County, Illinois).

The frac-out occurred approximately 50 feet south of the surveyed pipeline alignment at the base of the hill downslope from Whitefield Road and on the western edge of the Millhurst Fen. The approximate point of release of the drilling mud is shown on Figure 2. The release point was adjacent to a small spring head emanating from a forested fen area. From the release point in the forested area, the bentonite flowed in a northeasterly direction down a small feeder spring run

Remedial activities were initiated on July 24, 1998, the day after the release was discovered. The drilling mud was removed by hand using shovels, buckets, and soft-bristled brooms, disposed of in 55-gallon drums, and removed from the site. Most (90 to 95 percent) of the drilling mud was removed from the containment area (Area 1, Figure 2) and the upper portions of the main spring run (Area 3, Figure 2) during remediation. Drilling mud was left along the edge of the lower

portion of the main spring run (Area 4, Figure 2) because of the low volume of drilling mud present and because access to the downstream property had been denied by the landowner.

The area downstream of the containment area (Area 2, Figure 2) was the most difficult area to remediate due to the soft peat soils, the dense emergent vegetation, and the soft consistency of the drilling mud. After 2 to 3 days of removing drilling mud from this downstream area, activities were suspended due to the ancillary damage being done to the vegetation and soils. Only 10 percent of the total volume of drilling mud was removed from this area.
