Stratton Lock and Dam Life Extension Reconnaissance Study

Summary Report, Prepared for the Illinois Department of Natural Resources,
Office of Water Resources - June 2005

Prepared by HNTB Corporation
111 North Canal Street
Chicago, Illinois 60606

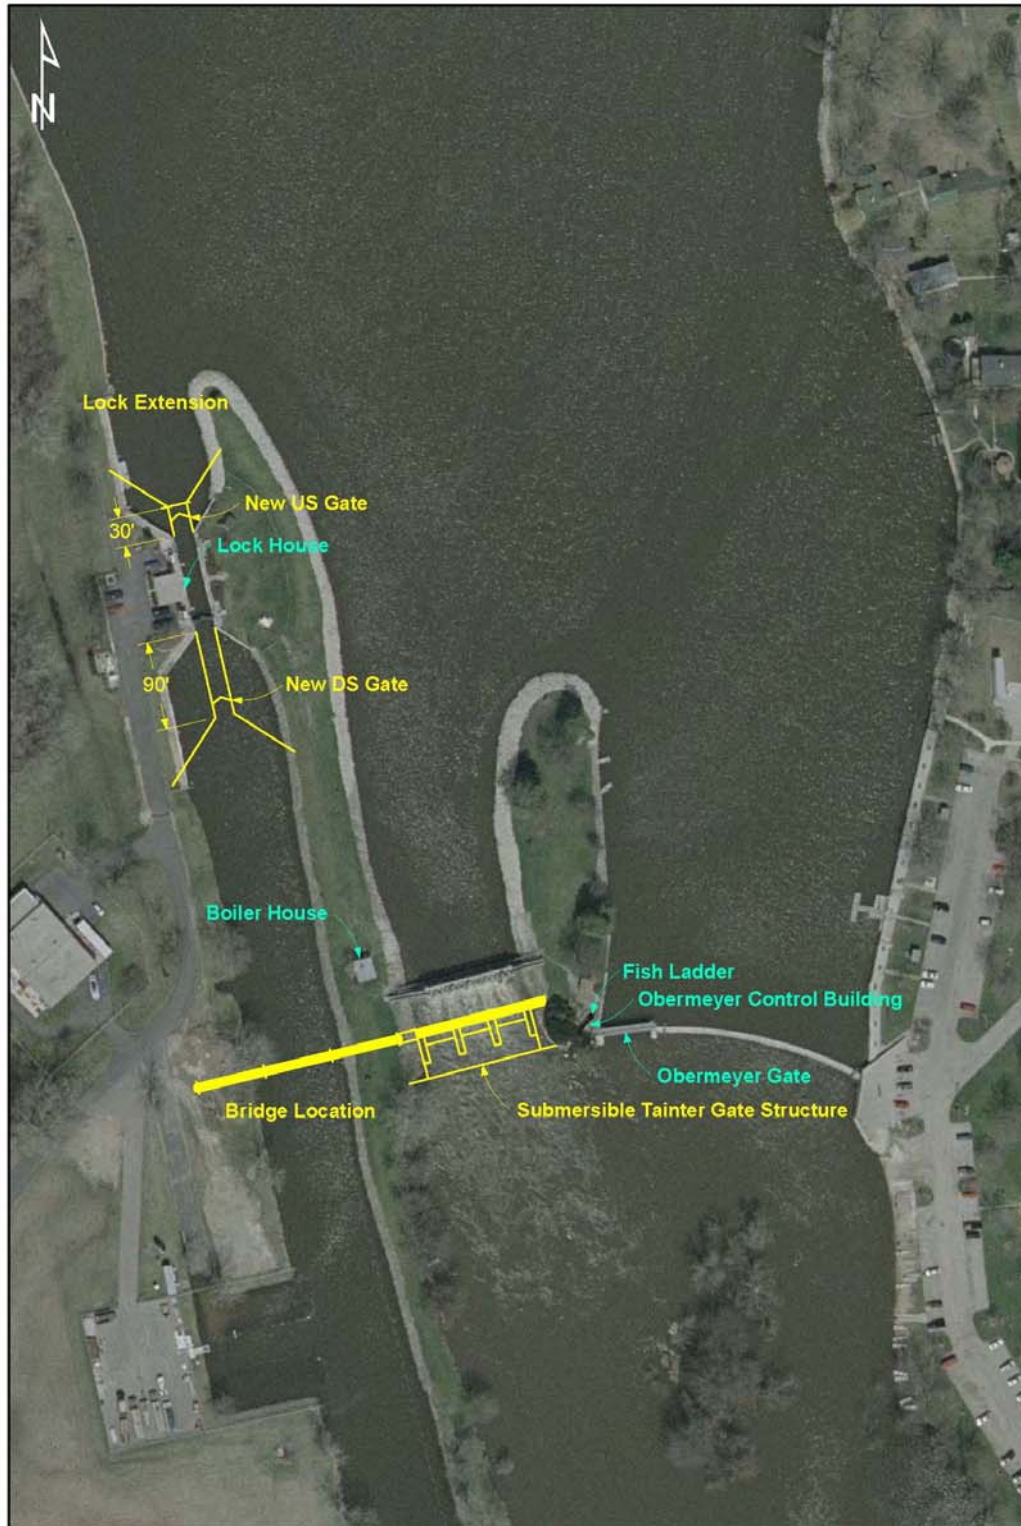
Recommended Reconstructed Facilities

1. The vertical sluice gate structure should be replaced with an equivalent discharge capacity submersible Tainter gate structure.
2. Vehicular access should be provided from the service center on the west side of the river to the submersible Tainter gate structure (and thereby the east side of the lock).
3. The existing lock should be extended in length by 120' to ease navigation congestion at the lock.
4. These facilities should be designed for a life of approximately 50 years.
5. The cost for the implementation of the above project is approximately \$10.8M and the location of the modified, reconstructed, or newly constructed facilities is as shown in yellow on the next page.

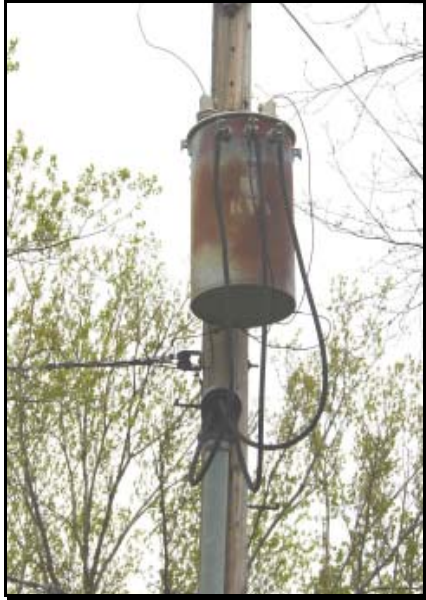
The existing facilities receive power from Commonwealth Edison through a 50 KVA, 120/240-volts single phase, pole-mounted transformer. A 70 KW standby generator provides backup power. An automatic transfer switch selects the power source and directs the power to a 400 Ampere main distribution panel that distributes power to the Lock House, the Service Building, the Boiler House, and Obermeyer Control Building. It is noted that three-phase power is not available in the area.

Power Utility 50 KVA Pole-Mounted Transformer

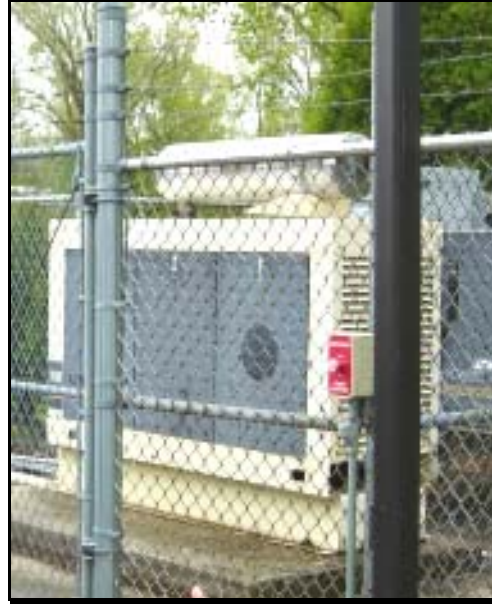
70 KW Standby Generator

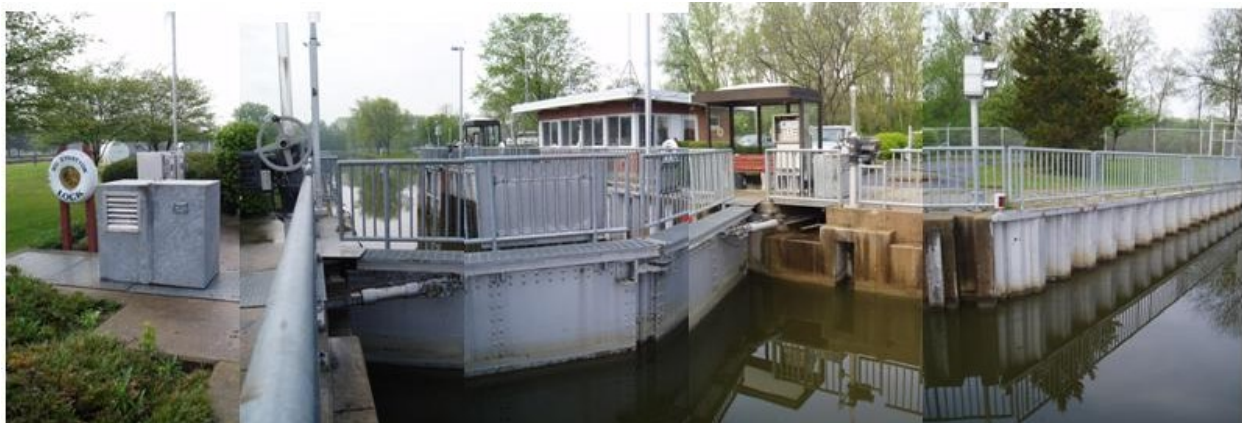
Lock - Upstream Miter Gates

During the site visit, a small leak at the northwest hinge was reported. Typically this can be corrected with a turnbuckle adjustment. In addition, a small hole (approximately 1/2" in size) through the 3/8" steel skin plate of the west leaf of the north (upstream) mitre gate was observed approximately one foot above tailwater level. The vertical sheet piling in the lock has experienced some leakage in the past, which has been corrected by welding the piling seams.

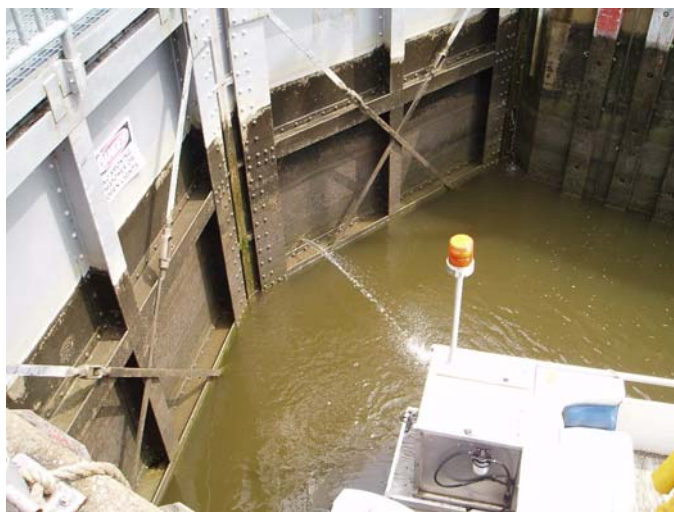
Small hole through the 3/8" steel skin plate

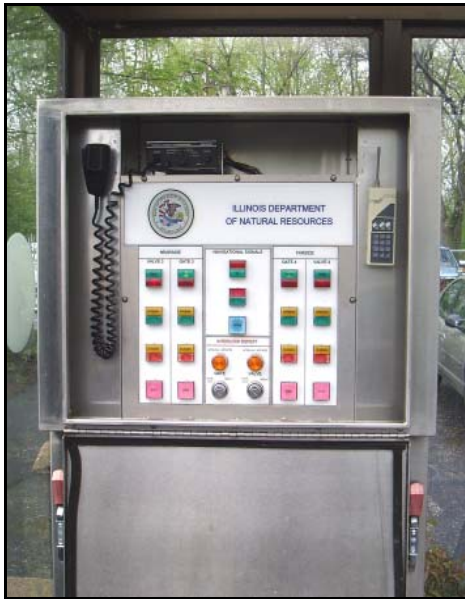
Each mitre gate has two control stations: the nearside control station and the farside control station. Each control station houses reversing contactors for the associated gate and valve, and parallel controls for both the nearside and the farside gates and valves.

Mitre Gate Control Station

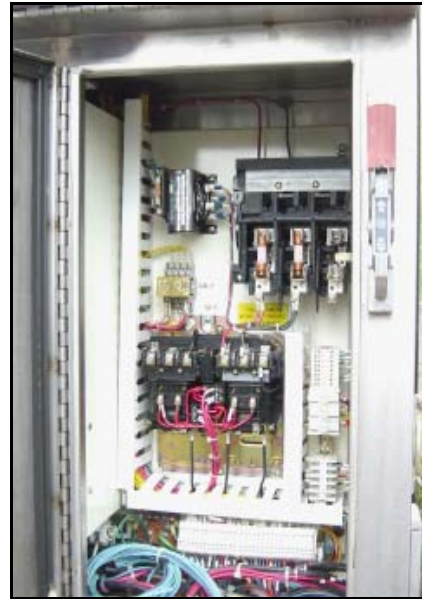
Reversing Contactors below the Mitre Gate Control Station

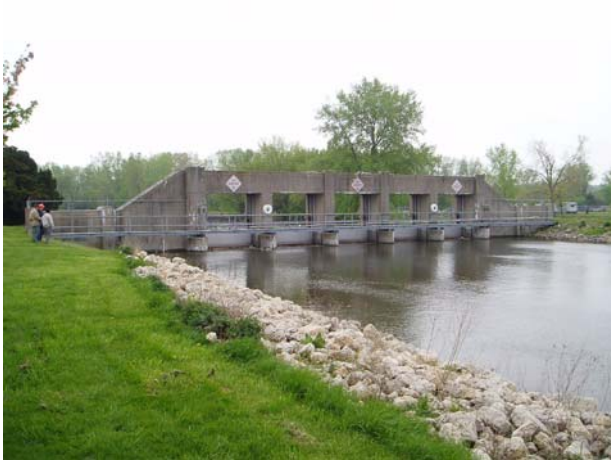
The gate section of this structure has significant concrete deterioration. The tops of the walls along the access steps on both the east and west sides have heavy spalling and loss of concrete. The upper walkway

surface repair topping is heavily cracked and spalled. It was reported that the concrete on the piers has recently been repaired.

Sluice (Wheel) Gate Structure

The vertical sluice (wheel) gate structure and equipment is in severely deteriorated condition. The staff is doing excellent work keeping the facility in operation. A total rehabilitation or replacement is required soon. Rehabilitation, while possible, would leave the DNR with an outdated structure, which is difficult to operate in winter, requiring extensive deicing operations. The rehabilitation option is not recommended, and costs for such have not been estimated.

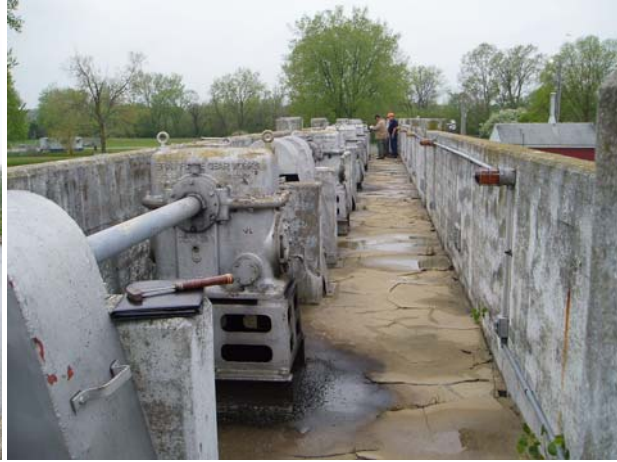
Hoists

The steel gates are heavily corroded with visible steel delamination on the downstream side of the gates. It was reported that during a recent dewatering, the upstream side of the exposed gates were found to be heavily corroded in certain areas.

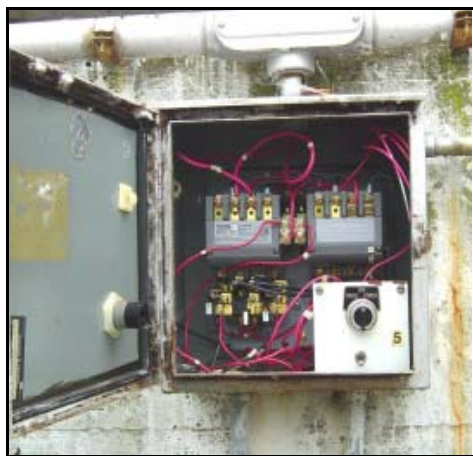
Each gate is driven by a 1 HP single phase motor. A reversing starter with an integral “Raise – Off – Lower” selector switch is installed adjacent to each motor. The starter receives power from a distribution panel in the boiler house. A parallel control station is located at each gate to allow full observation of the gate movement during operation. No other remote control and monitoring are available.

Sluice Gate Reversing Starter adjacent to each Actuator Motor

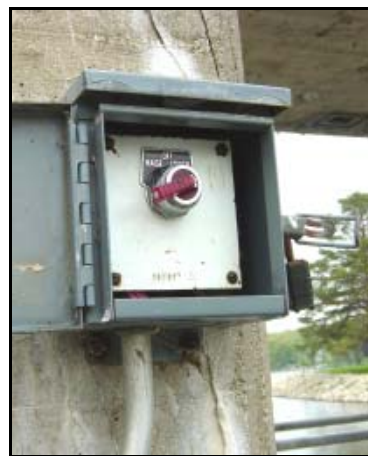
Parallel Control Station at each Gate

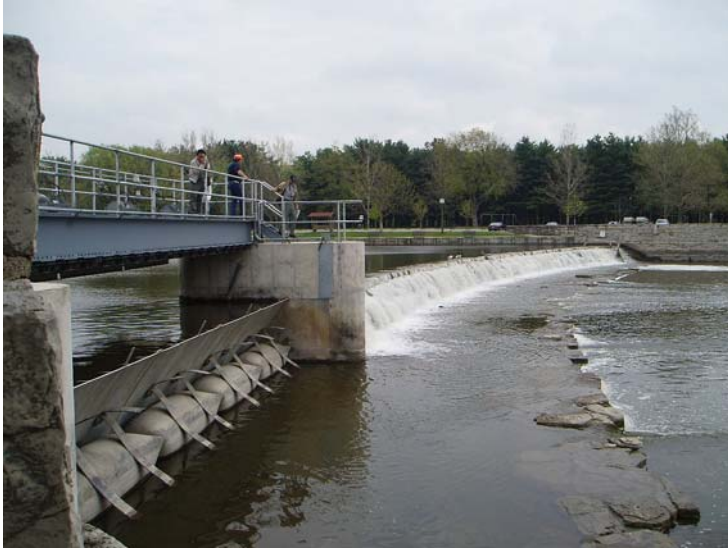
The pneumatically operated hinge leaf gate was commissioned in 2002 and is in good condition. A wire rope actuated bulkhead gate was also provided, which allows emergency shut-off of water in the event of hinge leaf gate failure. Only minor modification of the structure and gate is needed.

Pneumatically Operated Hinge Leaf Gate (Obermeyer)

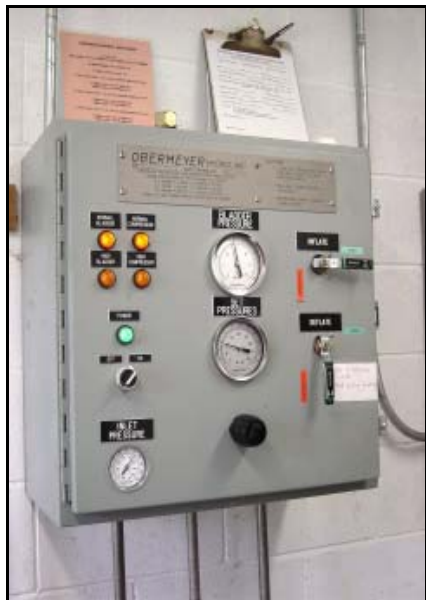
The Obermeyer gate is controlled from a control panel located in the Obermeyer Control Building, by adjusting and maintaining the bladder air pressure. The control panel receives air from a 5 HP air compressor with an 80 gallon storage tank. No other remote control and monitoring are available.

Obermeyer Gate Control Panel in the Obermeyer Control Building

- Automatic remote control and monitoring system
- Remote video monitoring system

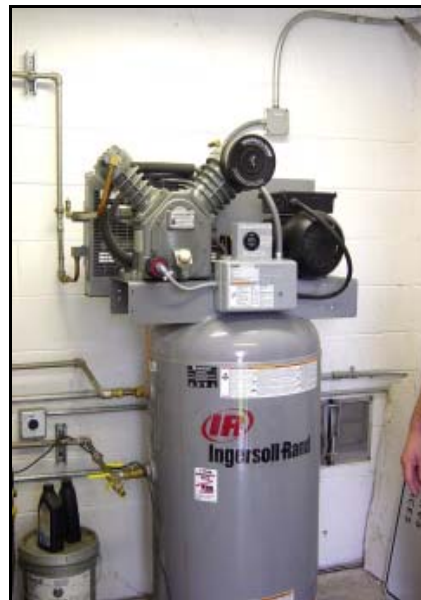
Obermeyer Gate Air Compressor in the Obermeyer Control Building

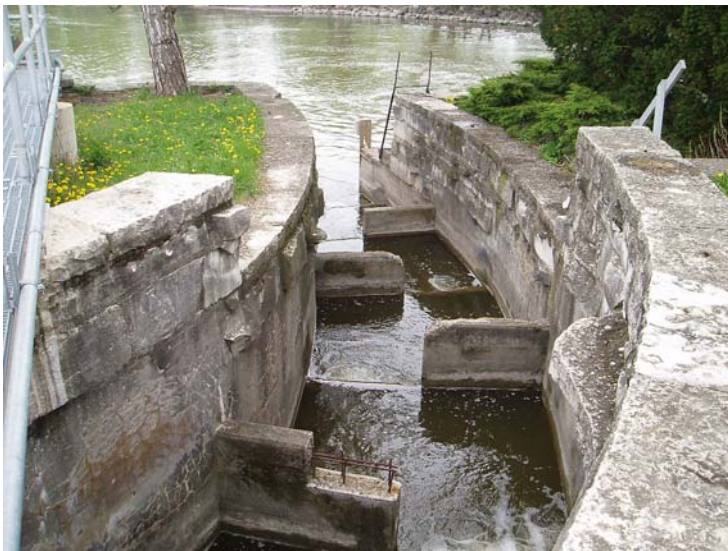
The fish ladder is currently under rehabilitation / modification design to improve its performance. Further improvements beyond implementation of this design are not anticipated at this time.

Existing Fish Ladder

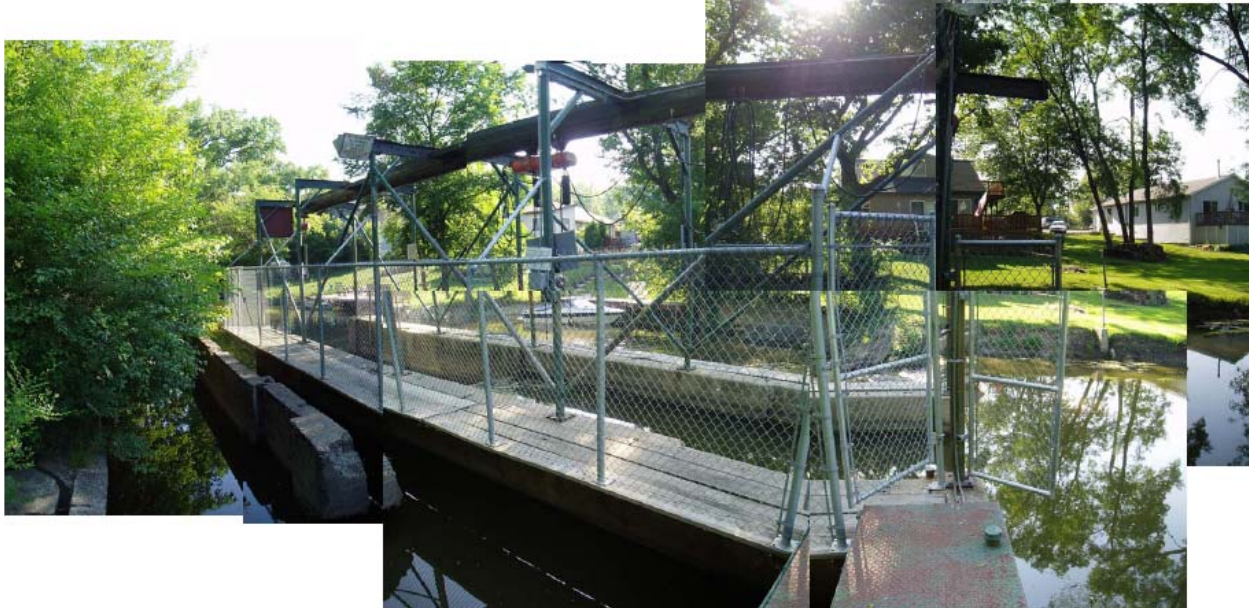
A monorail hoist boat lift is a possibility for small increases in boat passage capacity. A schematic layout is presented in Exhibits 2 and 3. Such a facility would have a capacity of approximately 12 boats per hour. This type of facility is often used as a self serve type operation for private clubs or lake owners associations. The state would probably require the addition of an operator to reduce the risk of injury or damage. An example of a small version of such a facility is shown on the next page and is owned by the Long Lake Property Owners Association, giving them access to Fox Lake.

Monorail Hoist Boat Lift at Long Lake

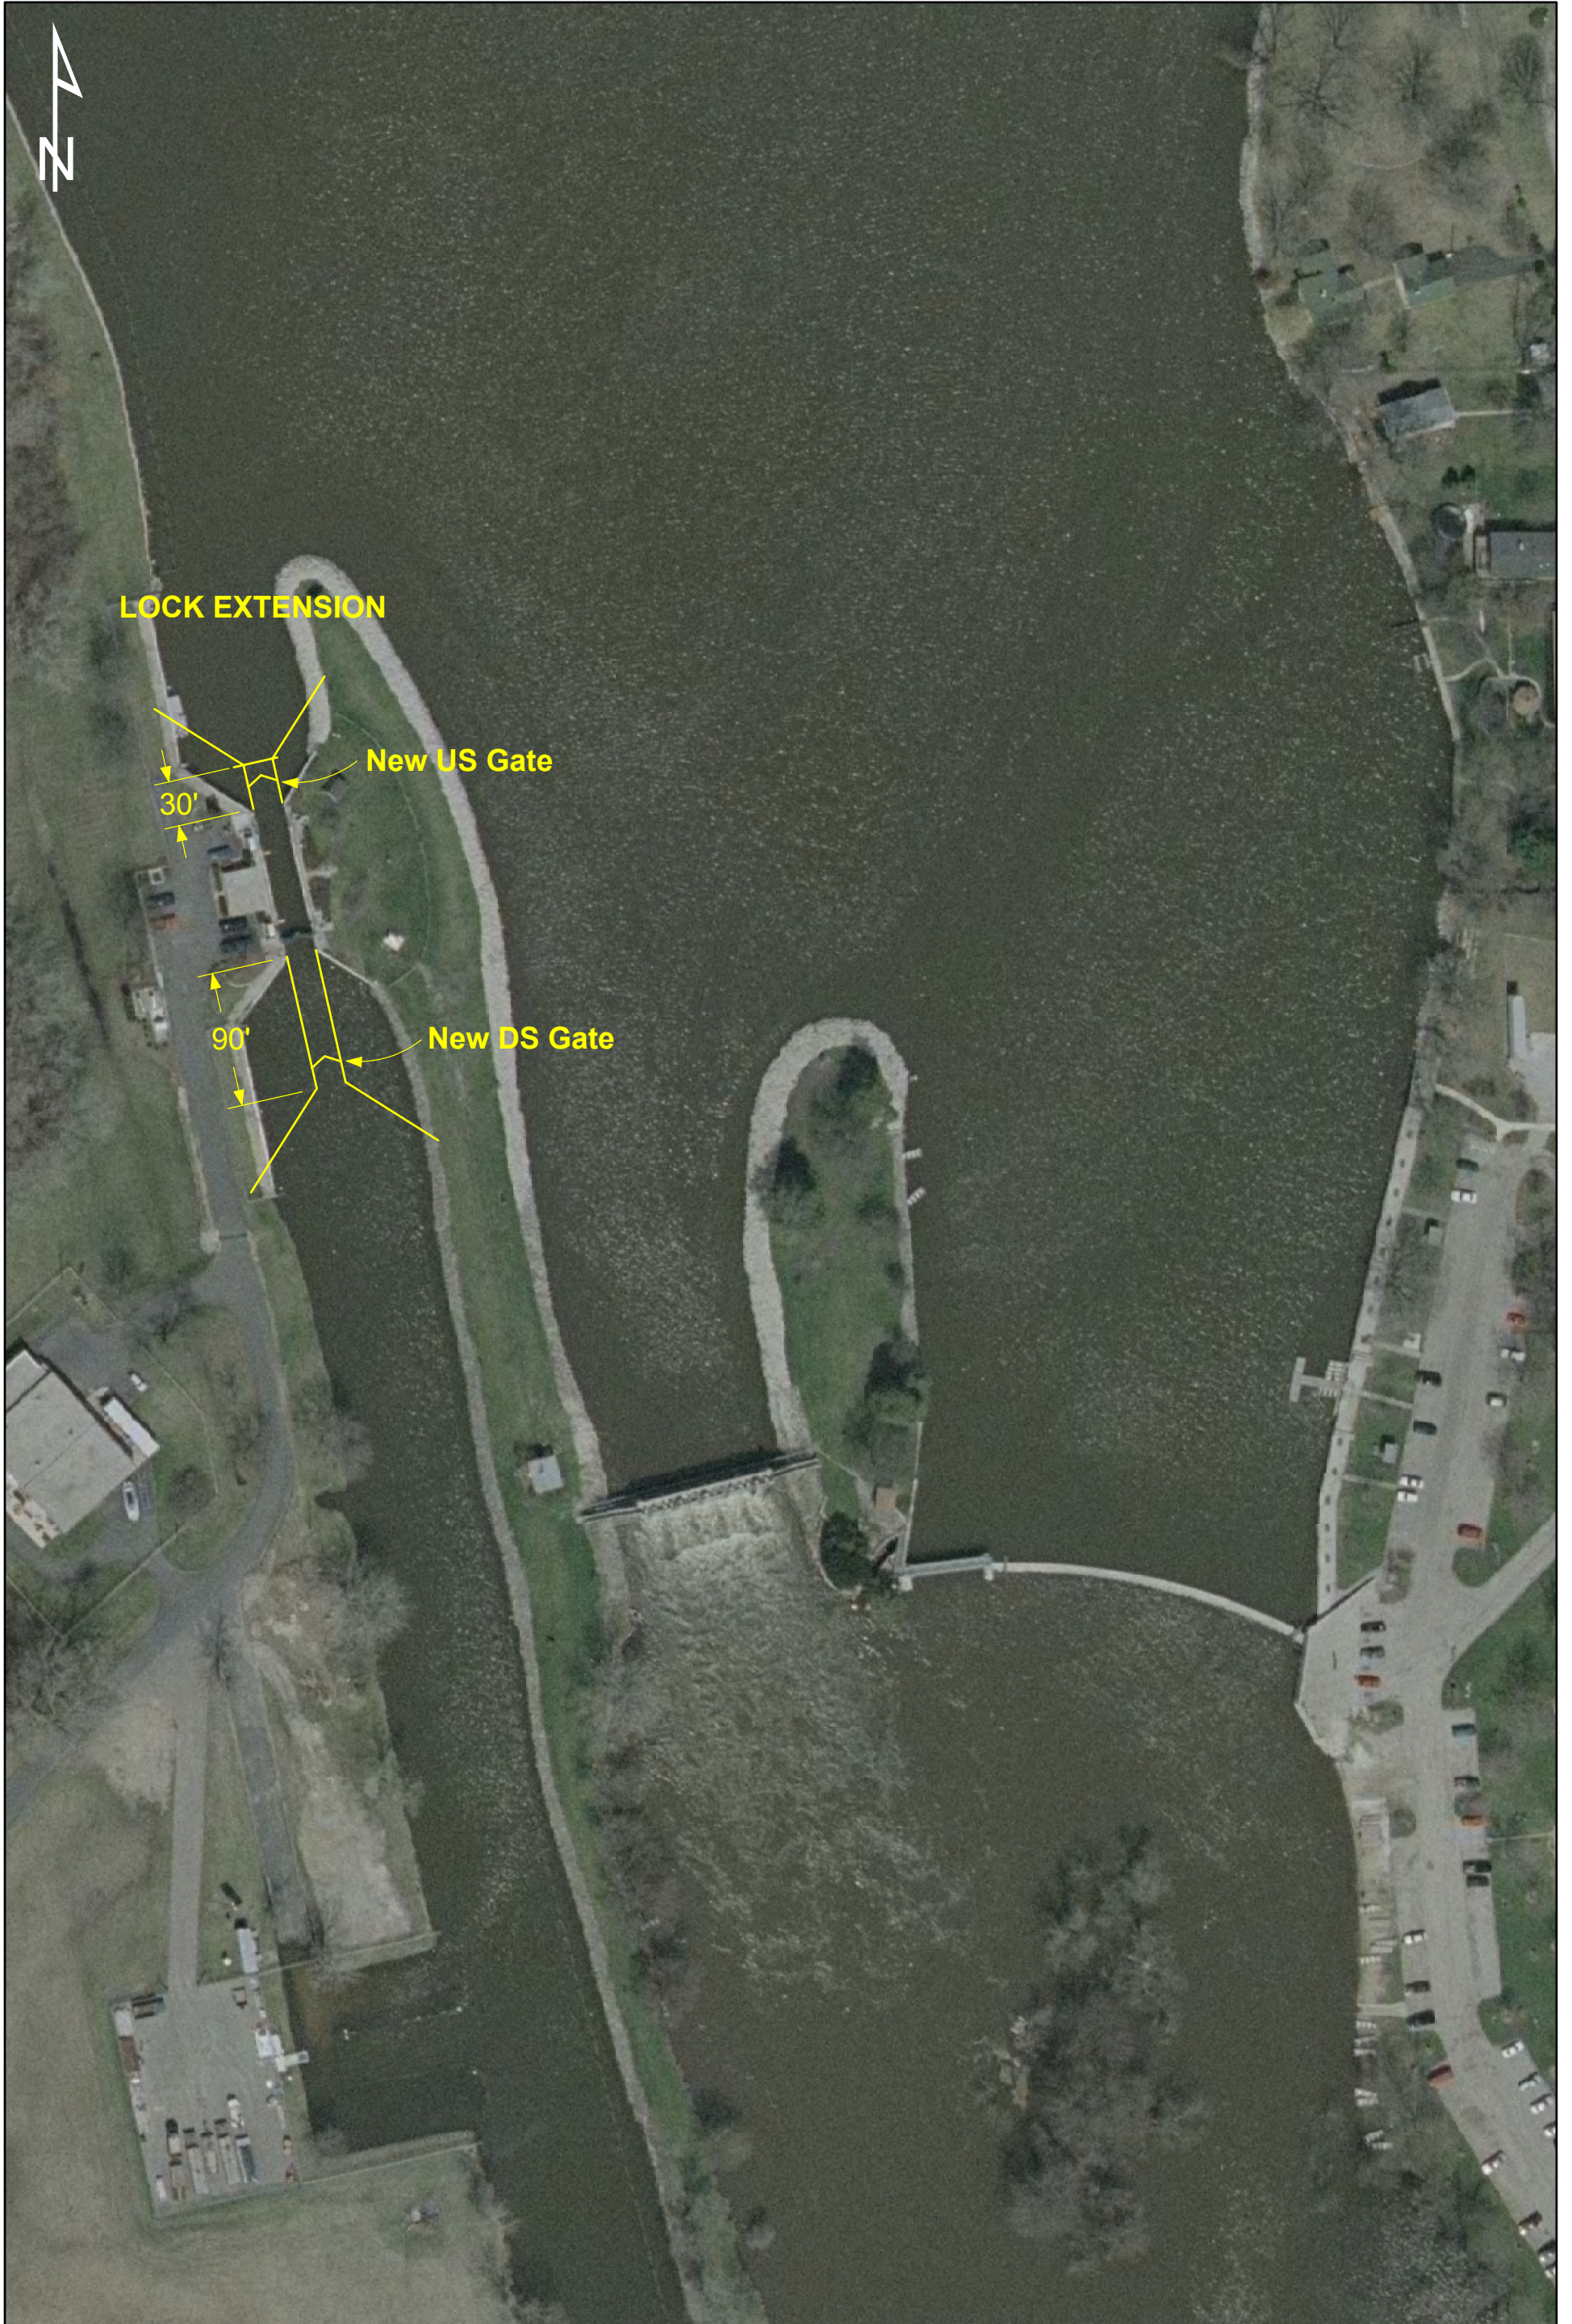
Exhibit #1 - Lock Extension

A preliminary layout of an extended lock was made (see Appendices, Exhibit 1). Consideration was given to a parallel lock of similar configuration and extending the existing lock length by the addition of new miter gates upstream and downstream of the existing gates and connecting walls, similar to the existing tied back sheet pile walls. The lock extension was determined to be more cost effective with respect to life cycle cost (in particular having to operate two locks simultaneously) and an extension length of 120’ selected for capacity reasons. New miter gates may be hydraulically operated as that is the cost effective current technology. The lock gates will be controlled to allow operation in the following combinations depending upon capacity needs:

- New upstream gate and new downstream gate – high capacity, L=180’
- Existing upstream gate and new downstream gate – medium high capacity, L=150’
- New upstream gate and existing downstream gate – medium low capacity, L=90’
- Existing upstream and downstream gates – low (existing) capacity, L=60’

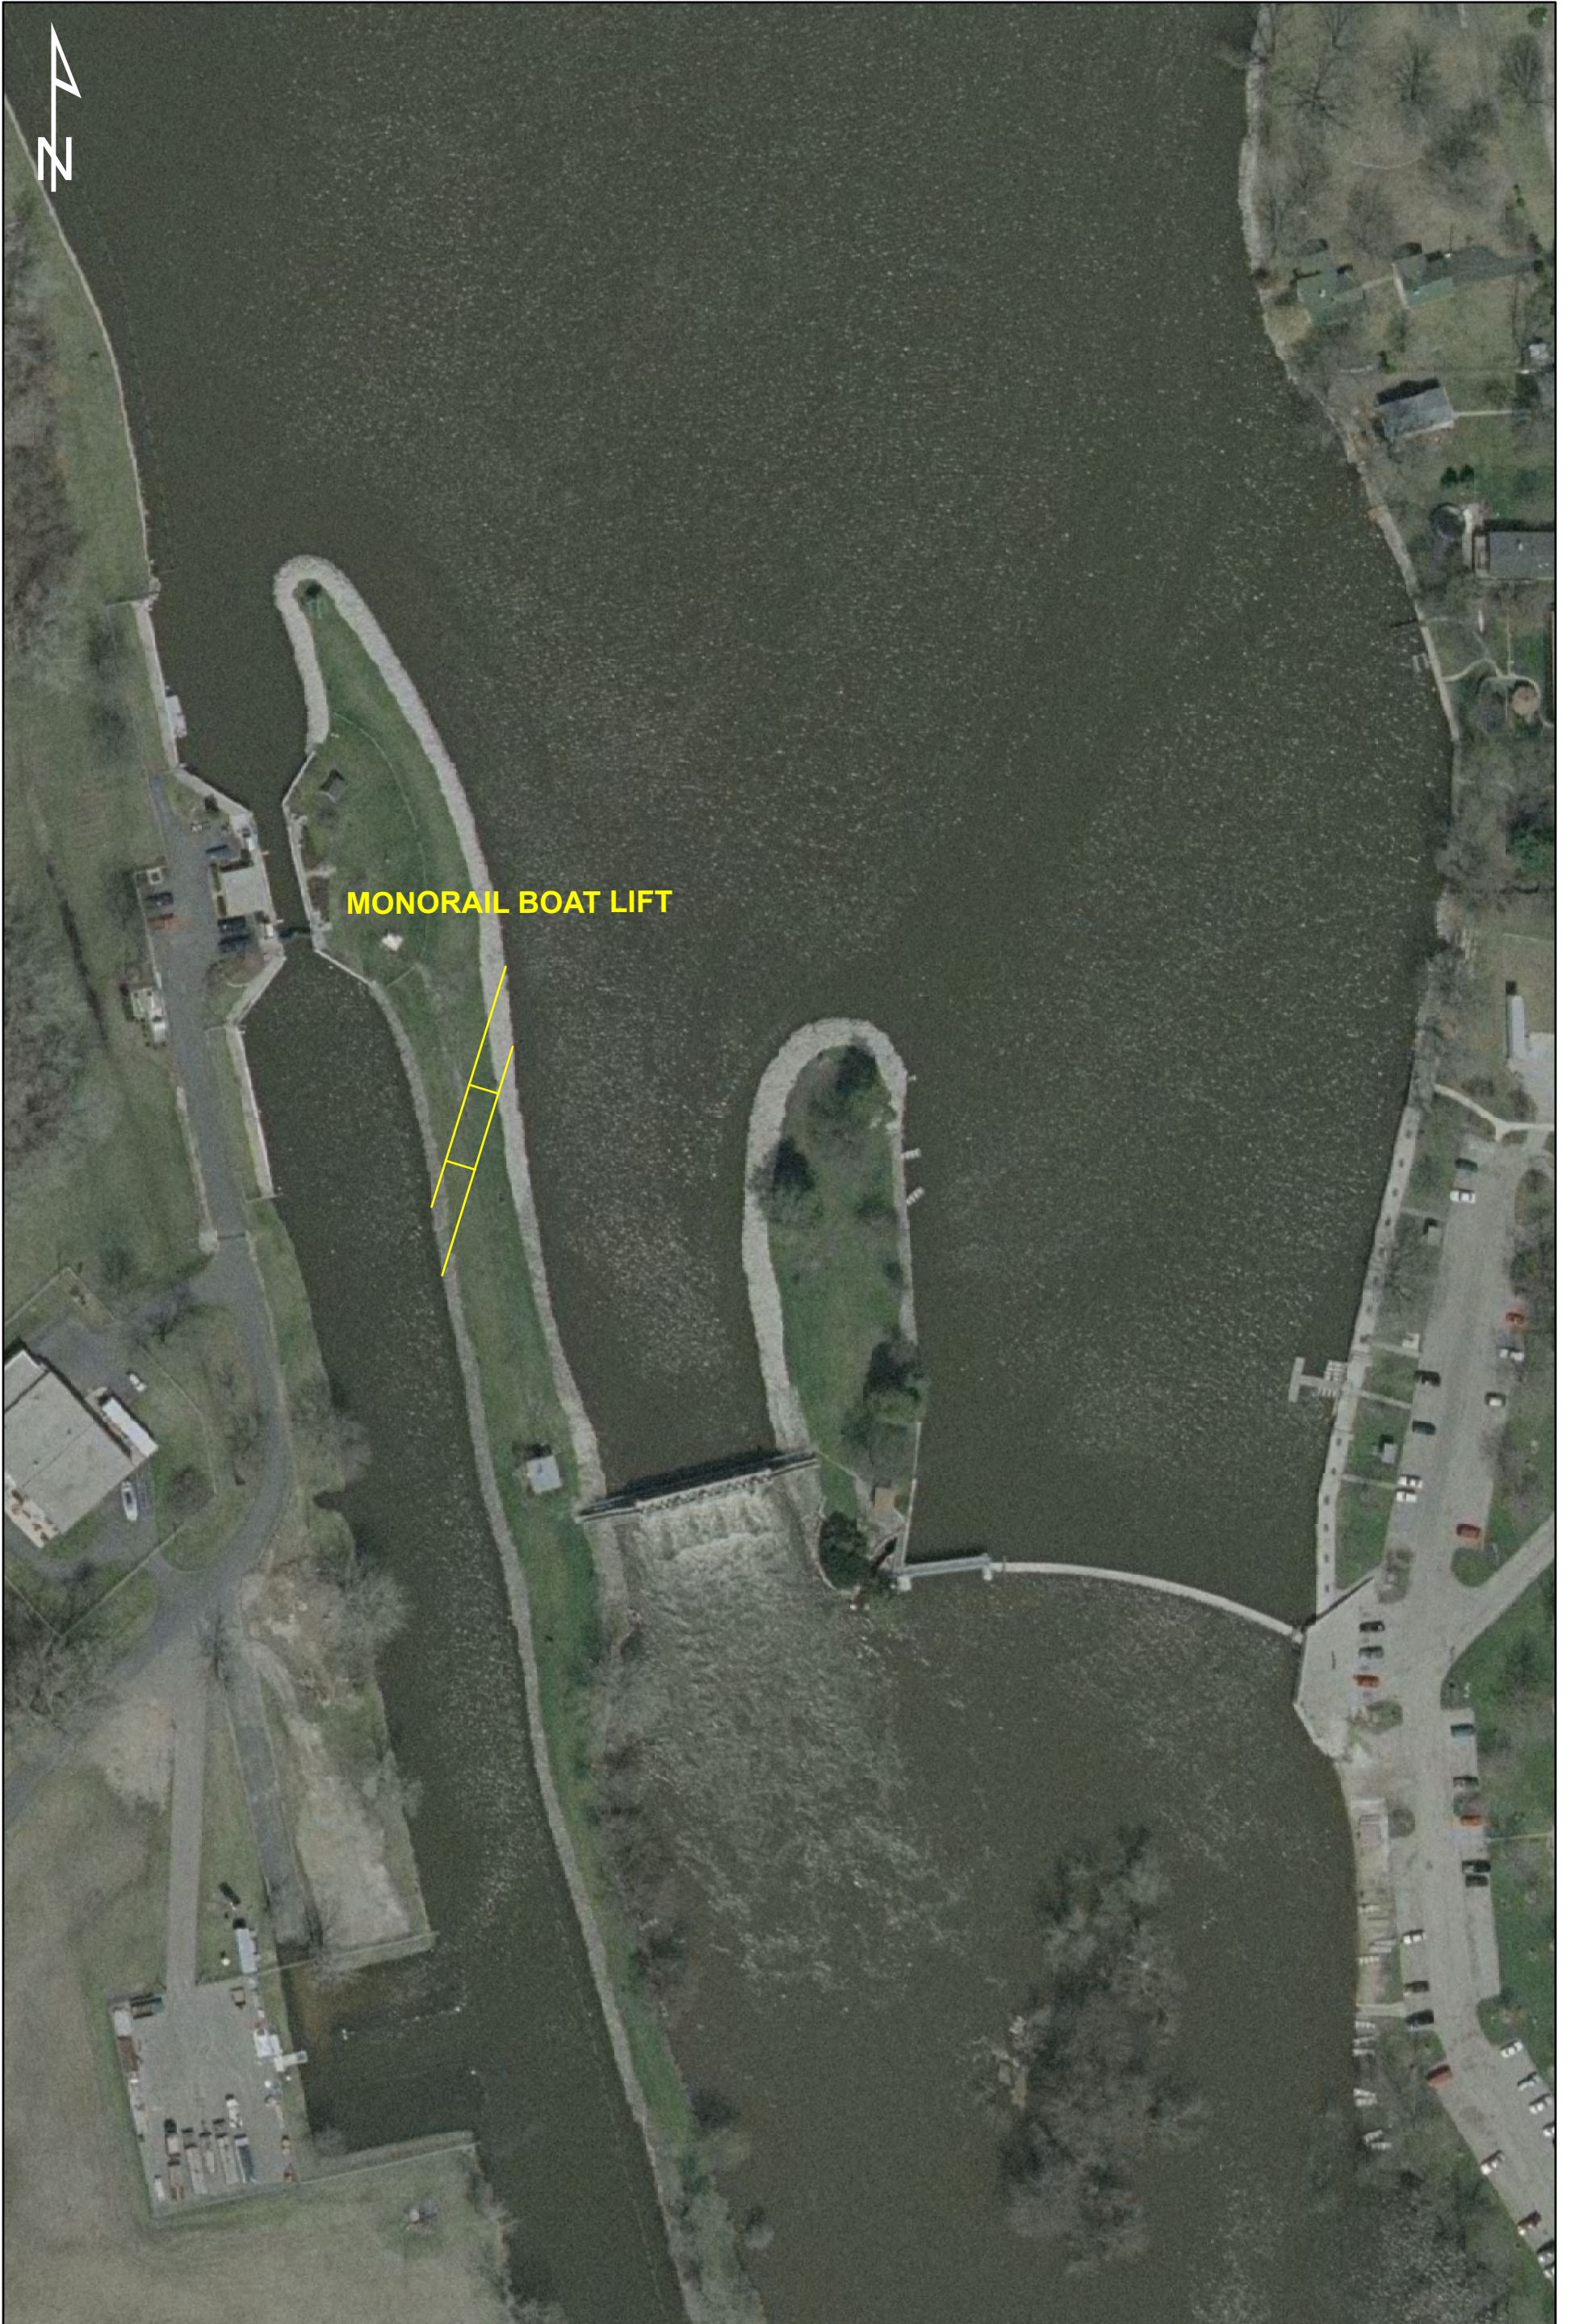
Exhibit #2 - Monorail Hoist

MONORAIL BOAT LIFT

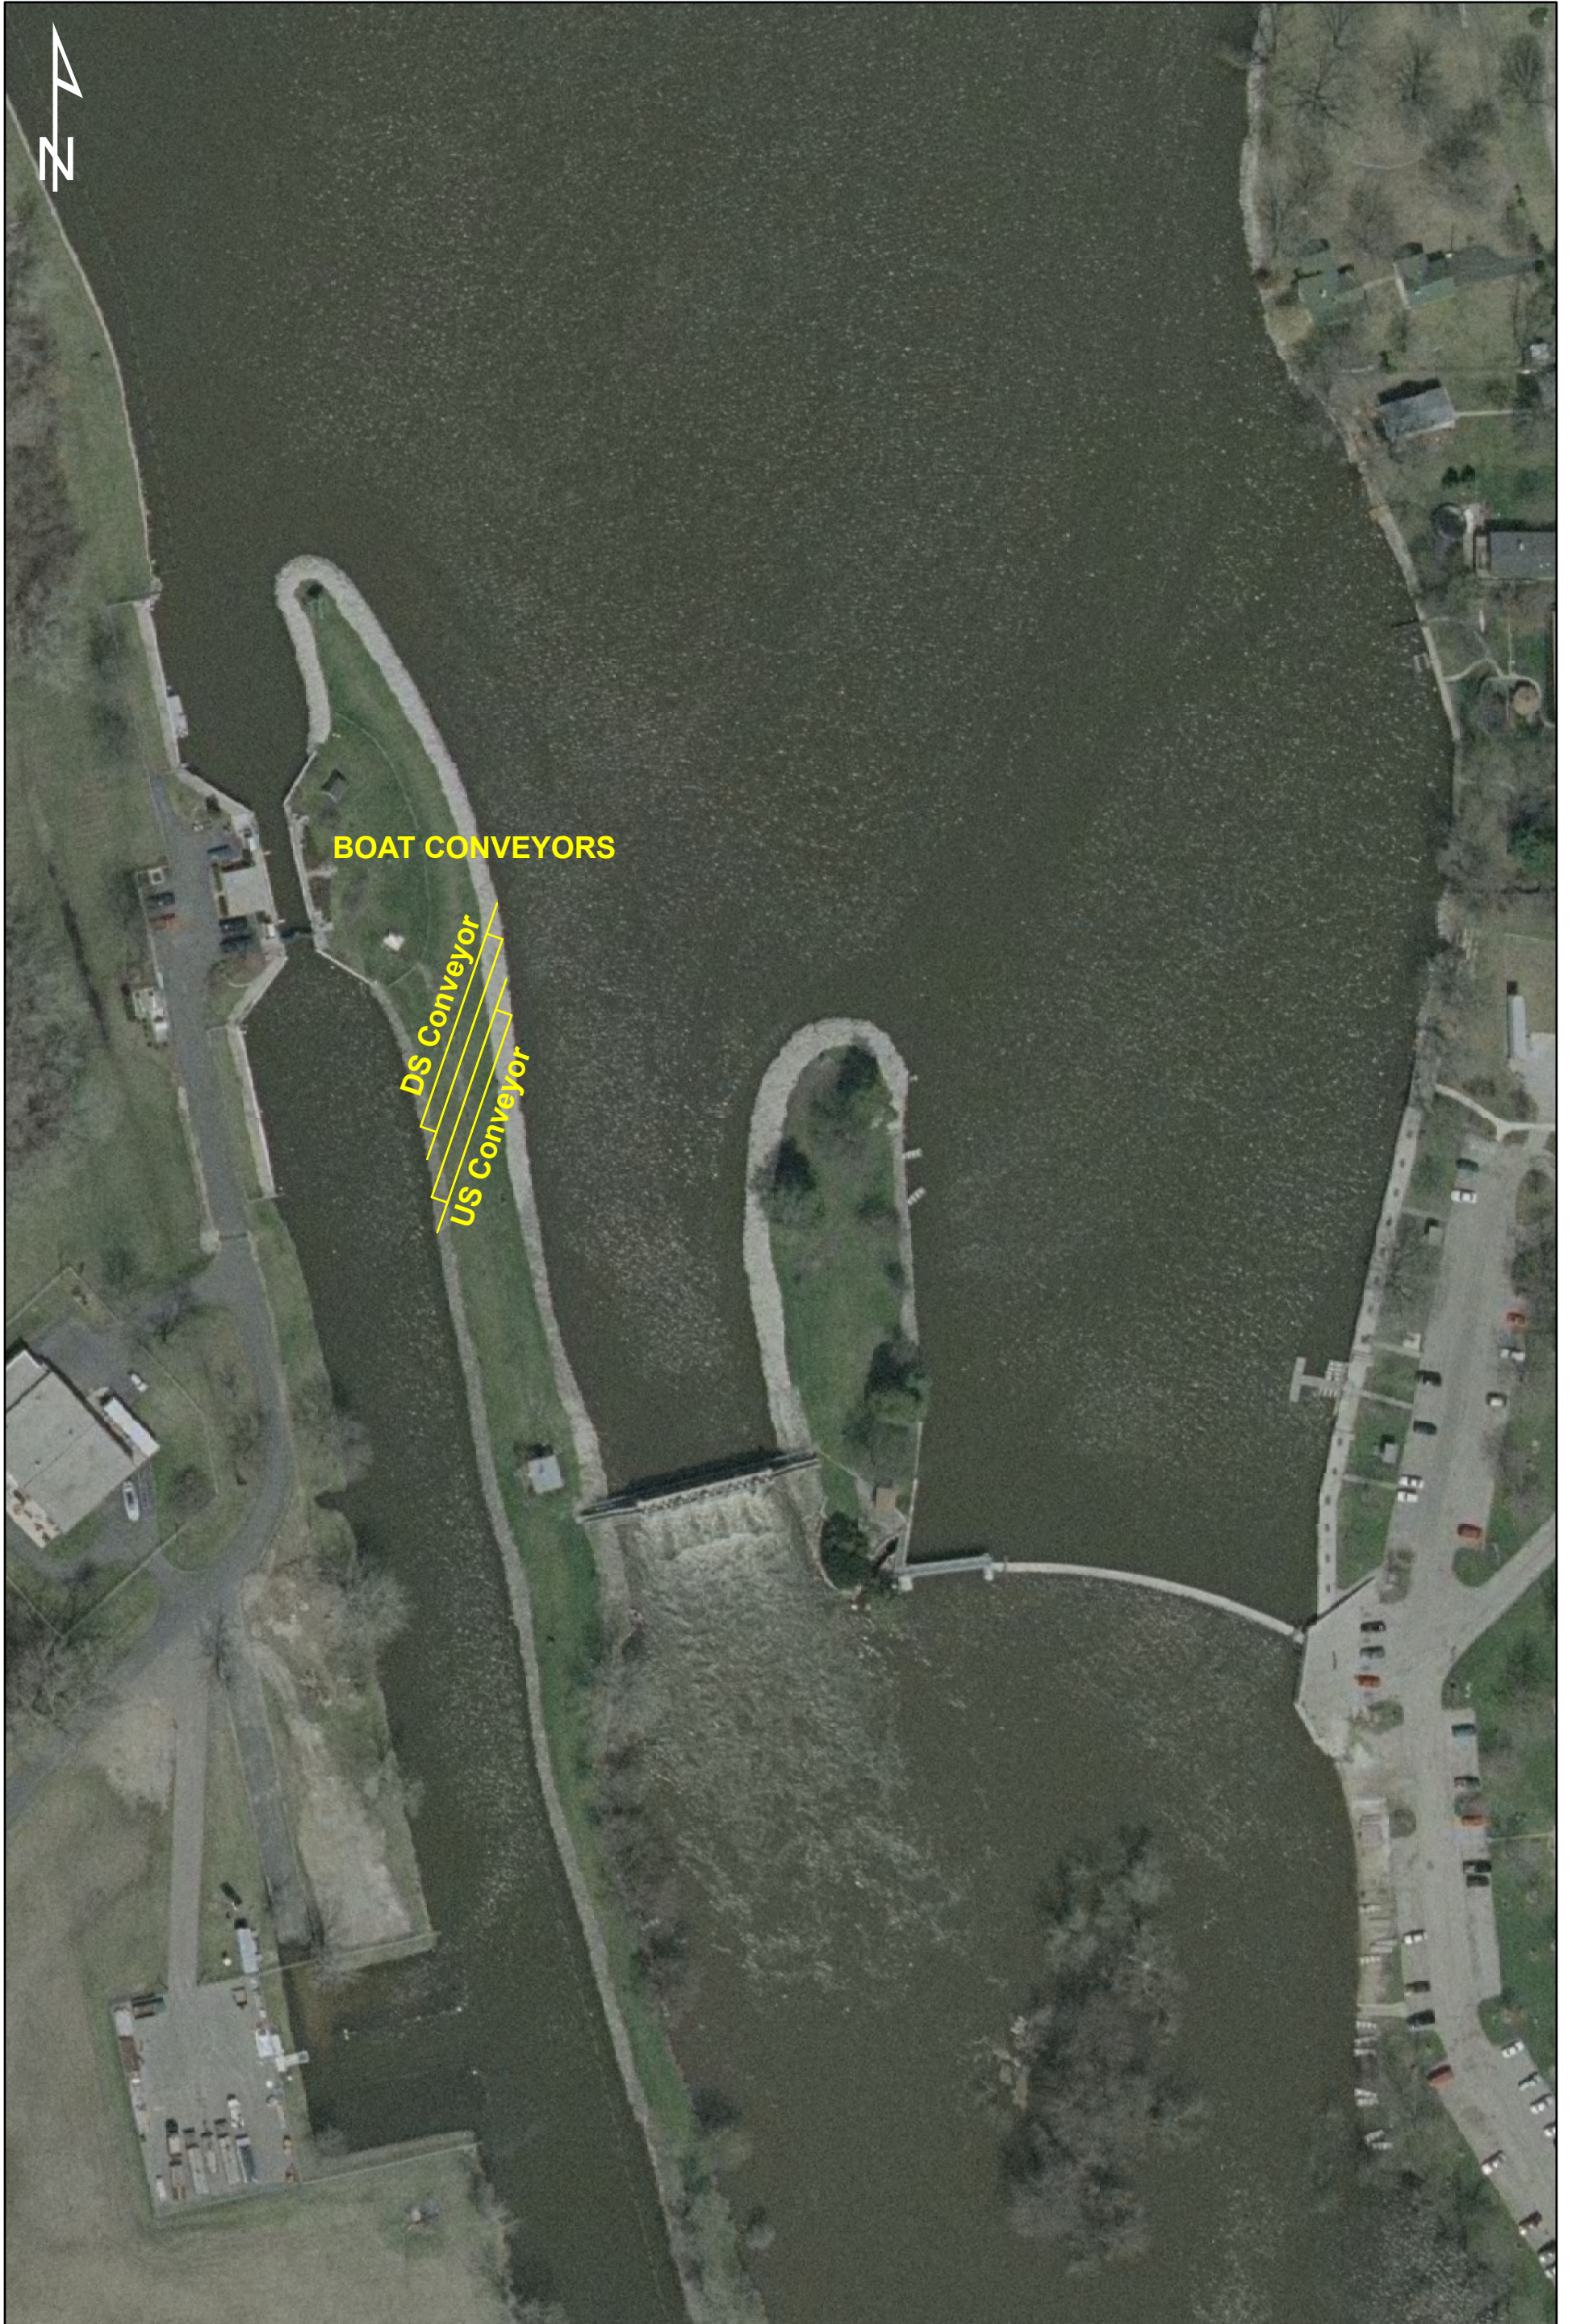
Exhibit #4 - Boat Conveyor

Boat conveyors are used regularly in amusement parks for water rides and are gaining in popularity in open water settings for kayak and canoe recreational facilities. Phone conversations with an experienced manufacturer of boat conveyors indicated conveyor cost for the length and lift range at Stratton of less than \$300,000 (supply and install in owner furnished structures) for a conveyor. Two would be needed, one in each direction. A schematic layout of such a facility is shown in Exhibits 4 and 5. The capacity of such a facility would be approximately 30 boats per hour. Construction materials and methods were assumed to be similar to the lock structure, relying for the most part on tied back sheet pile walls.
