Stratton Lock and Dam Life Extension Reconnaissance Study

Summary Report, Prepared for the Illinois Department of Natural Resources,
Office of Water Resources - June 2005

Prepared by HNTB Corporation
111 North Canal Street
Chicago, Illinois 60606

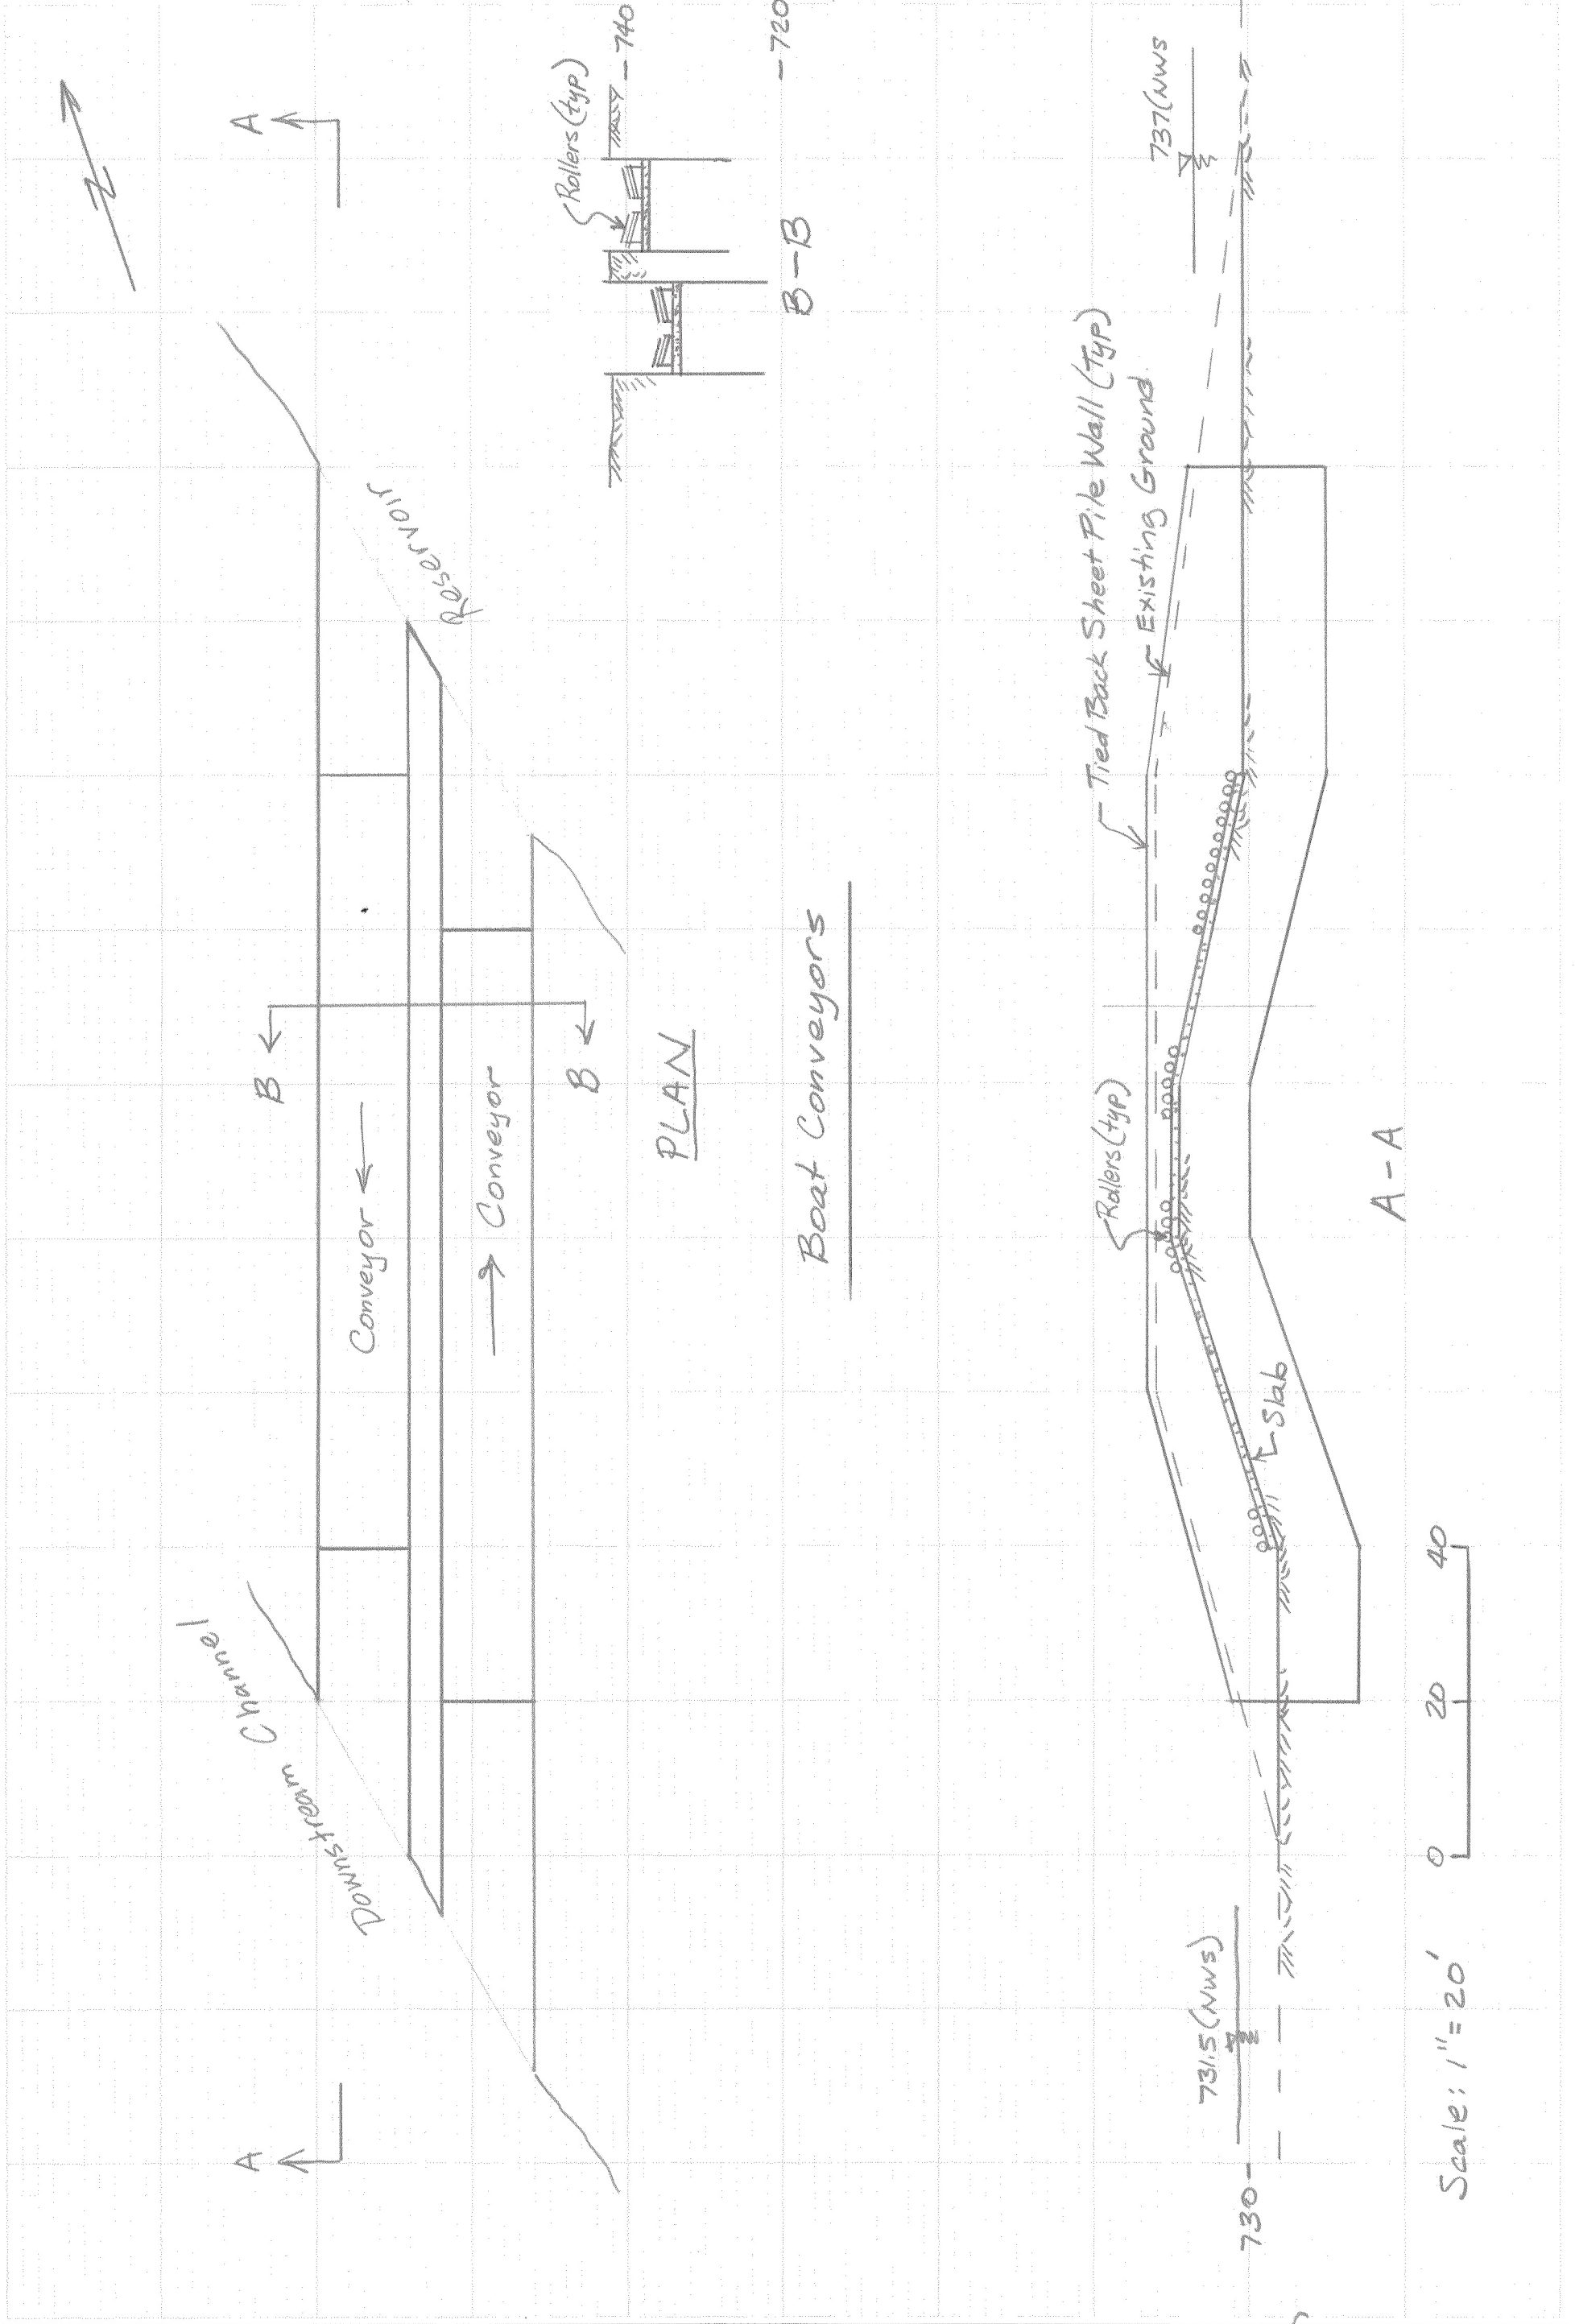
Exhibit #5 - Boat Conveyor Plan & Section

Disadvantages of this type of facility are primarily concerned with the different geometry of boats and power plants. The conveyor shown could only be used by single engine craft without out board instruments, such as velocity meters and depth sounders or sonar, unless these instruments are protected. Also, staff monitoring of such a facility may be required to provide emergency help or shut-off.

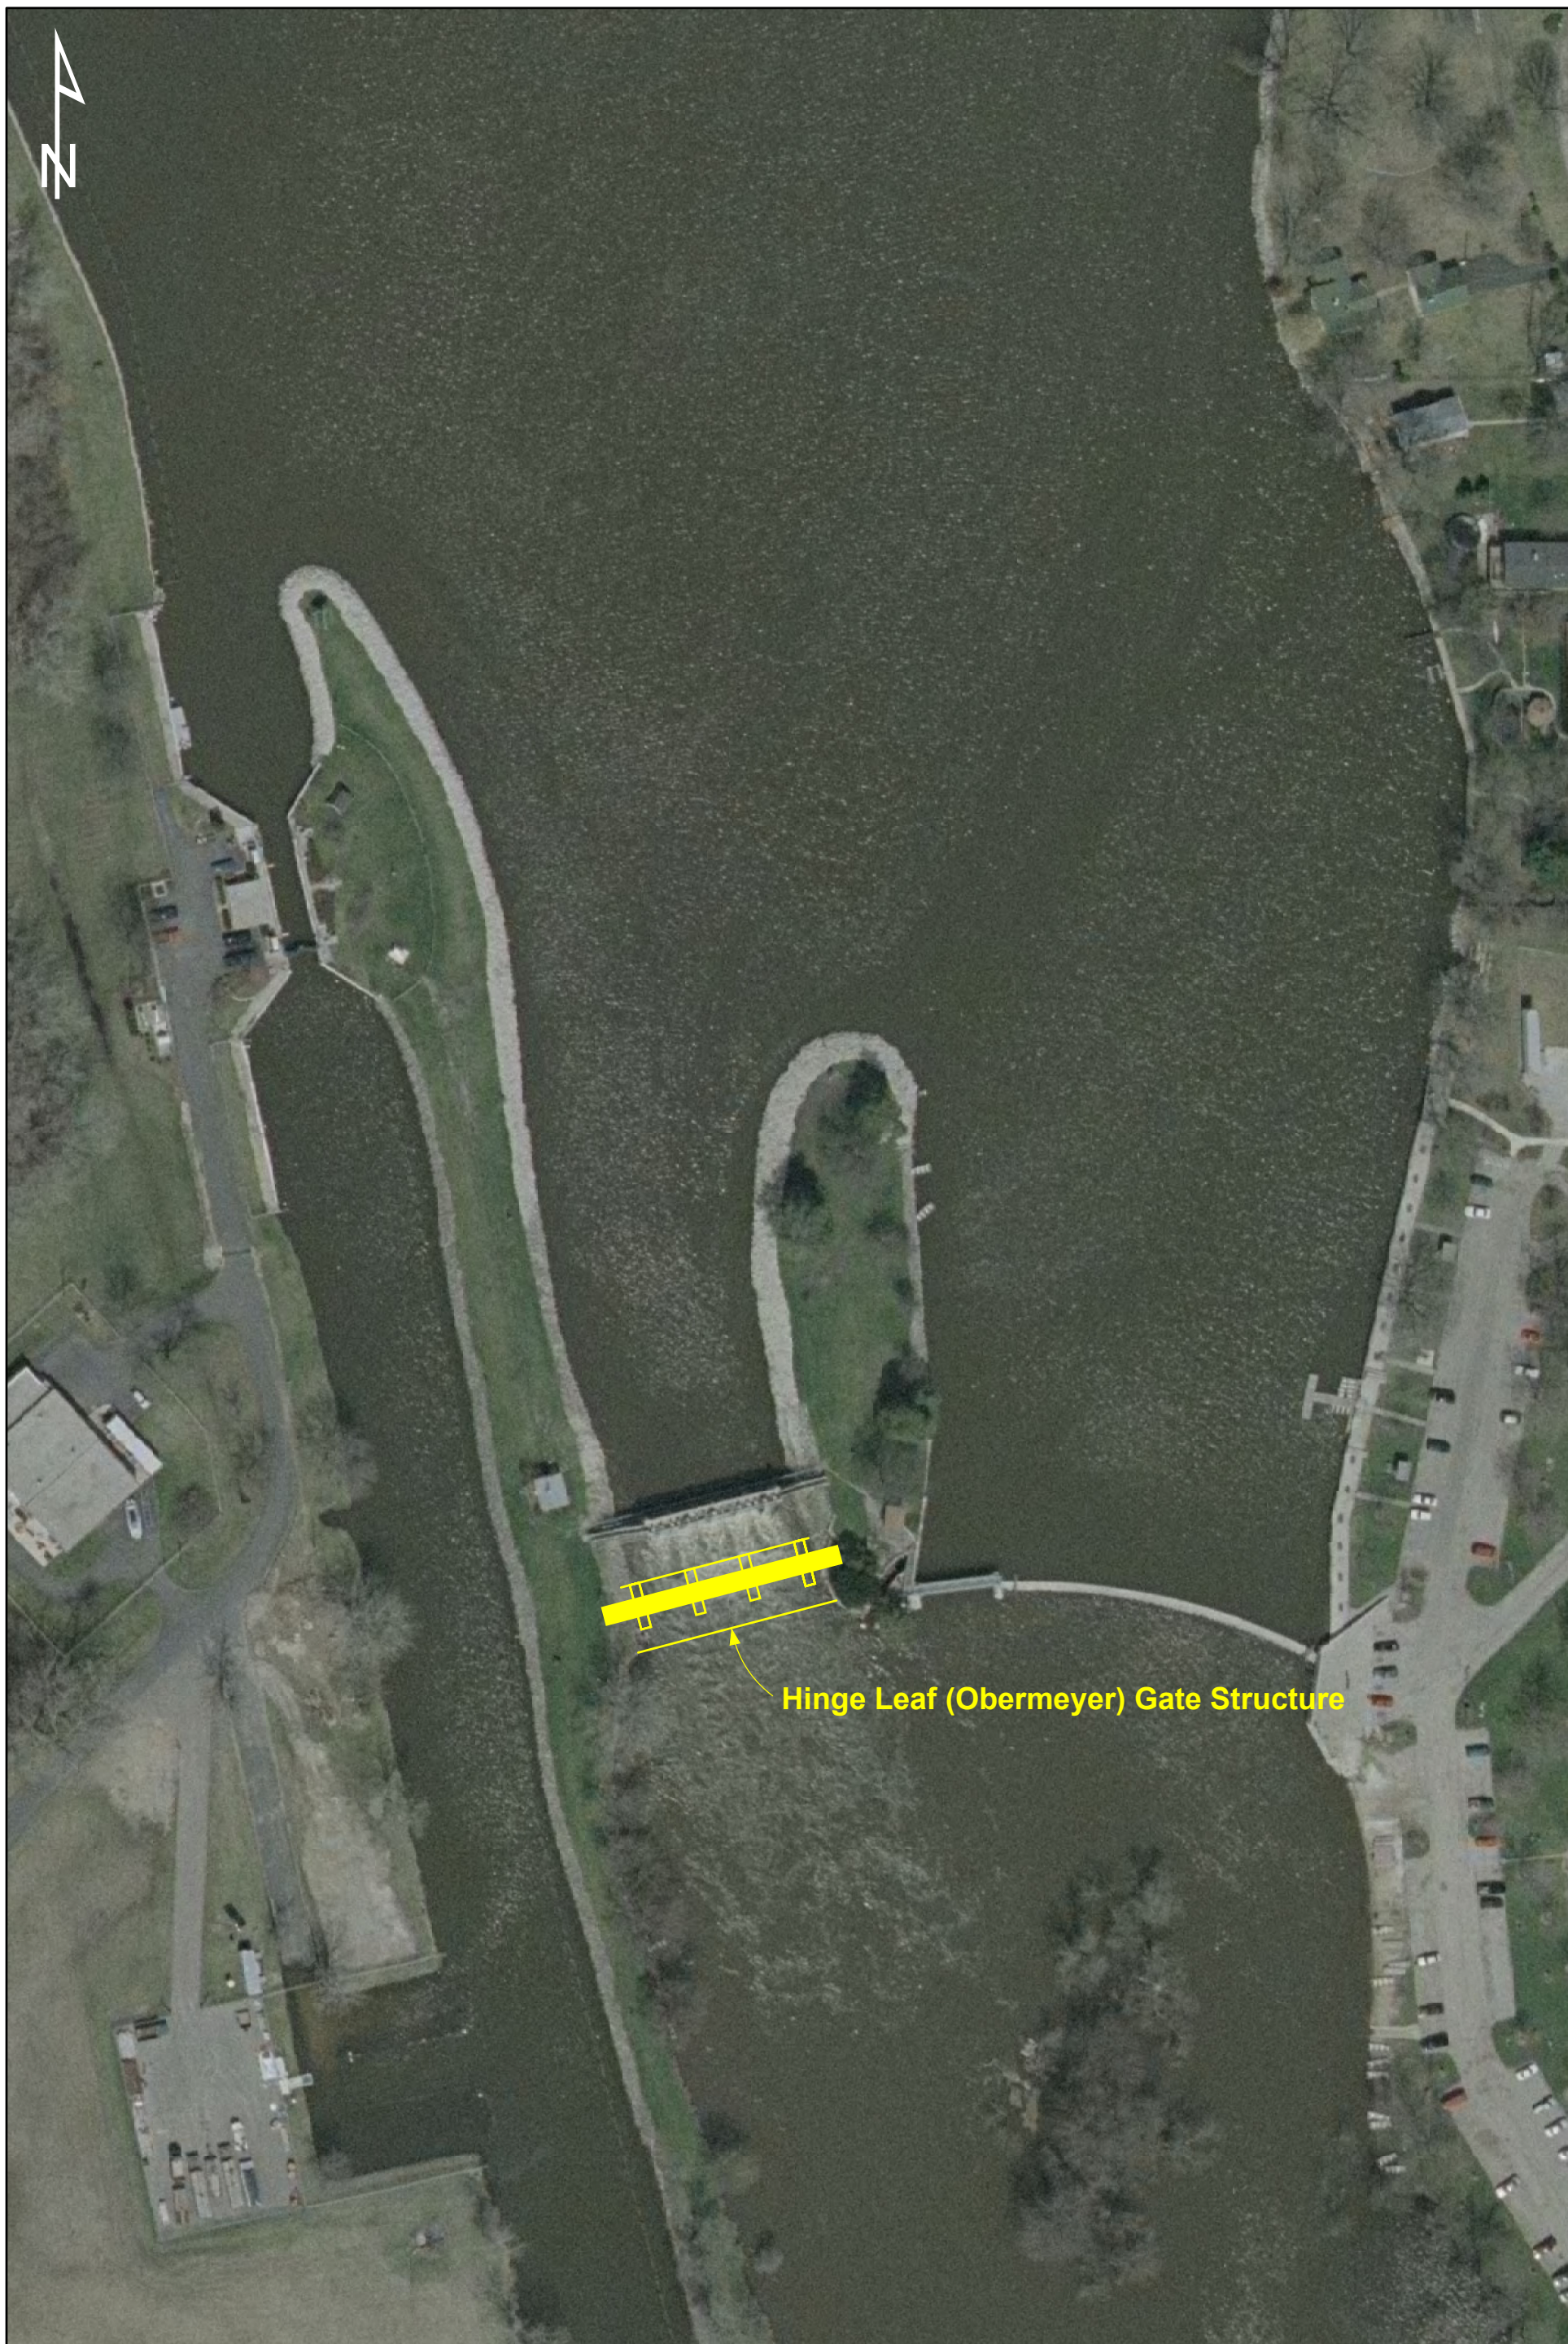
Exhibit #6 - Hinge Leaf (Obermeyer) Gate

The replacement of the sluice gate structure with a pneumatically operated hinge leaf gate would provide a gate easily operable in winter, similar to others in the DNR inventory. A conceptual layout is shown in Exhibits 6 and 7. An access bridge over the gates is provided for maintenance. Gate pier and abutment seal plates would be heated with immersion heaters in glycol filled embedded pipe or channels. The gate skin plate would be kept ice free by the continuous flow of water.

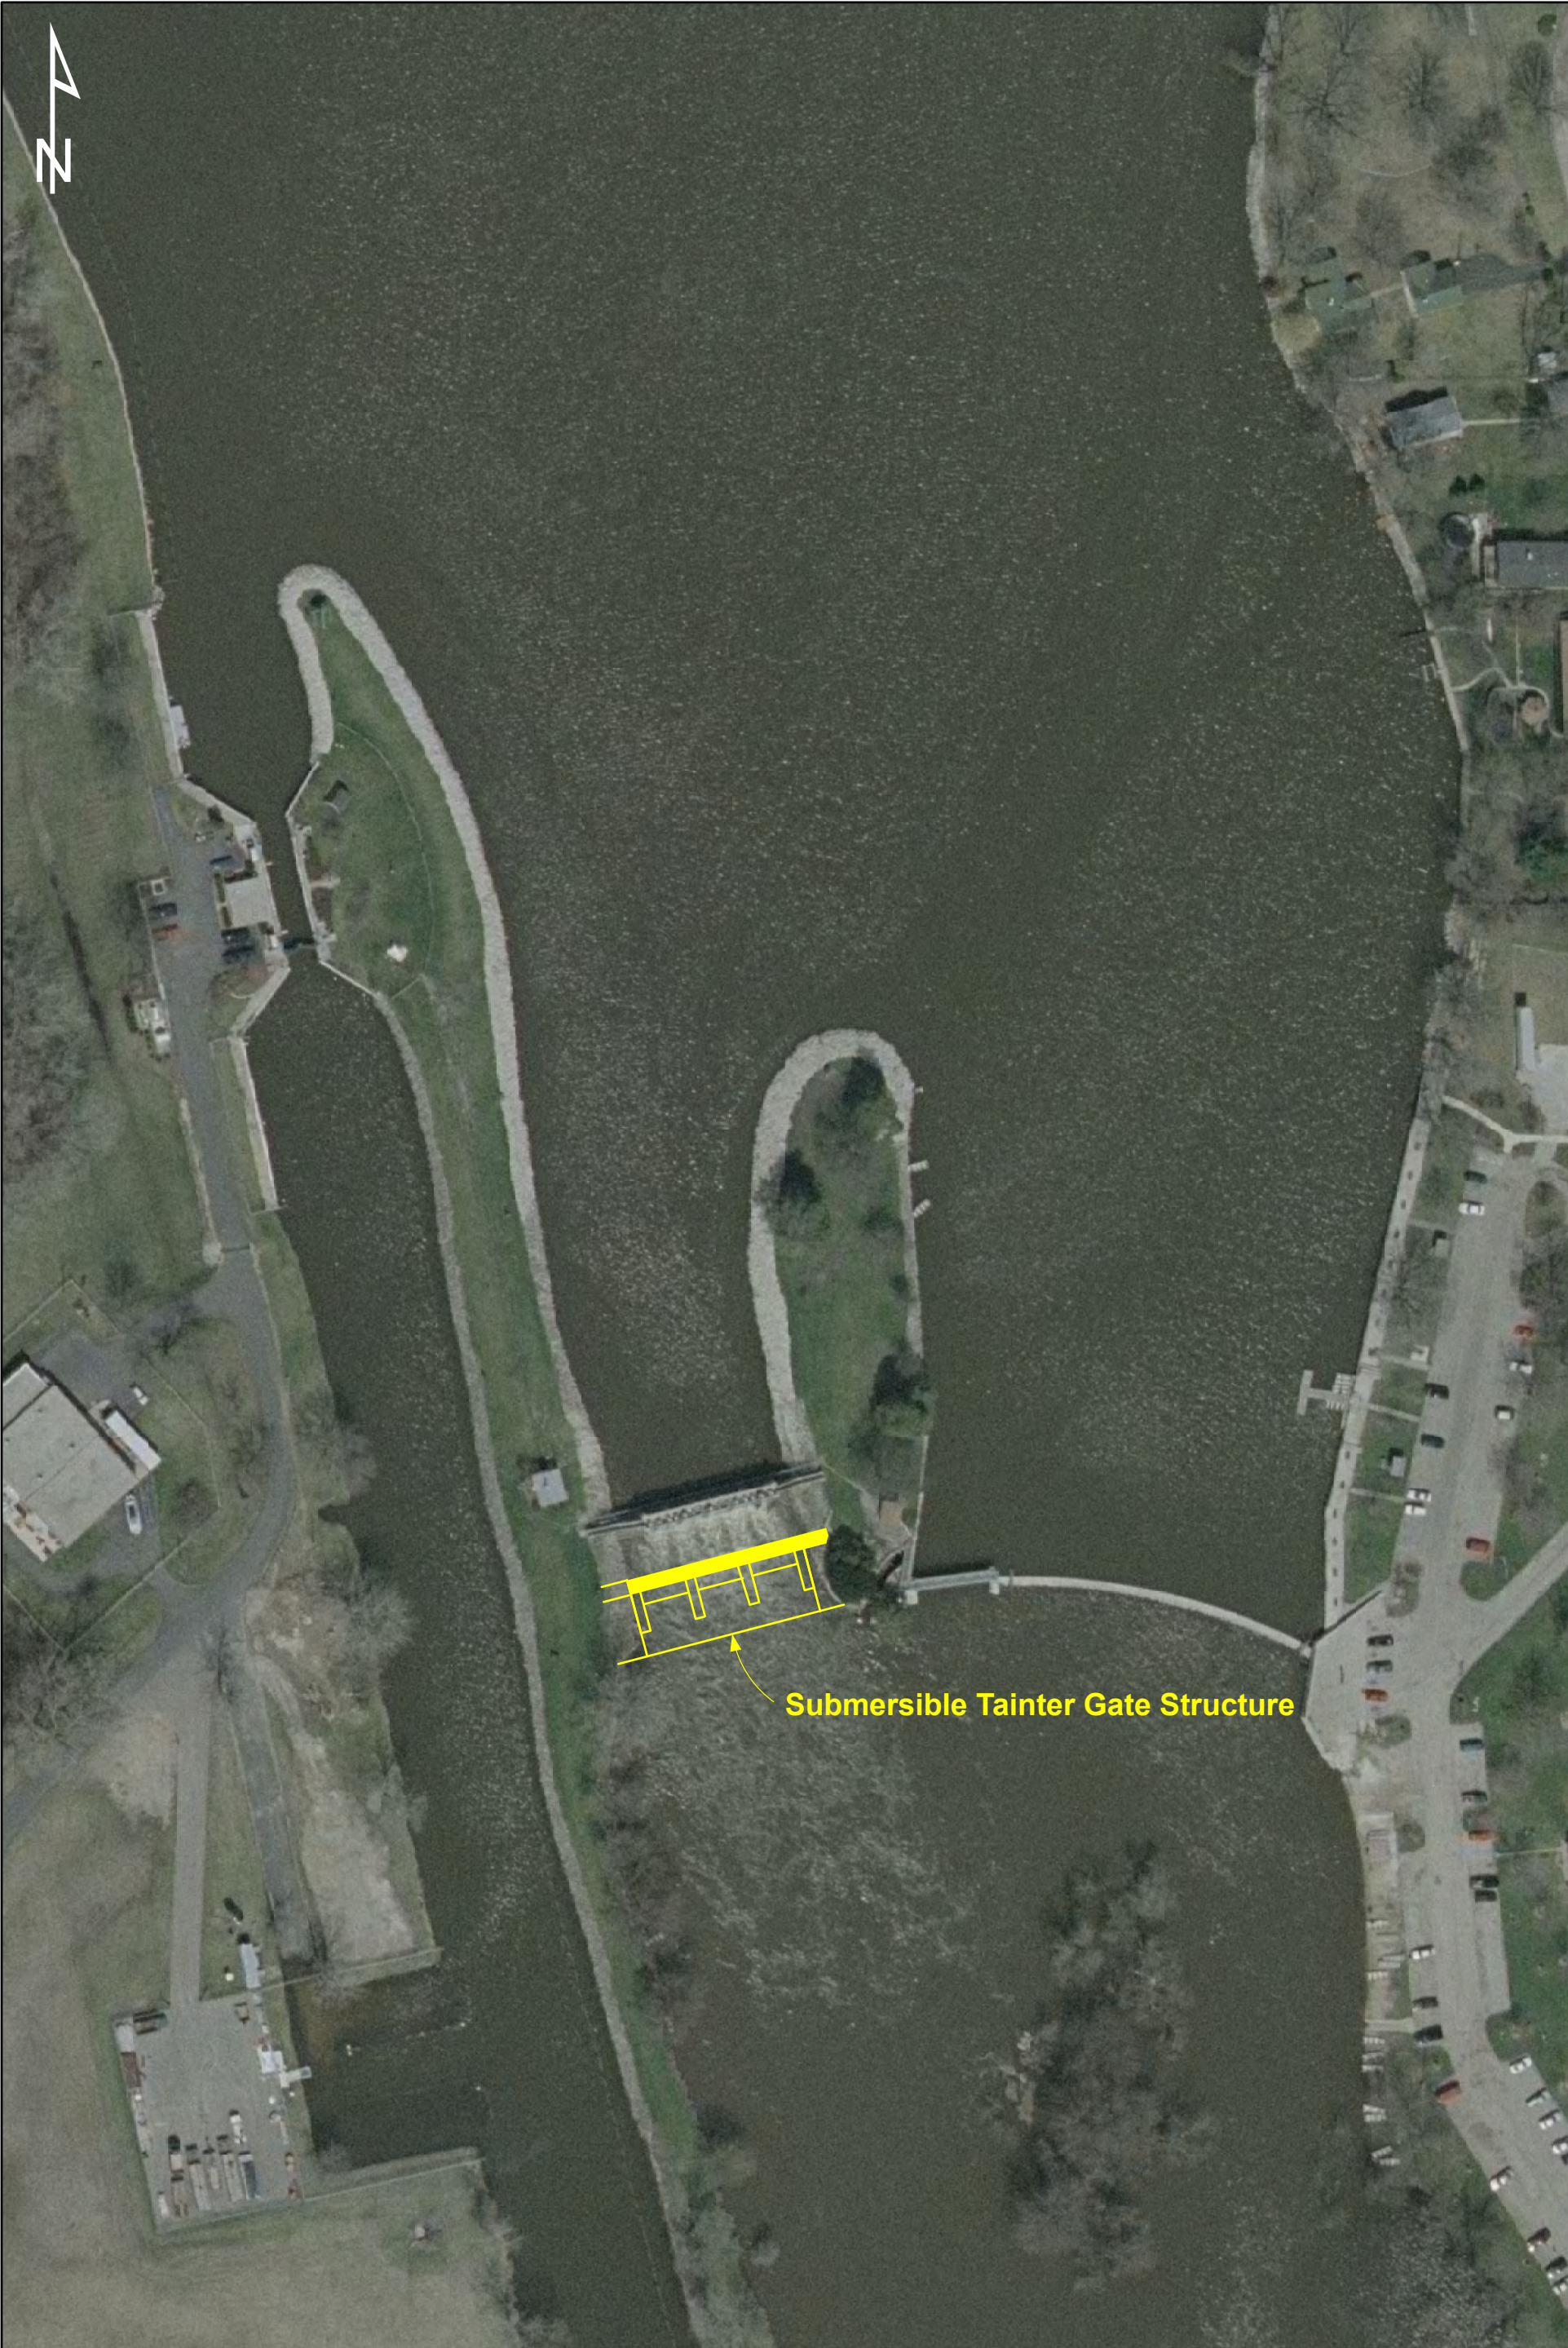
Exhibit #8 - Submersible Tainter Gate

The replacement of the sluice gate structure with a submersible Tainter gate would also provide a gate easily operable in winter. However, this gate type would be the first in the DNR inventory. A conceptual layout is shown in Exhibits 8 and 9. An access bridge over the gates is provided for maintenance. Gate pier and abutment seal plates would be heated with immersion heaters in glycol filled embedded pipe or channels. The gate skin plate would be kept ice free by the continuous flow of water. This type of gate is shown because it offers slightly finer control of upstream water levels, which are important to the Chain-O-Lakes.

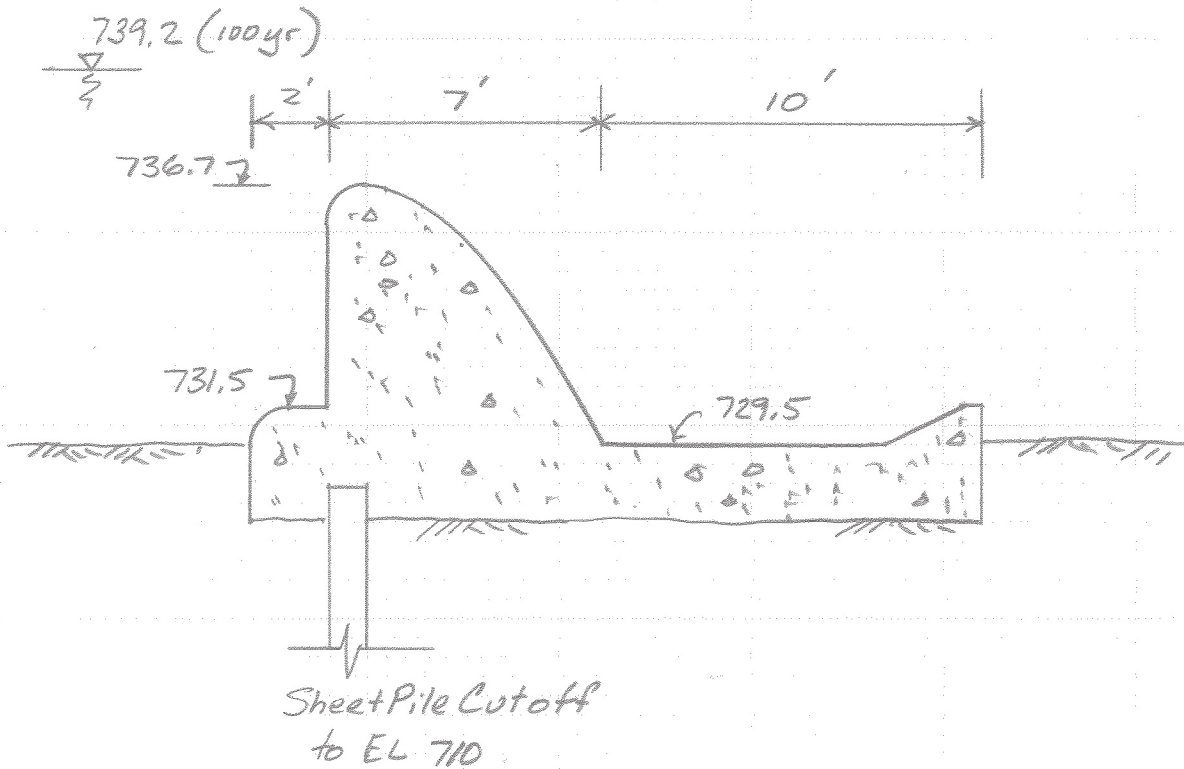
Exhibit #11 - Labyrinth Spillway Section

Labyrinth Spillway Section

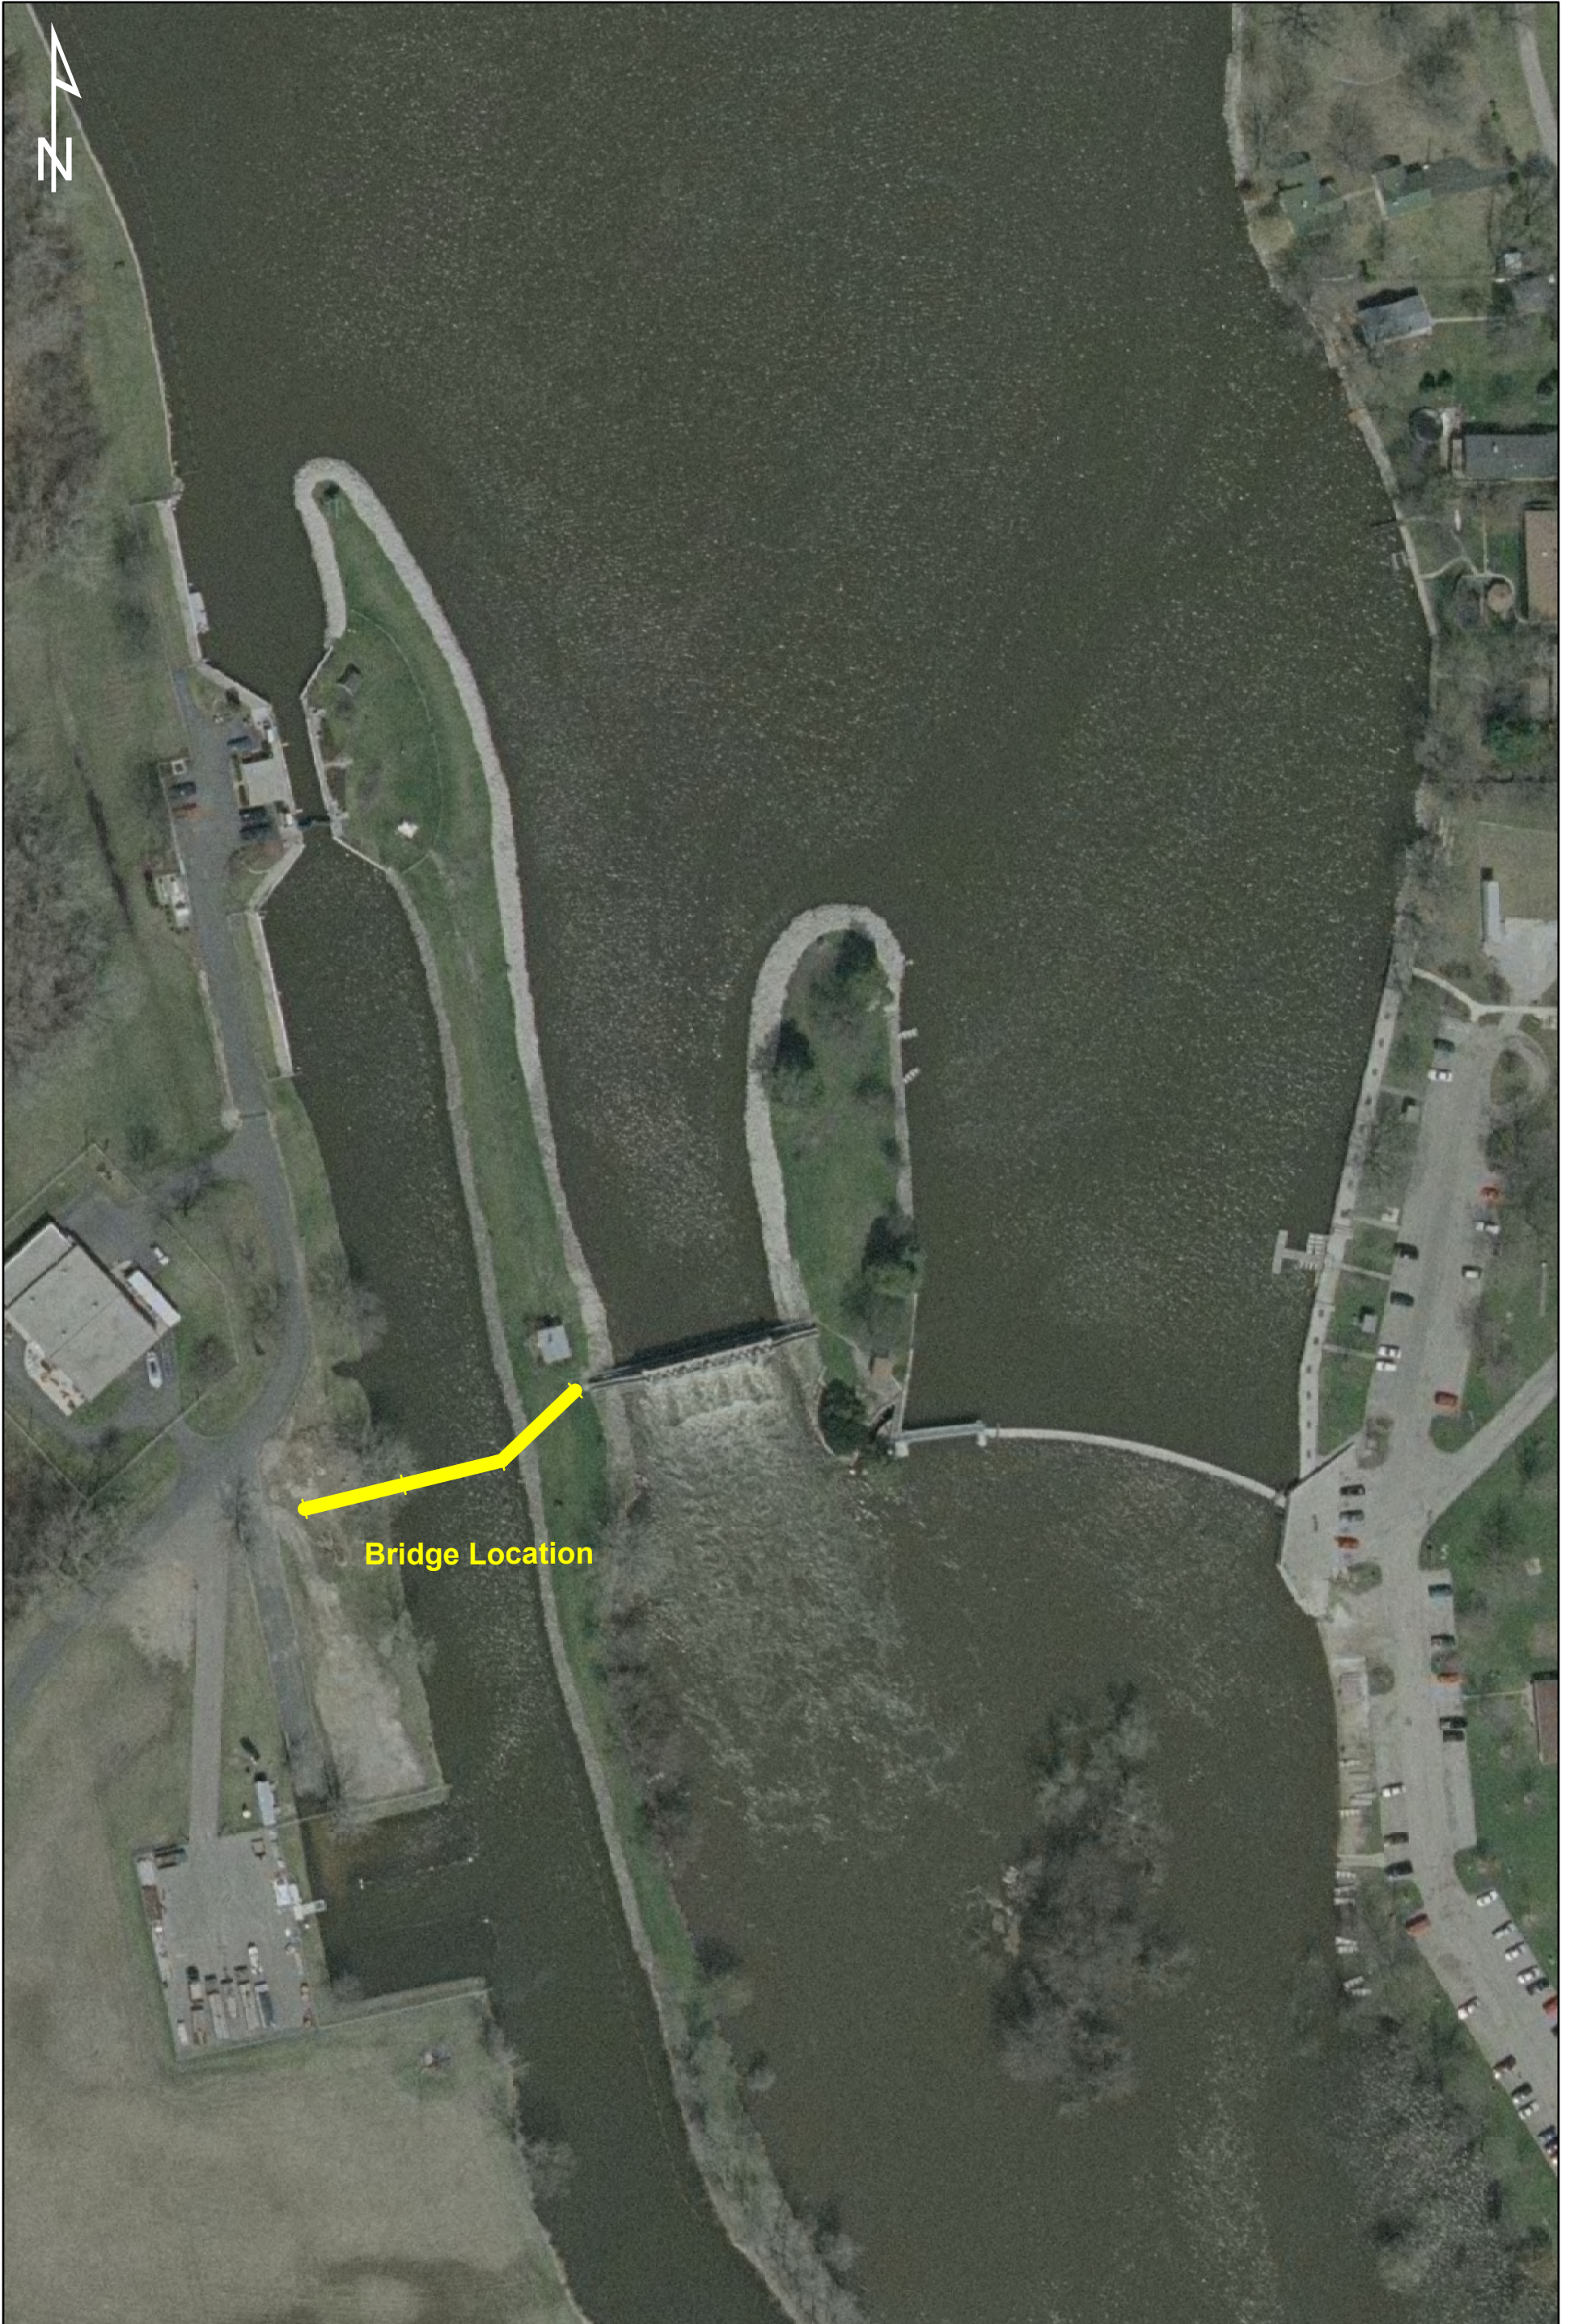
Exhibit #12 - Access Bridge

Currently there is no truck access to the east side of the lock and vertical sluice structure. Such access is possible while maintaining navigation clearance downstream of the lock even if the existing project features and configuration are maintained. If the vertical sluice structure is replaced, as we believe it should be, an access bridge to the new structure would be appropriate. Exhibits 12 and 13 show a possible location and elevation of an access bridge for the existing project configuration. The location of a bridge to a new gated spillway structure would differ slightly. The bridge is envisioned to be a three (3) span pre-engineered structure, fabricated in a factory or shop, then delivered and installed on site on piers and abutments constructed there.

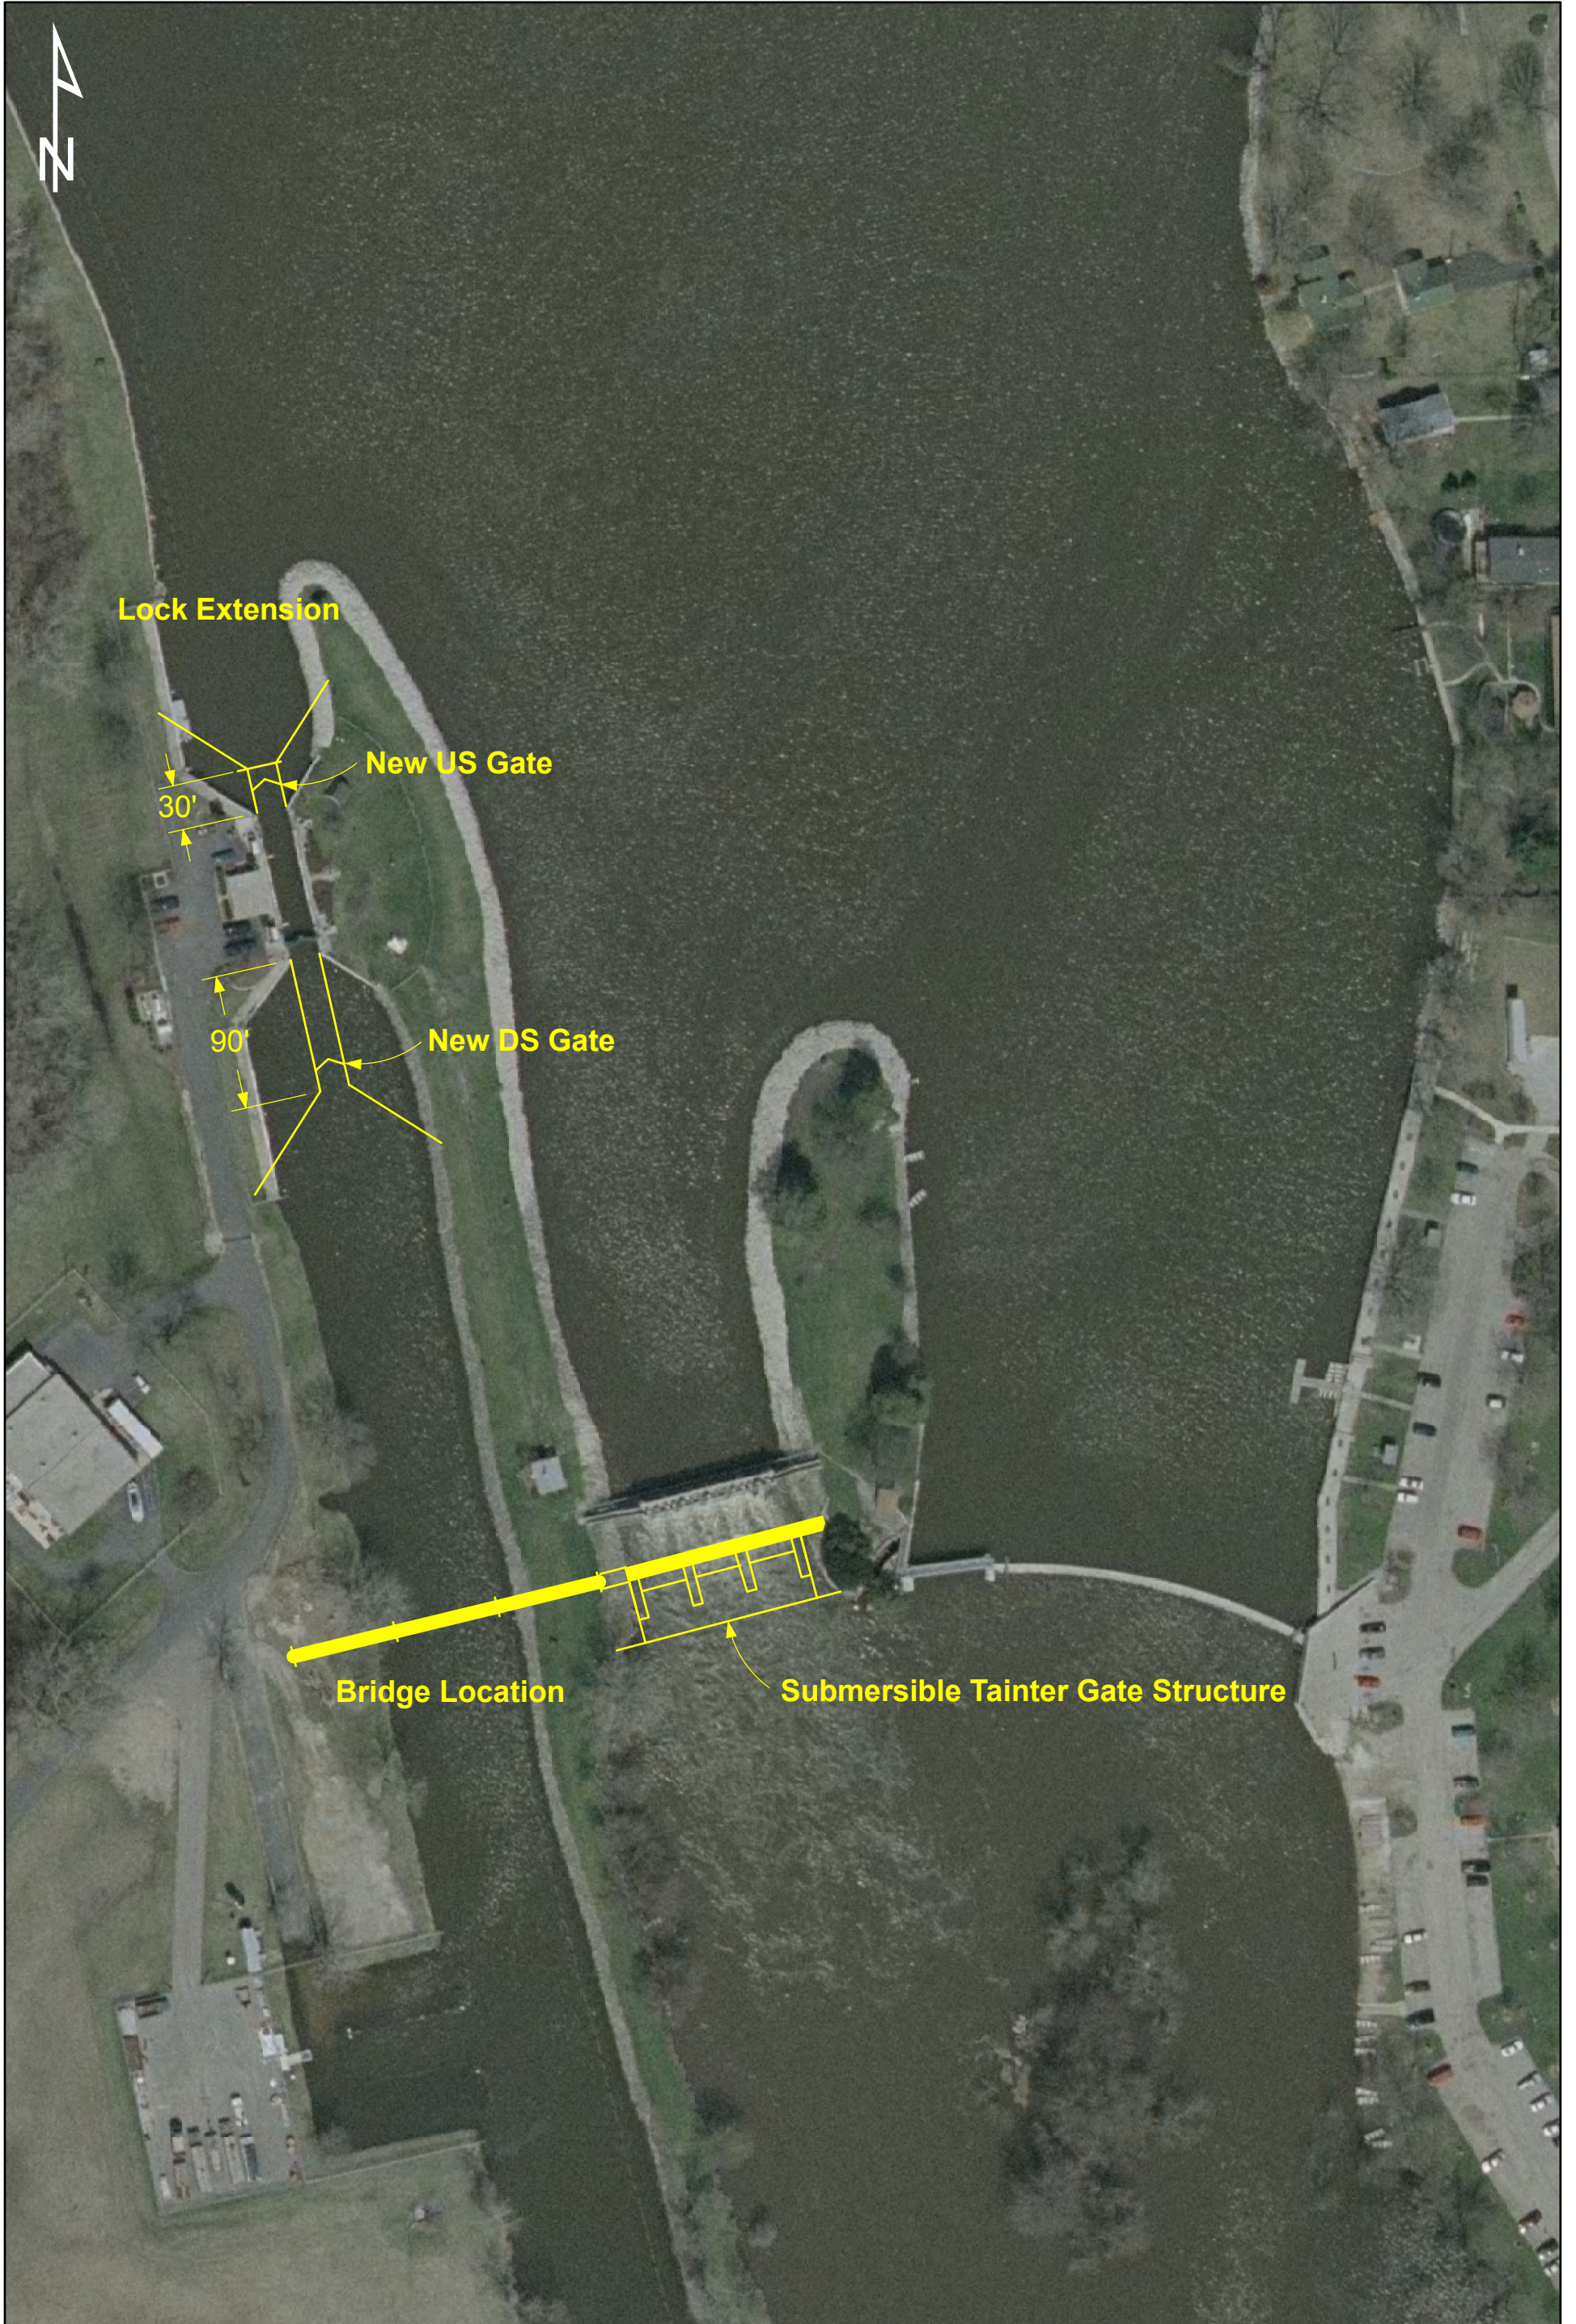
Exhibit #14 - Recommended Reconstructed Facilities

After reviewing the layouts and cost estimates for the various project features the recommended project configuration for a reconstructed Stratton Lock and Dam is as follows and as shown on Exhibit 14:

1. Replace the existing vertical sluice Gate Structure with a Submersible Tainter Gate structure consisting of three (3) – 30' wide gates, 6' high, as illustrated in Exhibit 9. The gate will have the ability to lower its crest by 2' for winter drawdown and permit water to flow over the rear skin plate, keeping it ice free.
